Marina Fire Rockfall Protection: A rapid, practical response

Yeh and Associates, Inc.

Prepared for Submission to the 68th Highway Geology Symposium

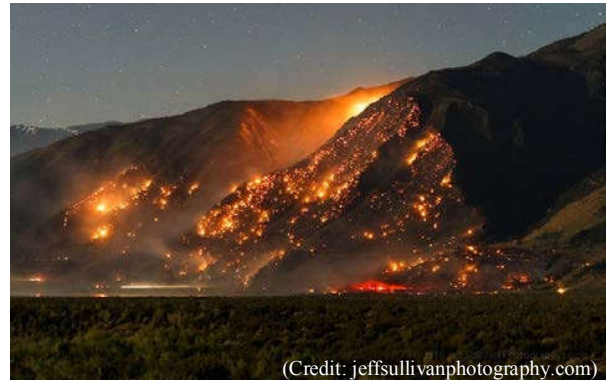
Figure 4. The Marina Fire burning on the slopes above US 395 on June 26, 2016.

The Marina Fire, Figure 4, burned 654 acres of steep slopes between its ignition on June 24, 2016 and its containment on July 7, 2016 (2). The fire was named for its proximity to the nearby old marina on Mono Lake. Prior to the fire, Caltrans had programmed a phased rockfall mitigation project to address rockfall originating from six cut slopes along US 395 from post mile 53.2 to 53.7. Phase 1 of that project had been completed in 2015, with an anchored wire mesh system consisting of cable net with double twist wire mesh backing installed on several cut slopes within the Caltrans right of way where US 395 traverses around Mono Lake. Subsequent to the Marina Fire, this section of roadway experienced rockfall events from source areas outside the Caltrans right of way, and resulted in a need for rapid mitigation of the increased rockfall risk. Phase 2 was temporarily suspended after the fire, until the post fire rockfall risk was mitigated.

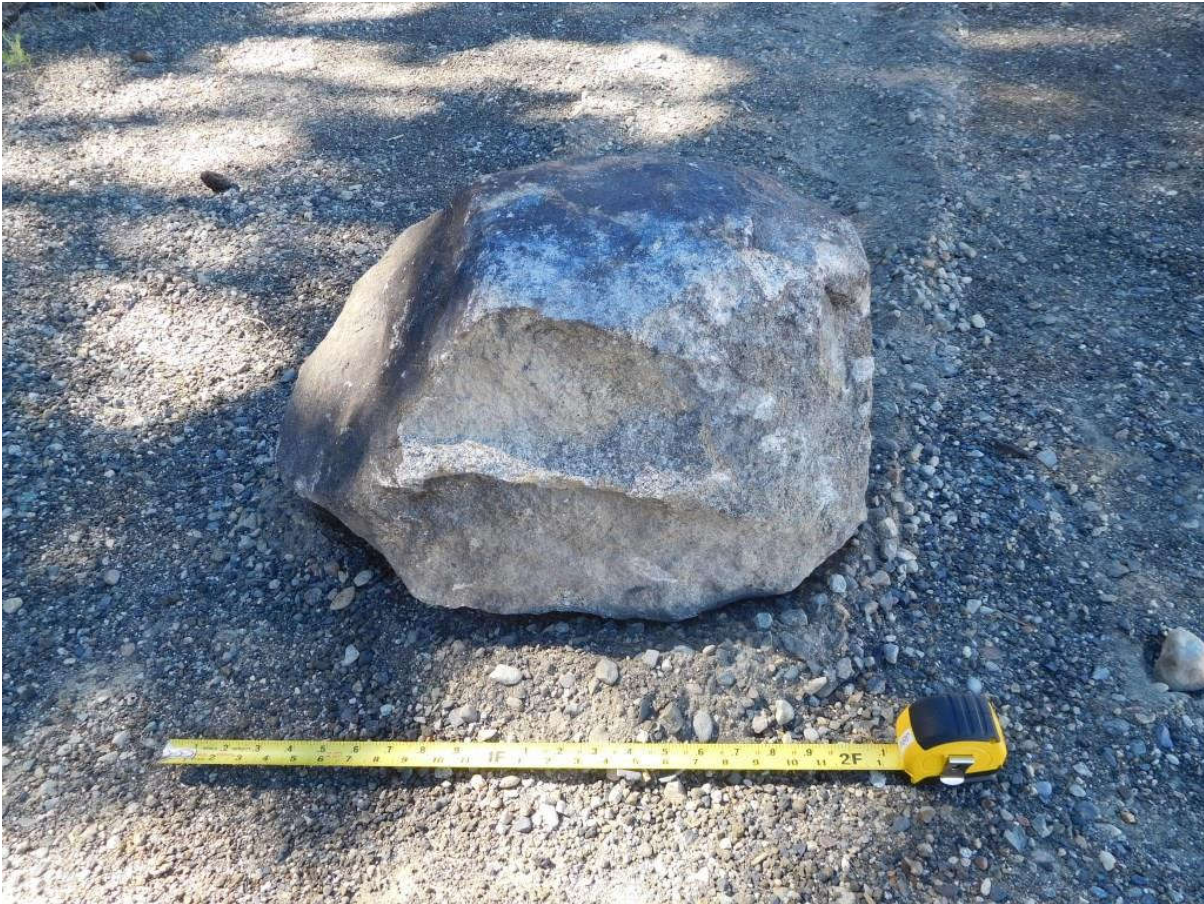
Yeh engineering geologists observed rockfall in the catchment area, Figure 5, and evidence of rockfall impacts to the K-rail along the fog line and to the pavement in the traveled way. Caltrans maintenance personnel reported that a rockfall event had occurred that spalled concrete from the top of the K-rail and crossed into the highway.

Figure 5. Largest rockfall observed in catchment area during field investigation on July 19, 2016.

The largest boulder observed by Yeh engineering geologists in the catchment area within the project limits was a blocky-shaped granodiorite boulder with dimensions 2-ft x 2-ft x 1-ft, Figure 5. The design rock used in this analysis had dimensions 3-ft x 3-ft x 1-ft and was based on rocks observed in the rockfall source areas at the site. The design rock was igneous (granodiorite) and was assumed to have a unit weight of 160 pcf. The weight of the design rock was estimated to be 1,500 lbs. Utilizing the potential energy equation, the maximum potential energy that could be expected from the design rockfall event is approximately 150 ft-tons (408 kJ).

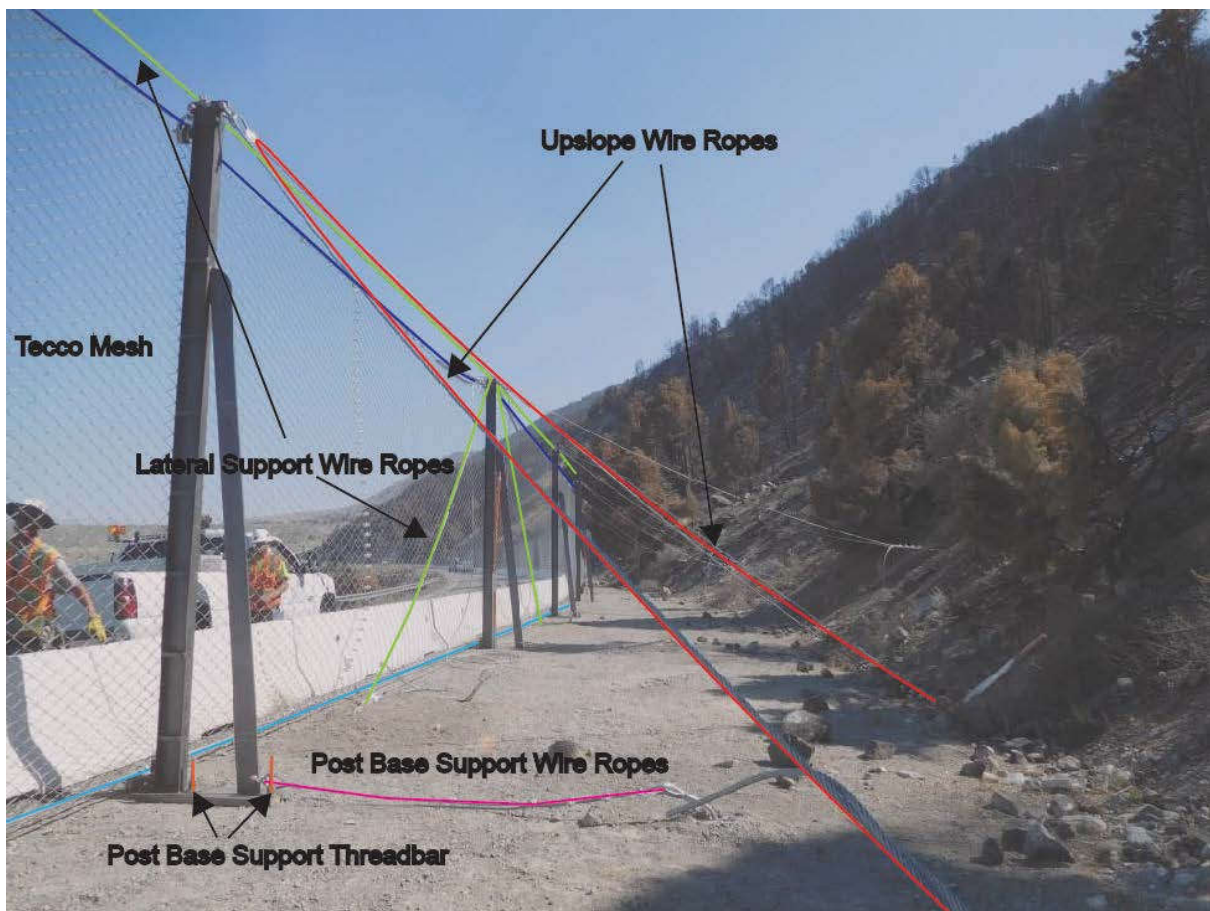
The GBE A model rockfall fence post design is a hinged post and baseplate configuration supported by upslope and lateral wire ropes, while the GBE AR model rockfall fence posts consist of a braced post design welded to a baseplate, without support ropes. For this project, the braced post design was modified, for global support, to accommodate a post base support wire rope, Figure 6, and upslope and lateral support wire ropes. The post base wire rope is attached to the base of the post and attached to a ground anchor installed at the base of the slope. The intent is to prevent the post from kicking out upon impact. The upslope and lateral wire rope supports were installed in typical fashion. For local stability, threaded bars were grouted 18 inches into the ground. The post baseplate was placed on the bar and secured with a nut. While not commonplace today, this type of rockfall fence post support has been in use in California since the early 1990s.

Figure 6. GBE 500AR temporary rockfall fence with upslope and lateral support wire ropes and threaded bar post support.

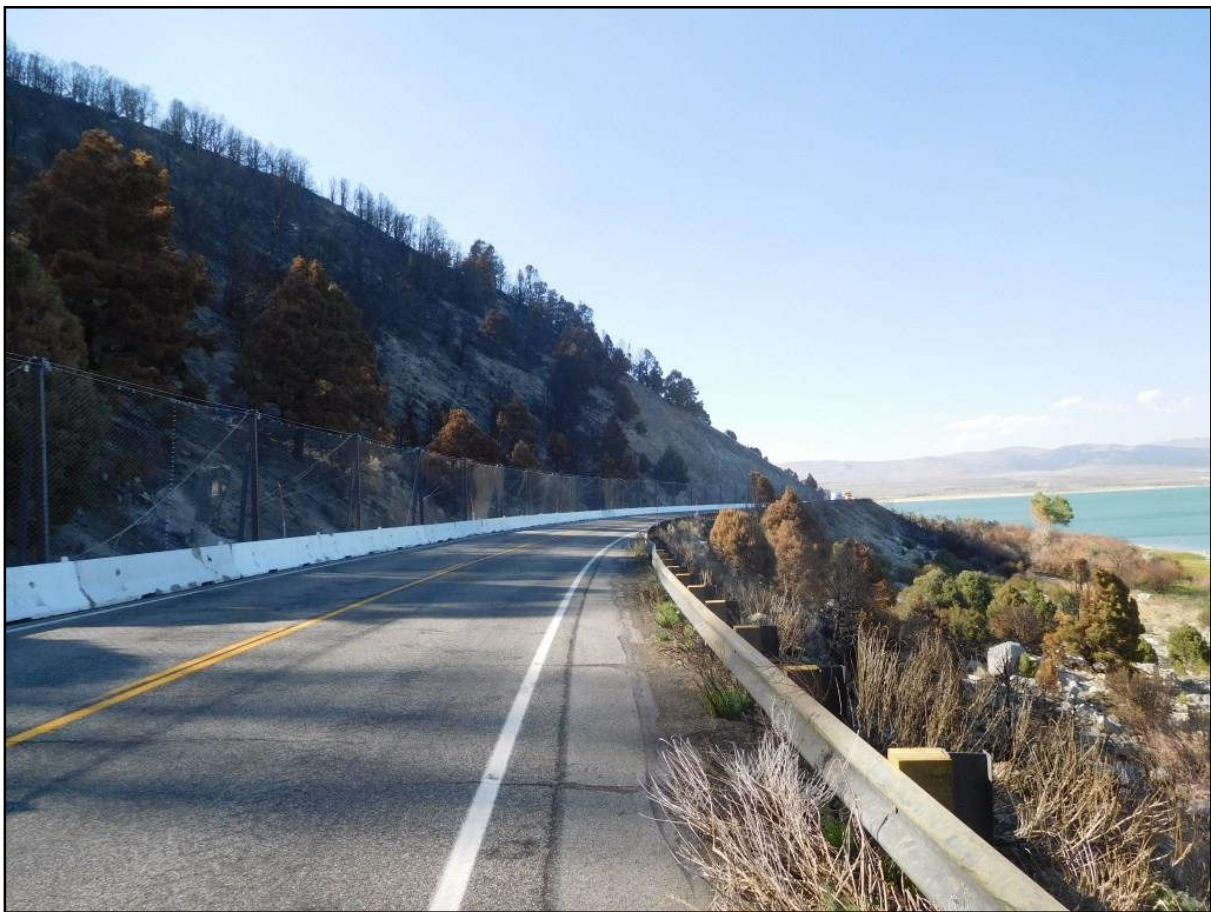
Yeh personnel visited the site on August 10, 2016 and the fence was nearly completed, Figure 7. Final completion of the fence was delayed until later in the fall to facilitate the completion of the temporally suspended Phase 2 of the anchored mesh system.

Figure 7. Completed rockfall fence looking north along US 395
