Marina Fire Rockfall Protection: A rapid, practical response

Yeh and Associates, Inc.

Prepared for Submission to the 68th Highway Geology Symposium

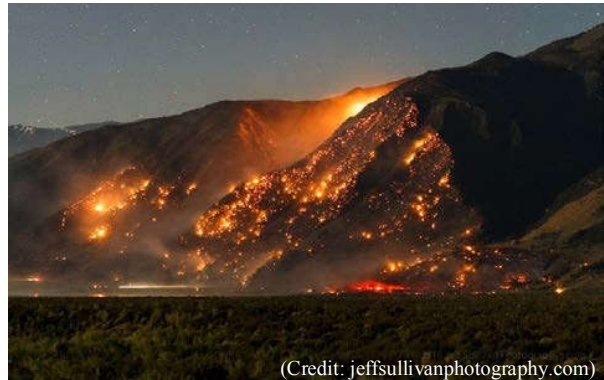
Figure 4. The Marina Fire burning on the slopes above US 395 on June 26, 2016.

The Marina Fire, Figure 4, burned 654 acres of steep slopes between its ignition on June 24, 2016 and its containment on July 7, 2016 (2). The fire was named for its proximity to the nearby old marina on Mono Lake. Prior to the fire, Caltrans had programmed a phased rockfall mitigation project to address rockfall originating from six cut slopes along US 395 from post mile 53.2 to 53.7. Phase 1 of that project had been completed in 2015, with an anchored wire mesh system consisting of cable net with double twist wire mesh backing installed on several cut slopes within the Caltrans right of way where US 395 traverses around Mono Lake. Subsequent to the Marina Fire, this section of roadway experienced rockfall events from source areas outside the Caltrans right of way, and resulted in a need for rapid mitigation of the increased rockfall risk. Phase 2 was temporarily suspended after the fire, until the post fire rockfall risk was mitigated.

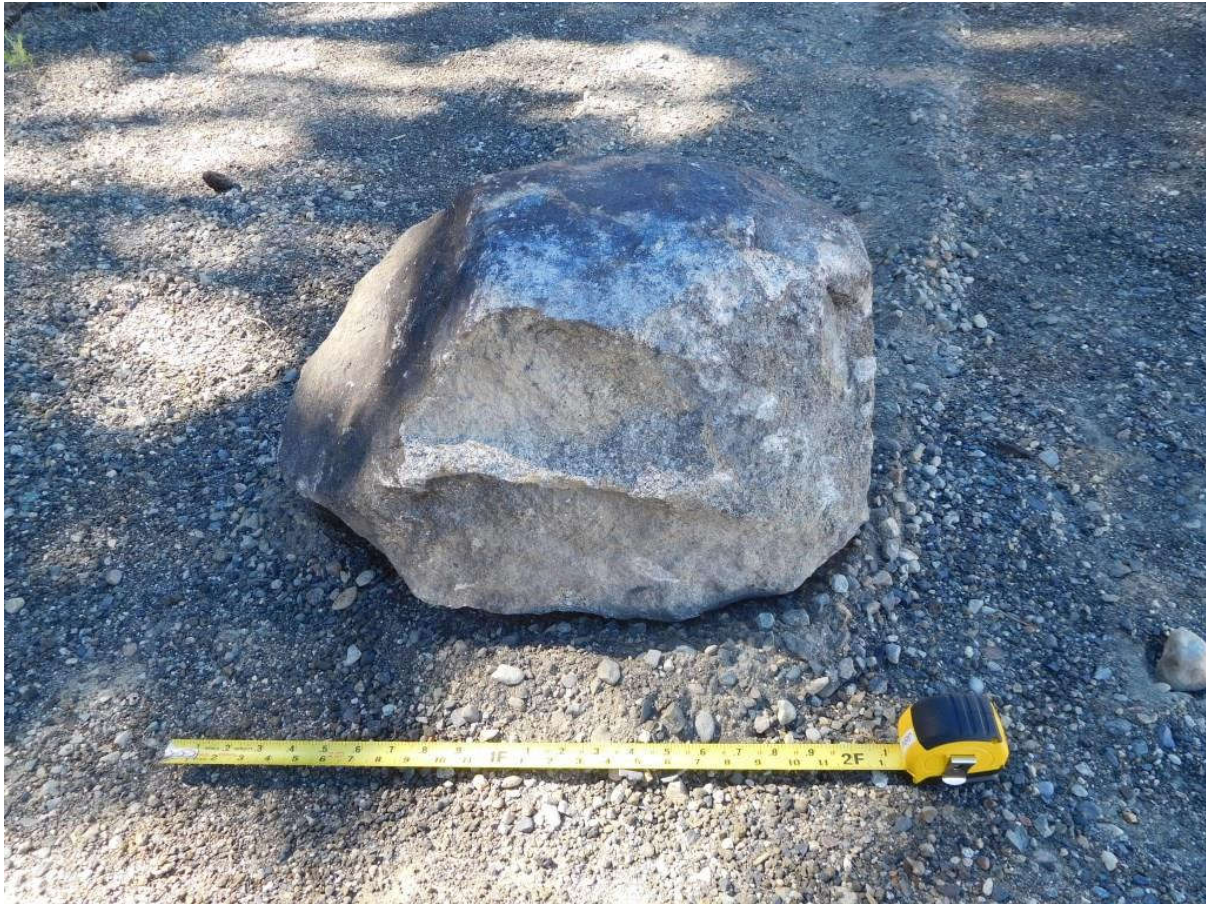
Yeh engineering geologists observed rockfall in the catchment area, Figure 5, and evidence of rockfall impacts to the K-rail along the fog line and to the pavement in the traveled way. Caltrans maintenance personnel reported that a rockfall event had occurred that spalled concrete from the top of the K-rail and crossed into the highway.

Figure 5. Largest rockfall observed in catchment area during field investigation on July 19, 2016.

The largest boulder observed by Yeh engineering geologists in the catchment area within the project limits was a blocky-shaped granodiorite boulder with dimensions 2-ft x 2-ft x 1-ft, Figure 5. The design rock used in this analysis had dimensions 3-ft x 3-ft x 1-ft and was based on rocks observed in the rockfall source areas at the site. The design rock was igneous (granodiorite) and was assumed to have a unit weight of 160 pcf. The weight of the design rock was estimated to be 1,500 lbs. Utilizing the potential energy equation, the maximum potential energy that could be expected from the design rockfall event is approximately 150 ft-tons (408 kJ).

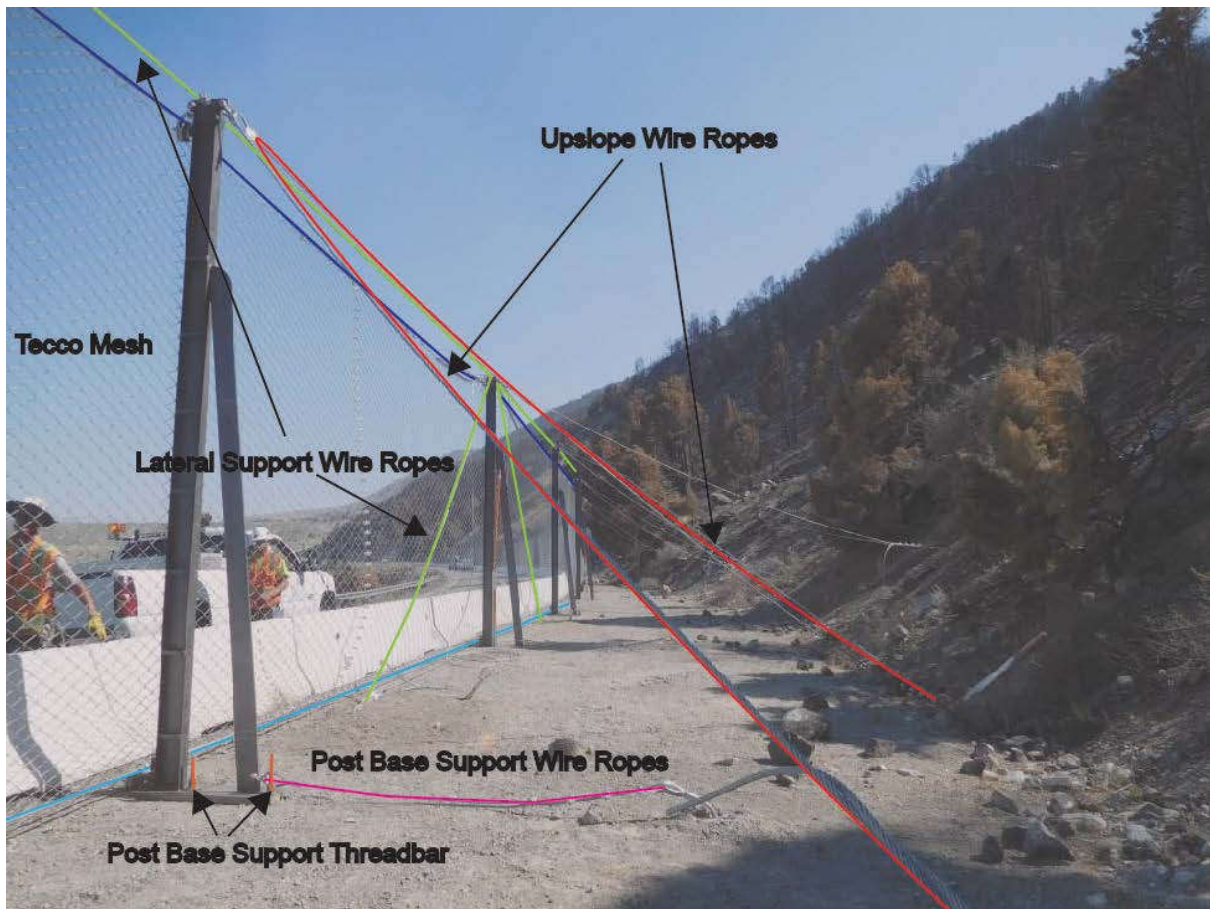
The GBE A model rockfall fence post design is a hinged post and baseplate configuration supported by upslope and lateral wire ropes, while the GBE AR model rockfall fence posts consist of a braced post design welded to a baseplate, without support ropes. For this project, the braced post design was modified, for global support, to accommodate a post base support wire rope, Figure 6, and upslope and lateral support wire ropes. The post base wire rope is attached to the base of the post and attached to a ground anchor installed at the base of the slope. The intent is to prevent the post from kicking out upon impact. The upslope and lateral wire rope supports were installed in typical fashion. For local stability, threaded bars were grouted 18 inches into the ground. The post baseplate was placed on the bar and secured with a nut. While not commonplace today, this type of rockfall fence post support has been in use in California since the early 1990s.

Figure 6. GBE 500AR temporary rockfall fence with upslope and lateral support wire ropes and threaded bar post support.

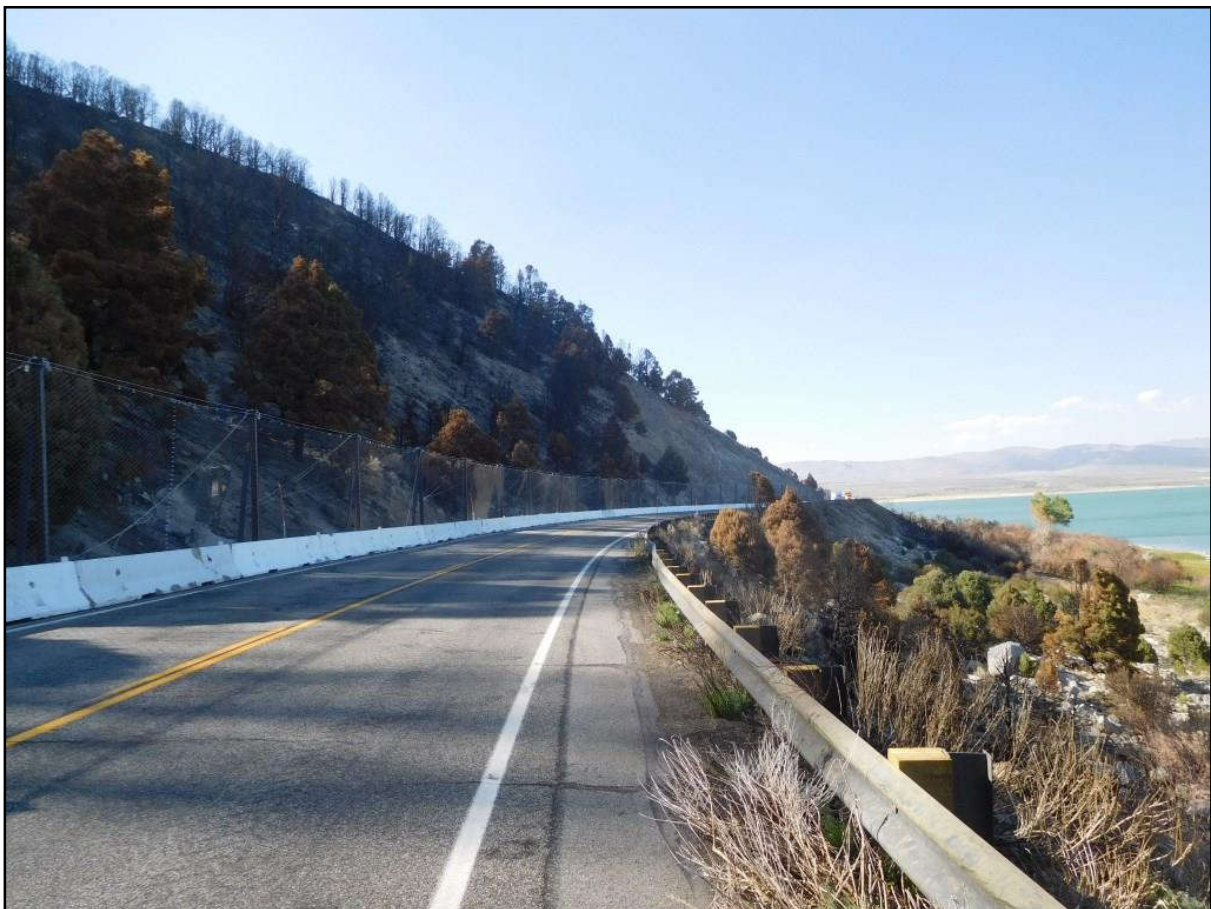
Yeh personnel visited the site on August 10, 2016 and the fence was nearly completed, Figure 7. Final completion of the fence was delayed until later in the fall to facilitate the completion of the temporally suspended Phase 2 of the anchored mesh system.

Figure 7. Completed rockfall fence looking north along US 395

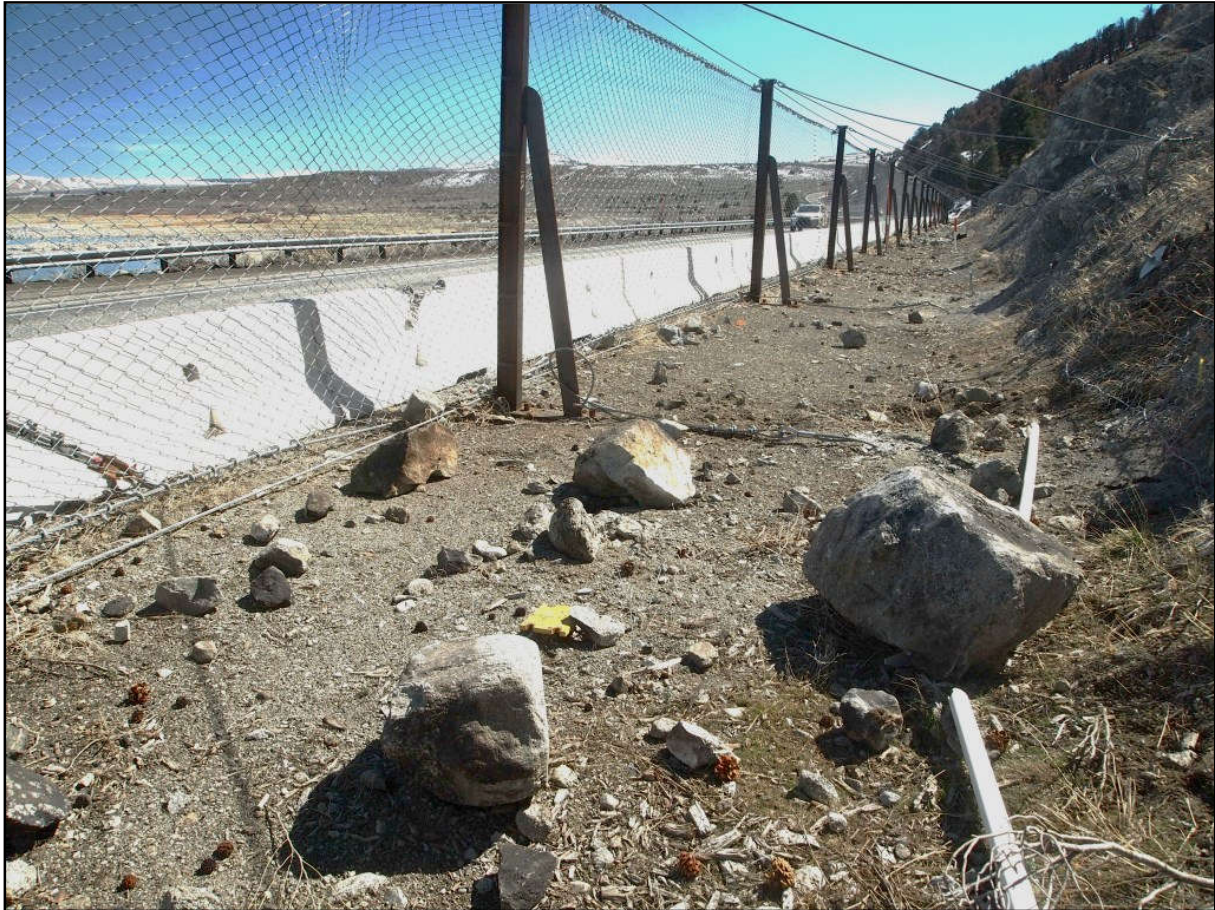
After the fences were installed, Phase 2 of the programmed anchored mesh project began and was completed by the end of November 2016. No significant rockfall events were reported until March 12, 2017 when the 3m GBE 500AR fence experienced an impact in the early morning hours. The event resulted in the rock being retained by the fence, but the impact elongated the

TECCO high tensile steel mesh enough that the force of the impact struck the adjacent concrete K-rail, resulting in a portion of the concrete spalling off into the traveled way, Figure 8.

Figure 8. Rockfall event occurring on March 12, 2017 retained behind 3m Geobruigg GBE500AR flexible rockfall fence. (Photo credit: Joe Blommer, Caltrans)

The source area of the rockfall was approximately 100 ft vertical height on a slope above the 10ft (3m) fence. Based on the damage to the K-rail and the deformed Tecco mesh, it appears that the rock rolled across the catchment with a significant rotational and translational velocity, struck the K-rail and was retained by the fence mesh. Rocks observed in the catchment behind the impacted fence were 3 ft x 3 ft x 2 ft, 2 ft x 2 ft x 1.5 ft, and 1.5 ft x 1.5 ft x 1 ft. K-rail debris was 6 inches and smaller and were reported by the California Highway Patrol to be scattered across the traveled way. The impact did not engage the friction brakes, indicating that the impact was below the upper energy capacity of the fence. While the Tecco mesh permanently deformed, it did not require any repair to maintain its effectiveness.

The system has performed as anticipated, retaining rockfall events up to the design event effectively. Due to the optimization of the catchment area and the need to prevent errant vehicles from impacting the fence, the K-rail remained in place and within the elongation zone of the mesh after the installation of the fence. While preventing traffic from striking the fence, the K-rail has the potential to be impacted by rockfall events and spall off into the traveled way. This occurrence was anticipated at the design phase, and measures to mitigate this undesirable result were recommended, including hay bales and timber lagging between the fence mesh and the K-rail.
