# Flexible Slope Stabilization In Cowichan Bay, BC – Using A High-Tensile Steel Mesh To Stabilize a Steep Eroding Soil Slope

Jillian Jackson, P.Eng.  
*British Columbia Ministry of Transportation Infrastructure*  
*Victoria, BC, Canada*  
Andi Buechi, ASCT,  
*Geobruigg North America, LLC*  
*Kelowna, BC, Canada*

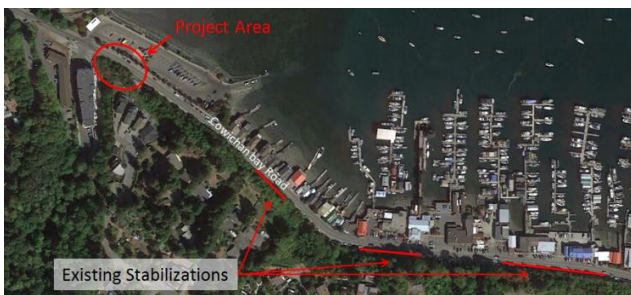
Figure 1. Cowichan Bay Road Slope Stabilization, Plan View.

Cowichan Bay Road is a busy commercial strip and vital hub for the local community, especially in the summer season. There have been numerous shallow landslides and soil falls east of the project location. Where treated, the failures have typically been addressed with concrete block walls see (Figure 1). Concrete block walls have been successful in addressing the slope concerns, but are regarded as somewhat undesirable because they diminish the aesthetics and carry a large footprint, where area is limited.

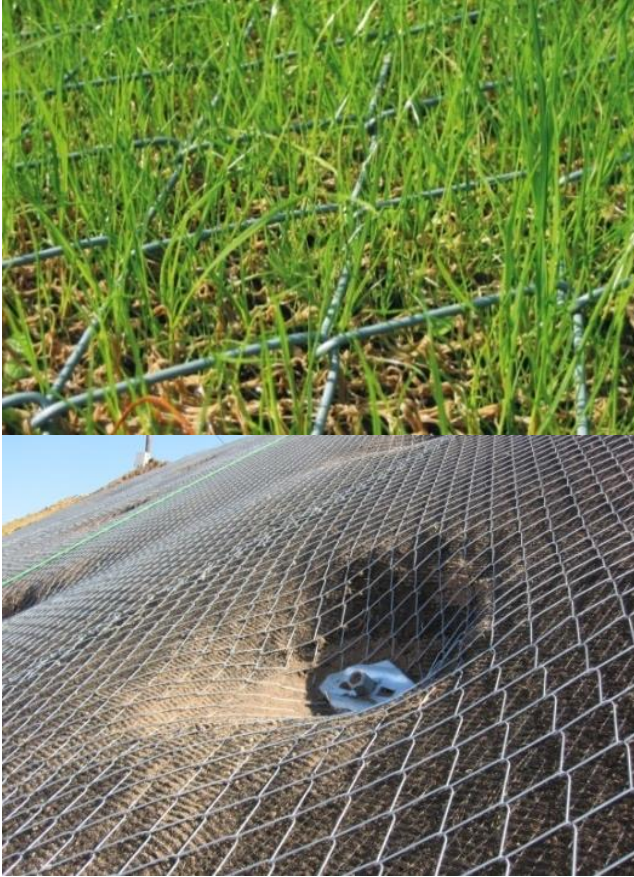
Figure 2. High-tensile wire mesh (upper) and spike plate to tension the high-tensile steel wire mesh against the slope surface (lower).

Aside from the higher bearing capacity, another advantage of high-tensile mesh over conventional mild steel wire mesh is that it has an even load transmission and no weak zones within the mesh. This is achieved by manufacturing high-tensile mesh with the same diameter wire, which forms a unified and homogenous mesh structure. This is achieved by manufacturing mesh with the same diameter high tensile wire, which forms a unified and homogenous mesh structure.

To insure optimal transfer of forces from the mesh to the anchors, a special diamond-shaped system spike plate has been developed. The spike plate matches the load capacity of the mesh and serves to fix the mesh to soil or rock nails. The spike plate design is specifically optimized and is diamond shape for force transmission using a plate designed with ribs (for stiffness), and has additional tabs designed to tightly secure the mesh. Once the nails are tensioned, the spike plates recess into the ground, tensioning the mesh to follow the surface contours (Figure 2 lower).

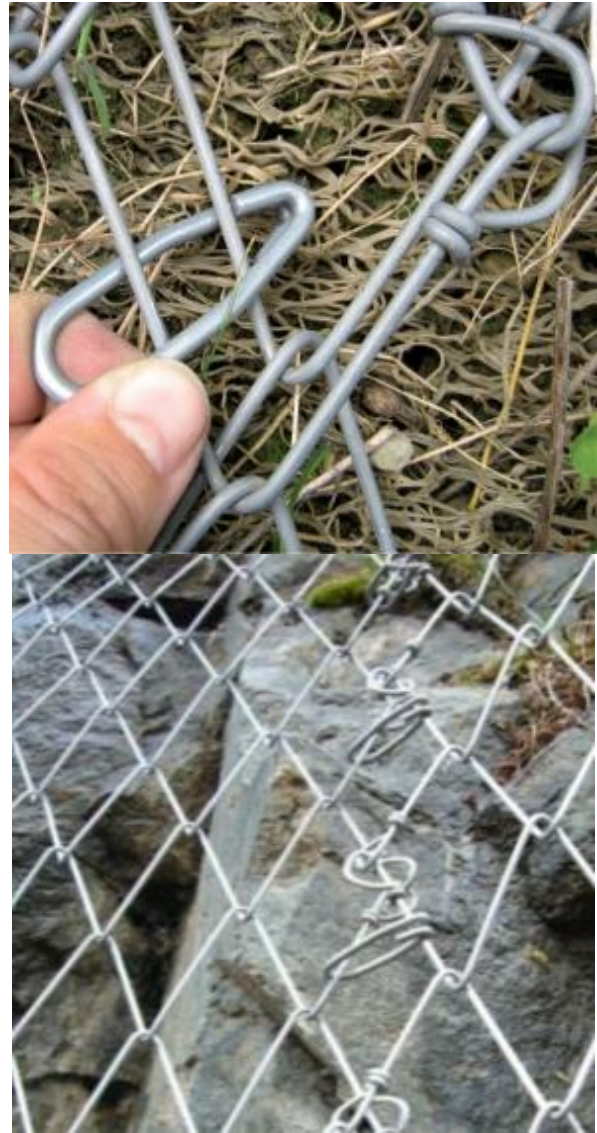
Figure 3. T3 Clip used to connect TECCO panels vertically in rock (lower) and in soil application (upper).

High-tensile mesh systems utilize T3 connection clips to allow for 100% force transmission at the seams and the system therefore has no weak links (Figure 3 lower). The specialized clip is made from the same high-tensile steel wire

and the same corrosion protection as the high-tensile wire itself. The connection clip has a wire diameter of 4mm and has two reversed end hooks on the one side of the clamp. It can easily and quickly be installed by hand without any power tools (see Figure 3 upper). No overlap of the mesh is required saving significant materials and can be connected longitudinally and laterally with only one clip per diamond.

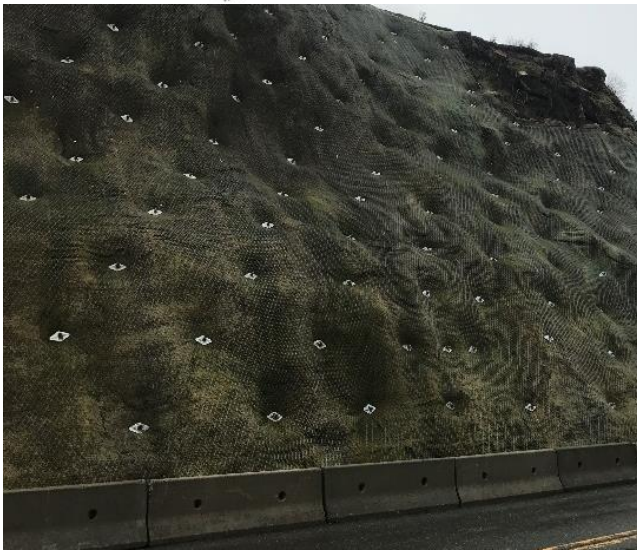
Figure 4. General profile with the nail arrangement (upper) and staggered pattern of nail installations at Cowichan Bay Road (lower).

The main anchors of the system are installed in a grid typically ranging from 2.0 to 4.0m horizontal and vertical spacing. With this slope stabilization system the rows of nails are offset to each other by half a horizontal nail distance. This limits the maximum possible break out between the individual nails to a width “a” and a length of “2 x b”. Actual spacing depends on the results of site analysis and modeling. The staggered layout is shown in Figure 4, with the general arrangement (upper) and the installations at Cowichan Bay (lower).

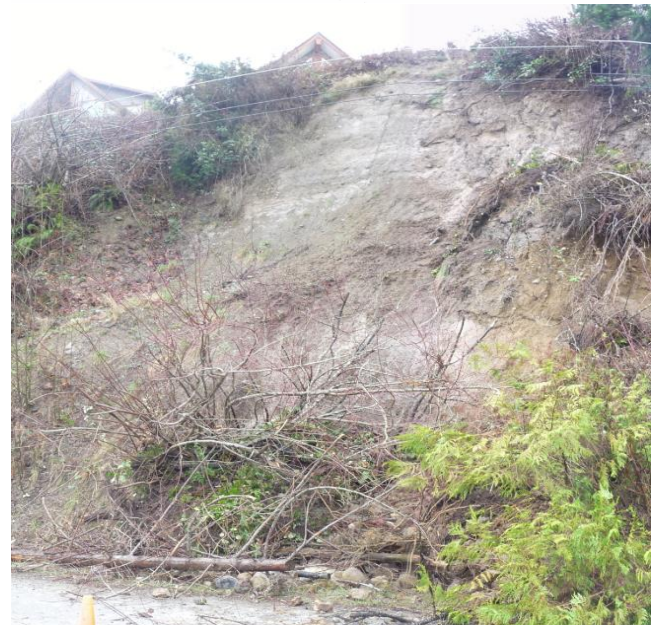
Figure 7. Cross section of the slope mesh installation (upper) and photo of slope at that location (lower).

In detailed design, the crest anchors needed to be redesigned to fit within the property line. Again, using Ruvolum software, the top two rows were redesigned at an inclination of 45 degrees (see Figure 7 below), and the bonded length of install was reduced to 3.5 meters (with an overall install length of 4.5 meters).

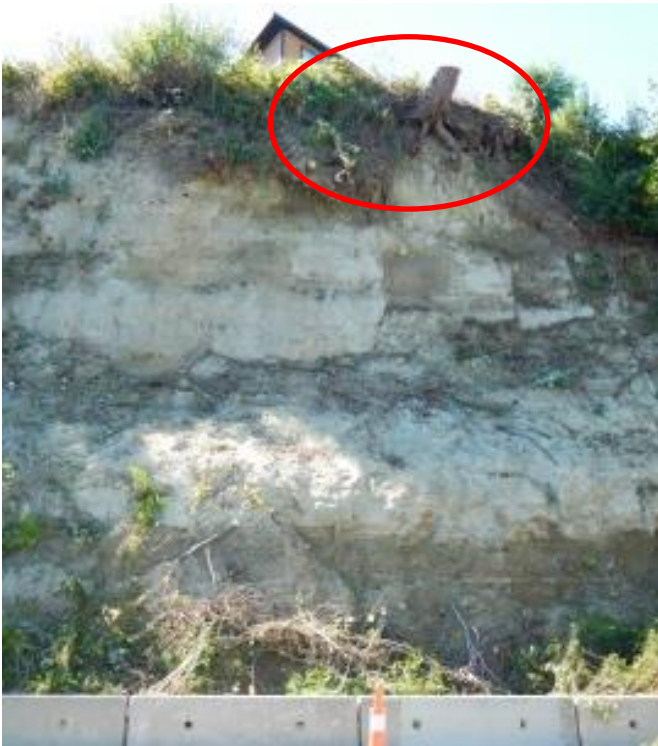
Figure 8. Roots and loose granular soils at the crest.

When shaping, the major focus was a root mass at the crest of the slope directly above the highest and steepest area of sloughing (Figure 8). There was the possibility that in removing the root mass and soil material (potentially including boulders), that too much material would come out of the slope and that the stabilization could not stay within property limits. As a result it was decided to cut the trees as close to the ground as possible, making it possible the stumps could be covered by the erosion mat and tensioned into the slope by the mesh.

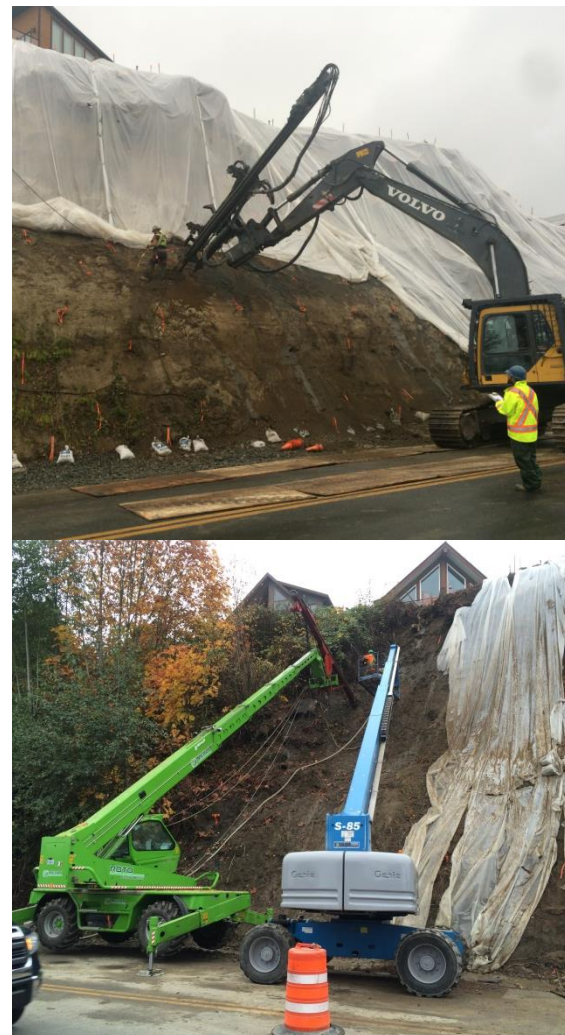
Figure 9. Installation of soil nails with excavator (upper) and zoom boom beside a man-lift (lower).

Following successful performance tests (as outlined in the PTI Recommendation for Prestressed Rock and Soil Anchors, 2004) the contractor began production using two drills mounted on a zoom boom and an excavator (Figure 9 upper). The thread bar installation and grouting was performed using a man-lift (Figure 9 lower)

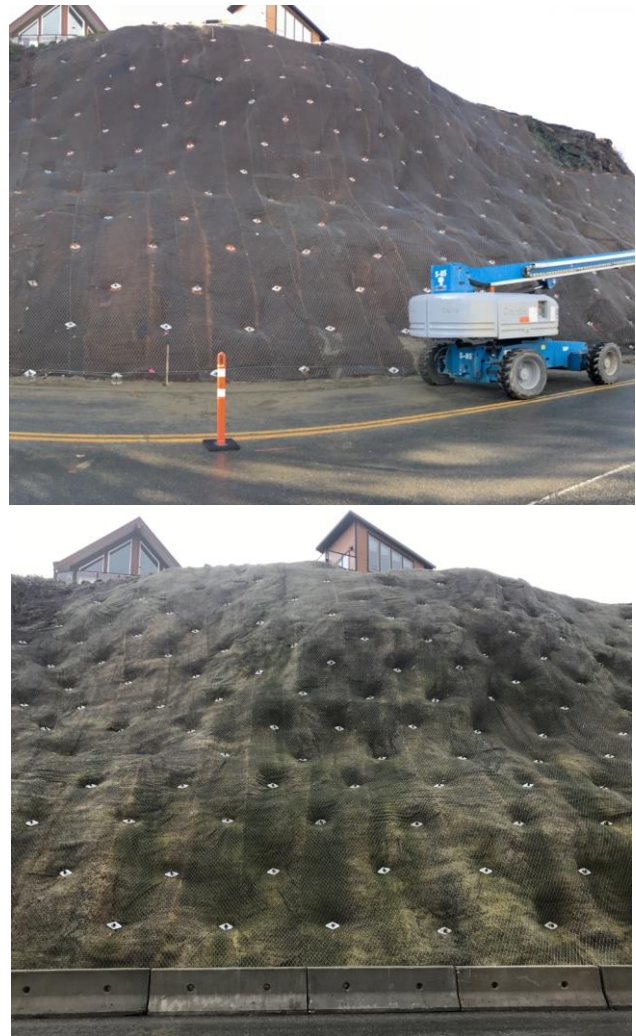
Figure 10. Condition of the slope in October 2016 (upper) and in February 2017 (lower) – in the process of revegetation 4 months later.

Finally, the erosion control mat (American Green SC 250 from Nilex) was rolled down the slope, and the mesh was then installed and pre-tensioned as per the design manual. The slope was hydroseeded on the soil slope before the erosion mat was installed and on top of the system installation (Figure 10 upper and lower).
