WISEMANSBRIDGE PEMBROKESHIRE, UNITED KINGDOM

Rockfall Protection

Project	Wisemansbridge Pembrokeshire
Location	Saundersfoot
Country	United Kingdom
Year of installation	2016
Customer	Pembrokeshire County Council
Engineering Contractor	Geobrugg ABCAS
Initial situation	After winter storms a small landslide had accured east of our existing 2014 installation.
Description	<p>It was decided to build an additional 60 m of GBE-100A-R barrier to protect the coast path and the public.</p> <p>The day after the installation period an additional rock fall occurred. The foot path was able to remain open as the materials stayed behind the barrier. The fence was then lowered, cleared and repaired. A small section of 6 metres of TECCO G80/4 material was ordered to make the fence look as new. No mesh destruction was detected.</p> <p>Impact, December 2020 Not only the rockfall barrier worked perfectly. Also, the Geobrugg GUARD, installed in February 2020, did its job by detecting the impact and monitoring the high corrosion rate in this coastal environment (see pictures).</p>

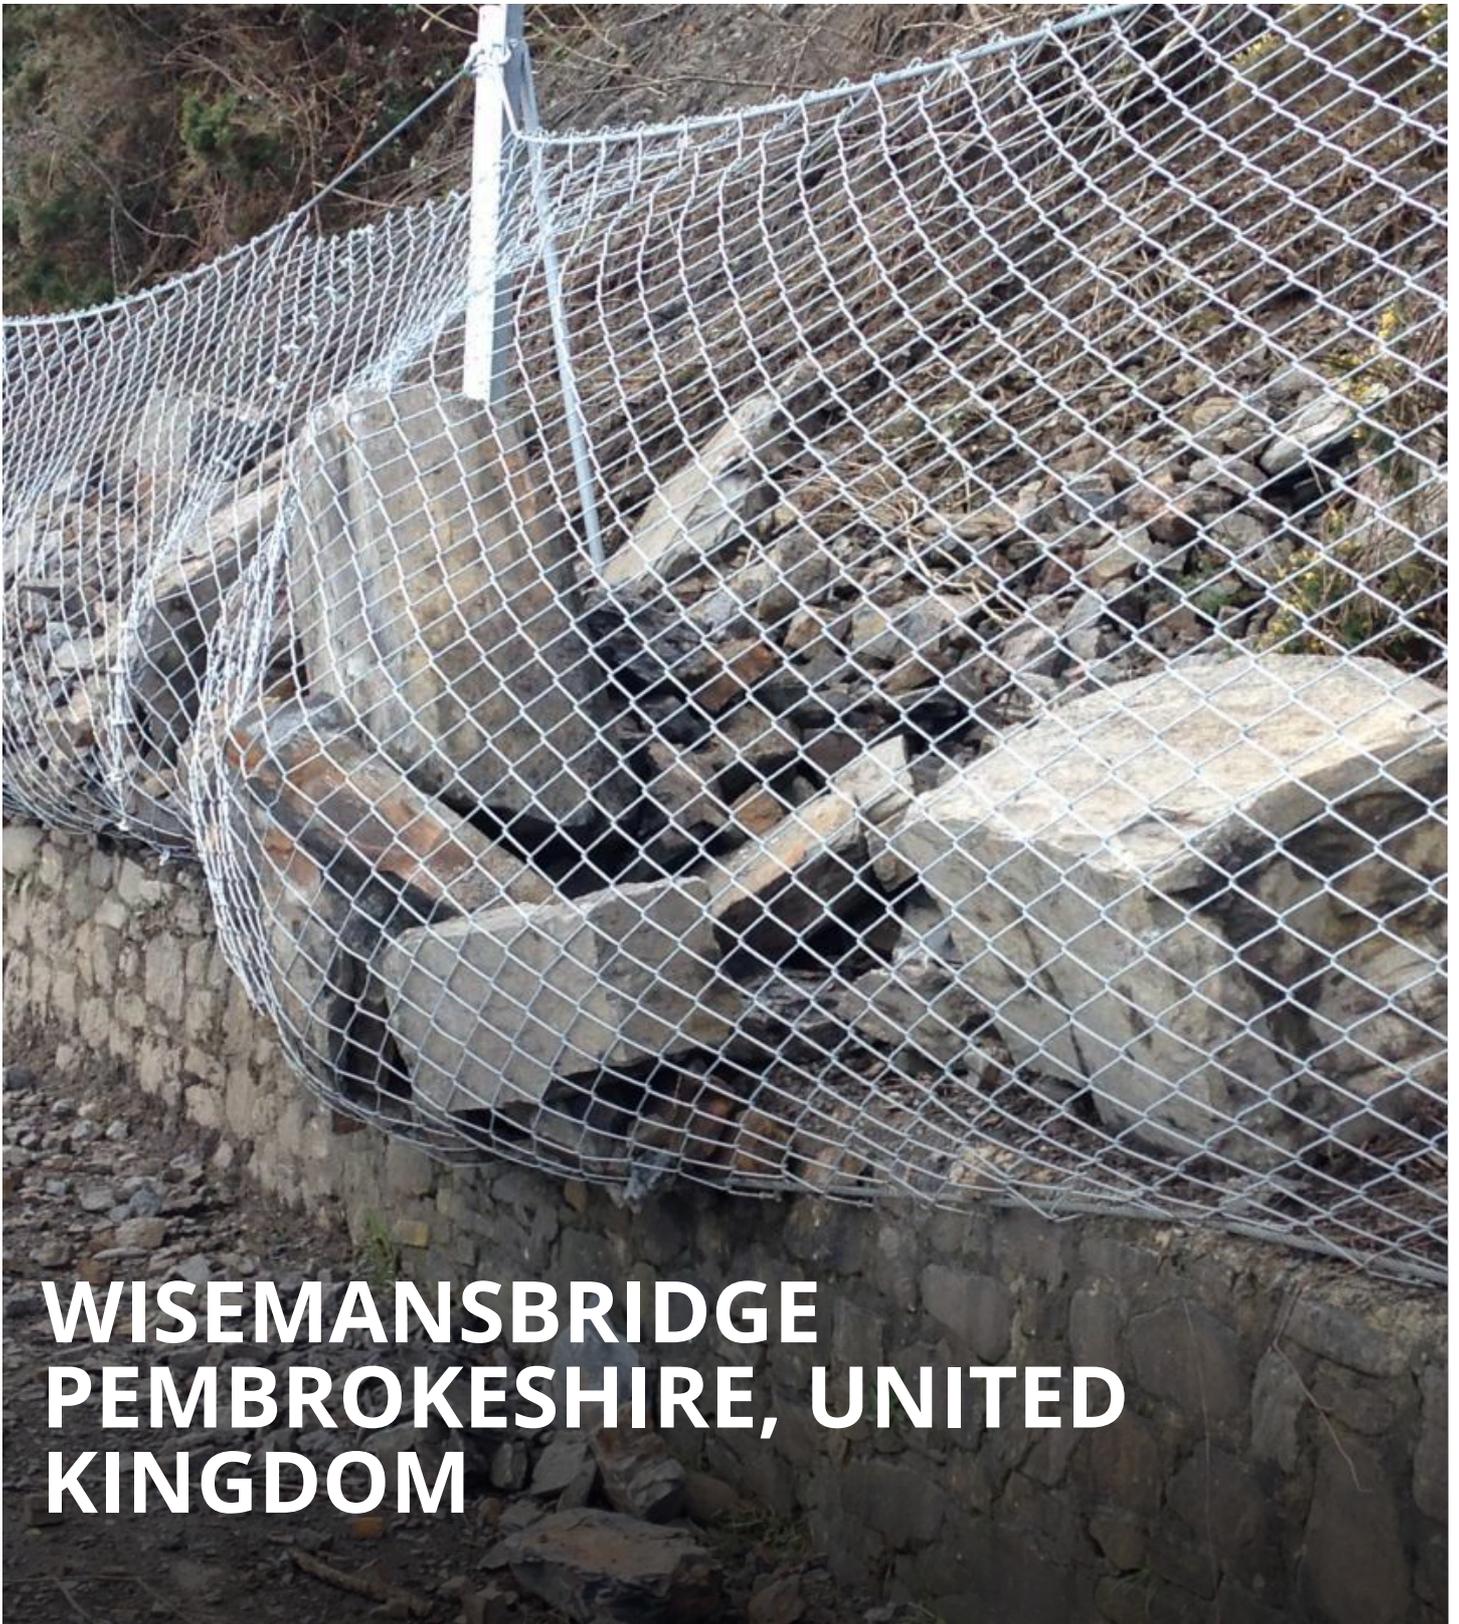
Protected object	Touristic infrastructure
Other installed applications	Monitoring
Corrosion protection	GEOBRUGG SUPERCOATING
Energy absorption capacity	100 kj
System height	2.0 m
System length	60 m
