COCKERMOUTH CASTLE, UNITED KINGDOM

Slope Stability

Project	Cockermouth Castle
Location	Cockermouth
Country/Region	United Kingdom
Year of installation	2016
Customer	Cockermouth Castle
Contractor	CAN Geotechnical
Initial situation	Following heavy storms and flooding in 2015 significant erosion was caused to the riverbank under the castle.
Description	In conjunction with the geotechnical contractor, who had already decided the slope needed soil nailing and TECCO® System, we looked to optimise the solution for the fine grained nature of the soil. We suggested the use of the TECCO® G45/2 in conjunction with an erosion control mat.
Protected object	Touristic infrastructure, Other
Corrosion protection	GEOBRUGG SUPERCOATING
Geology	Quaternary fluvial sands.
Stabilized area	840 m ²
Maximum slope height	20 m
Erosion control mat	Yes
Exposition	-

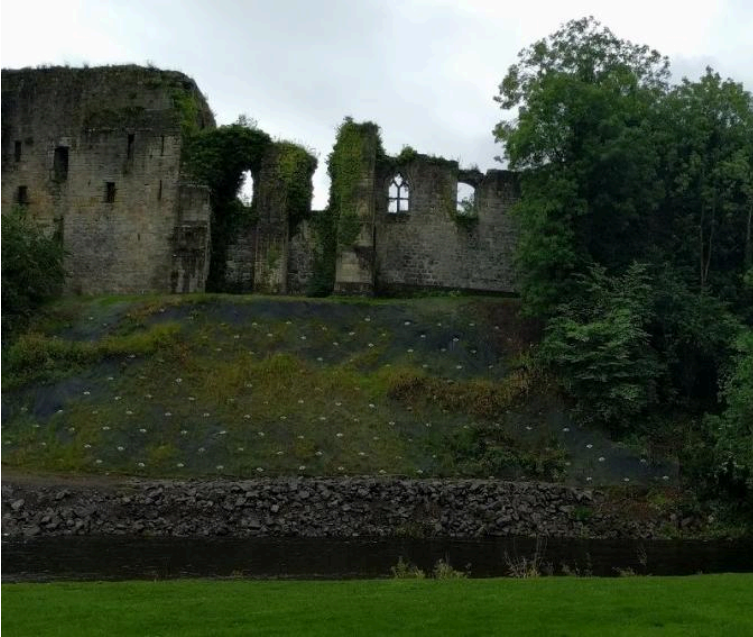
First summer after project completion showing first signs of re-vegetation

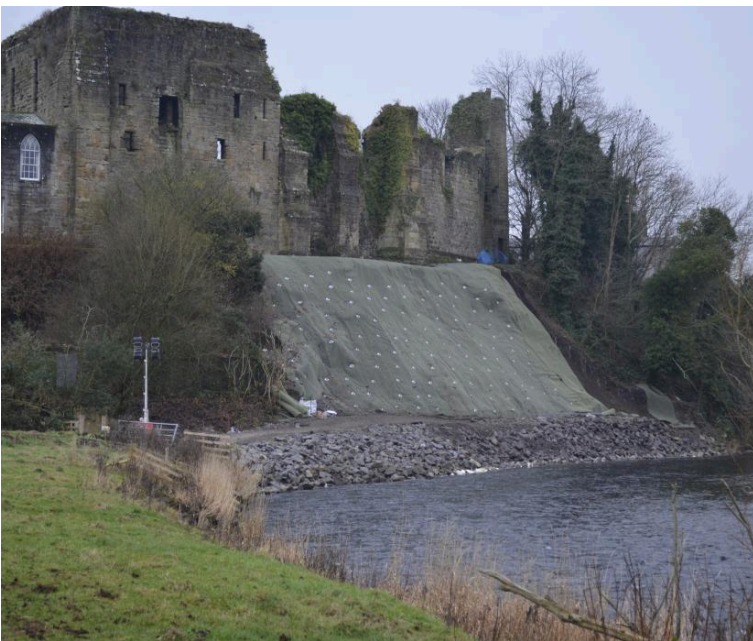
Cockermouth Castle slope after restoration works using TECCO® G45/2 mesh, system spike plates type P25 and nailing

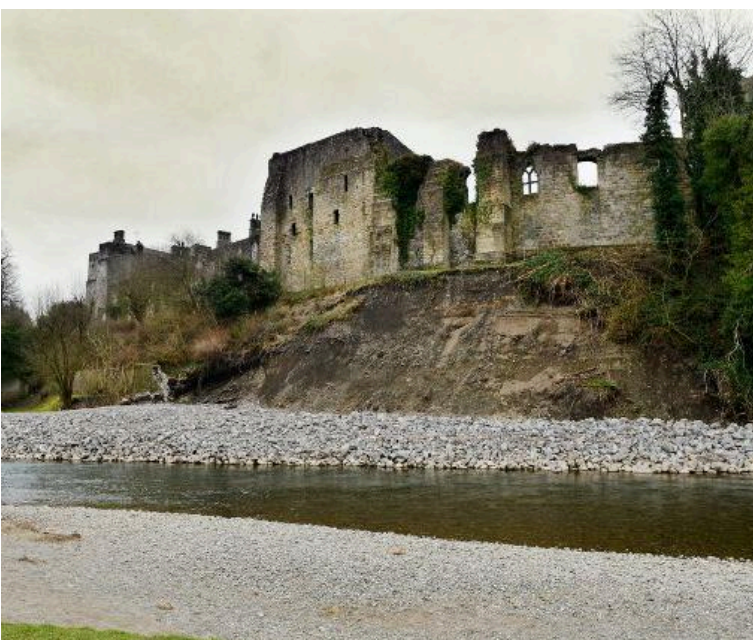
Overview of the slope failure directly endangering the Cockermouth Castle

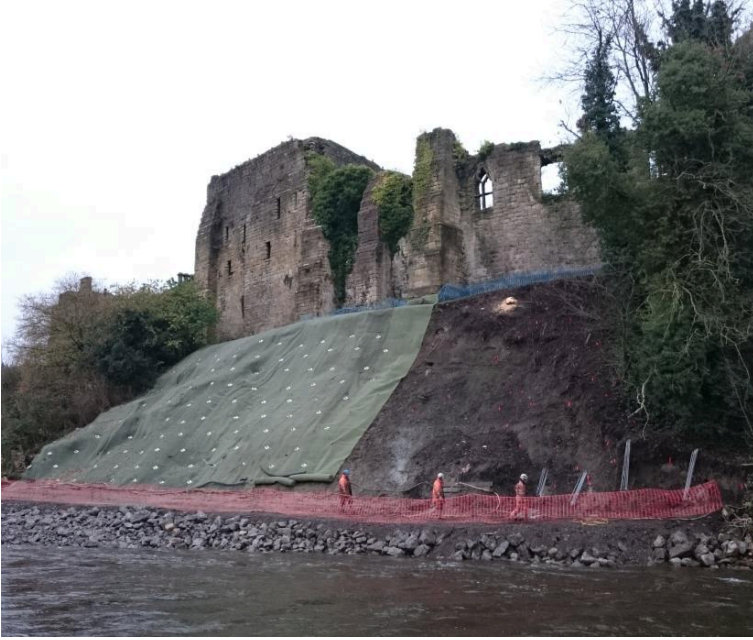
Part way through the installation of the TECCO® SYSTEM³. The smallest part of the failure is visible on the right

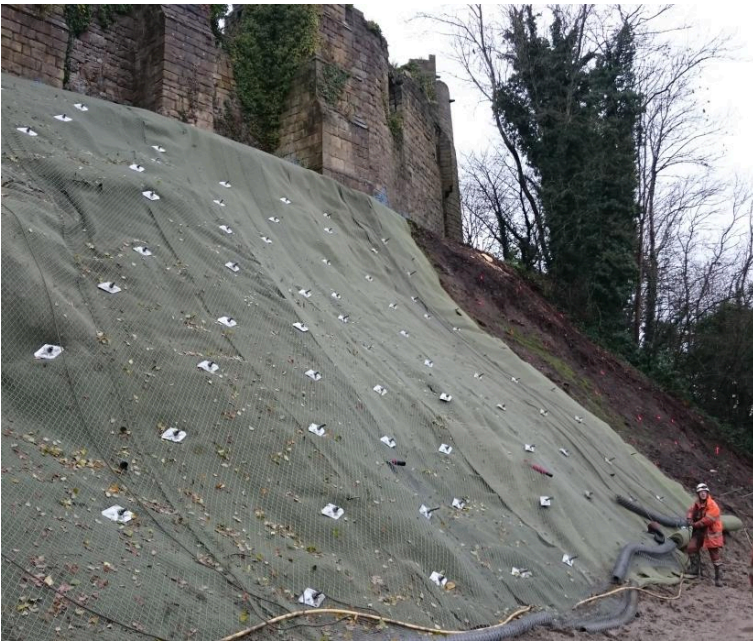
Close up of the completed solution - visible fine but lightweight structure of the high tensile steel mesh TECCO® G45/2
