Slope Protection

COCKERMOUTH CASTLE, UK

Project	Cockermouth Castle
Location	Cockermouth
Country/Region	United Kingdom
Year of installation	2016
Customer	Cockermouth Castle
Contractor	CAN Geotechnical
Initial situation	Following heavy storms and flooding in 2015 significant erosion was caused to the riverbank under the castle.
Description	In conjunction with the geotechnical contractor, who had already decided the slope needed soil nailing and TECCO® System, we looked to optimise the solution for the fine grained nature of the soil. We suggested the use of the TECCO® G45/2 in conjunction with an erosion control mat.
Protected object	Touristic infrastructure, Other
Systems	TECCO® G45/2
Corrosion protection	GEOBRUGG SUPERCOATING
Geology	Quaternary fluvial sands.
Stabilized area	840 m ²
Maximum slope height	20 m
Erosion control mat	Yes
Exposition	-

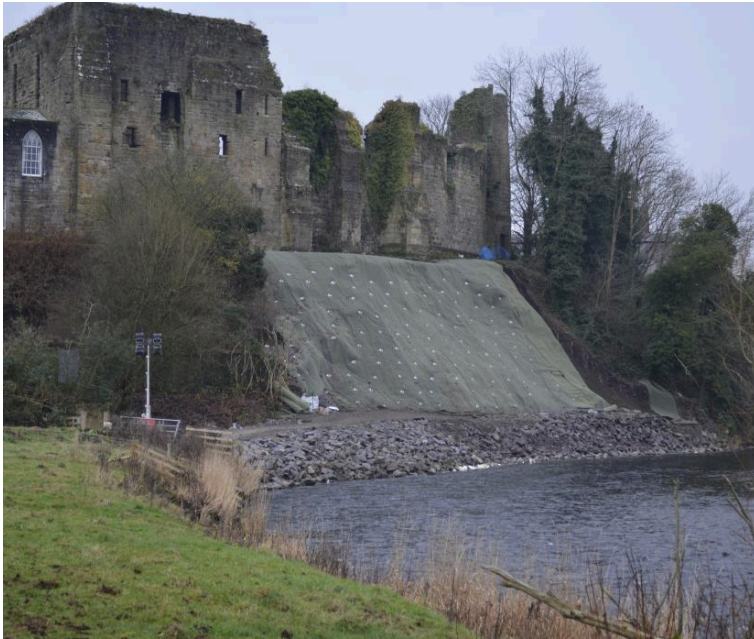
Cockermouth Castle slope after restoration works using TECCO® G45/2 mesh, system spike plates type P25 and nailing

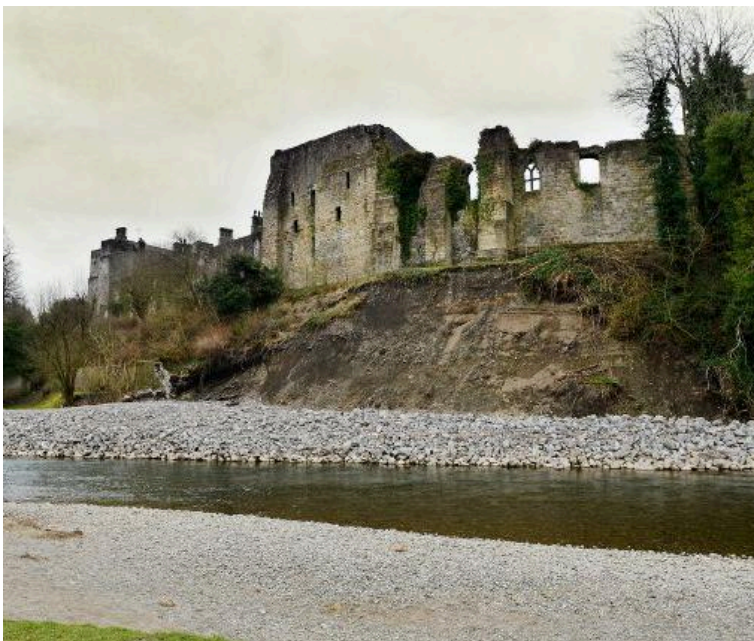
Overview of the slope failure directly endangering the Cockermouth Castle

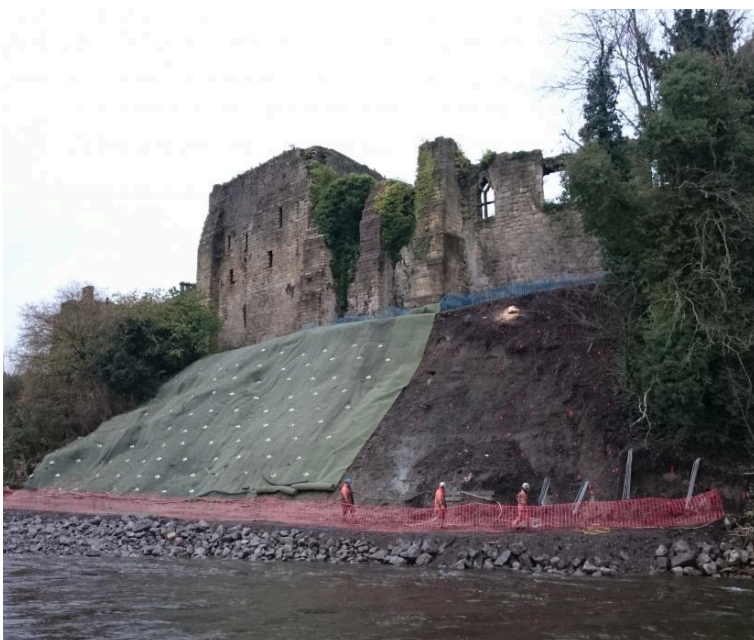
Part way through the installation of the TECCO® SYSTEM³. The smallest part of the failure is visible on the right

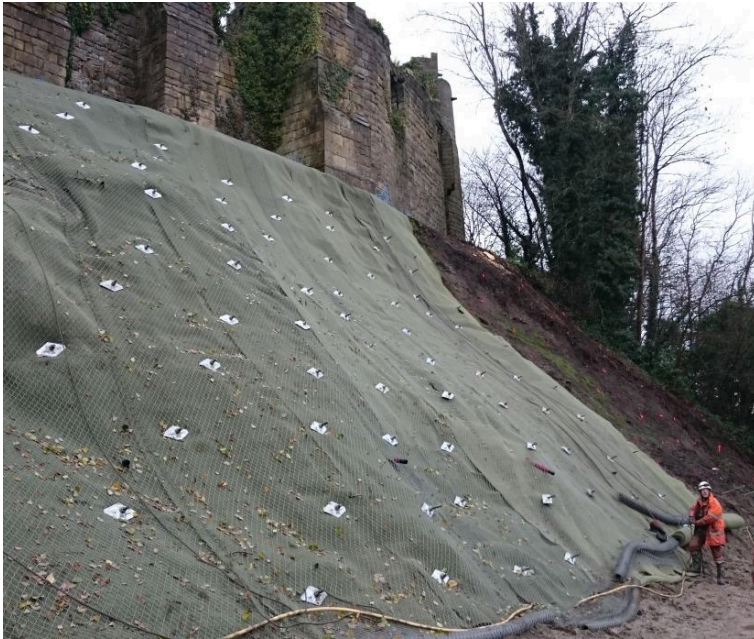
Close up of the completed solution - visible fine but lightweight structure of the high tensile steel mesh TECCO® G45/2
