# CASTELLO DI SAN TERENCE, ITALY

Slope Stability

<b>Project</b>	Castello di San Terenzo
<b>Location</b>	Marinella di San Terenzo, Comune di Lerici
<b>Country</b>	Italy
<b>Year of installation</b>	2017
<b>Customer</b>	Comune di Lerici
<b>Engineering</b>	Flow-Ing Srl.
<b>Contractor</b>	Siscom Srl.
<b>Initial situation</b>	At Lerici in Liguria a hiking path under the famous Castle di San Terenzo was endangered by rockfalls from the slope above.
<b>Description</b>	<p>As a solution active slope stabilization with nailing and TECCO® System was applied (with a smaller mesh opening band at the top). With a slope ranging from 60 ° to 80 ° the nail pattern is 3.0 x 3.0 meter, with nails of 28 mm in diameter. To ensure the stability of the debris cover, the nails have been drilled to a depth of 3 meter.</p> <p>Due to high corrosion resistance requirements (coastal area), special mesh was chosen: TECCO® System 45/2 STAINLESS.</p>
<b>Protected object</b>	Touristic infrastructure

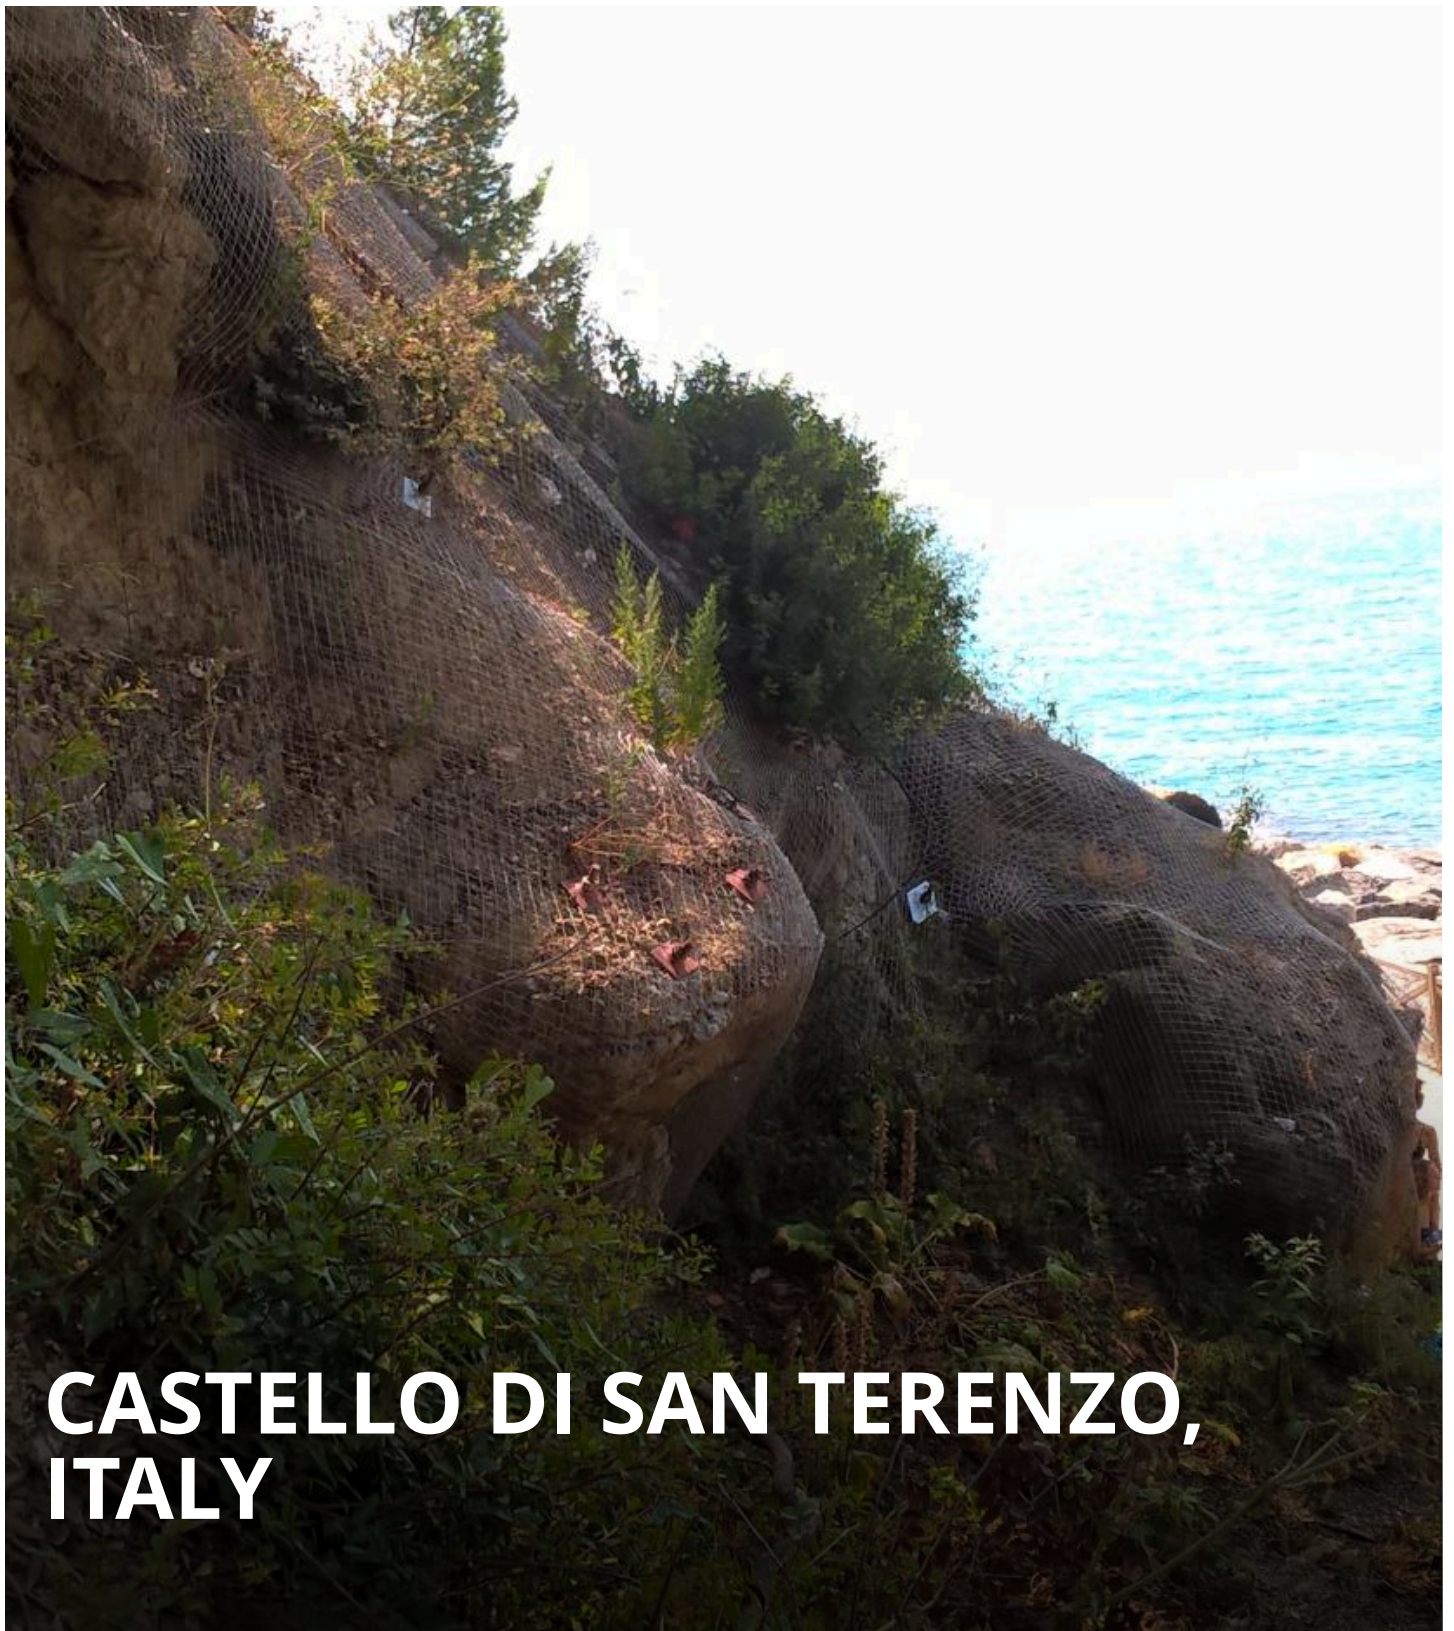
<b>Corrosion protection</b>	INOX / STAINLESS
<b>Geology</b>	Mica schists, phyllite.
<b>Stabilized area</b>	1260 m²
<b>Maximum slope height</b>	20 m
<b>Slope inclination</b>	60 ° - 80 °
<b>Exposition</b>	South-West
