JERUSALEN CANTERAS, COLOMBIA

Slope Stability

Project	Jerusalen Canteras
Location	Bogota
Country	Colombia
Year of installation	2014
Customer	Unidad Administrativa e Especial de Mantenimiento Vial
Engineering	Geocing
Contractor	HN Ingenieria
Initial situation	<p>Jerusalen Canteras is a former quarry in the township Ciudad Bolivar in Bogota. The predominant material is meteorized layers of sandstone and claystone.</p> <p>The quarry was abandoned and a neighborhood grew up around this slope. With little stabilization, the area was in dangerous condition.</p> <p>Rockfall menaced the road and the houses at the foot of the slope. Additionally grew the risk of slope sliding. In the crown of the cut, the access road to the upper neighborhoods plus the houses at the top were in danger.</p>
Description	TECCO® was installed in combination with anchors - 8 m long, 32 mm in diameter. The system was combined with anchored walls. To control erosion TECMAT® was implemented underneath the TECCO® mesh.

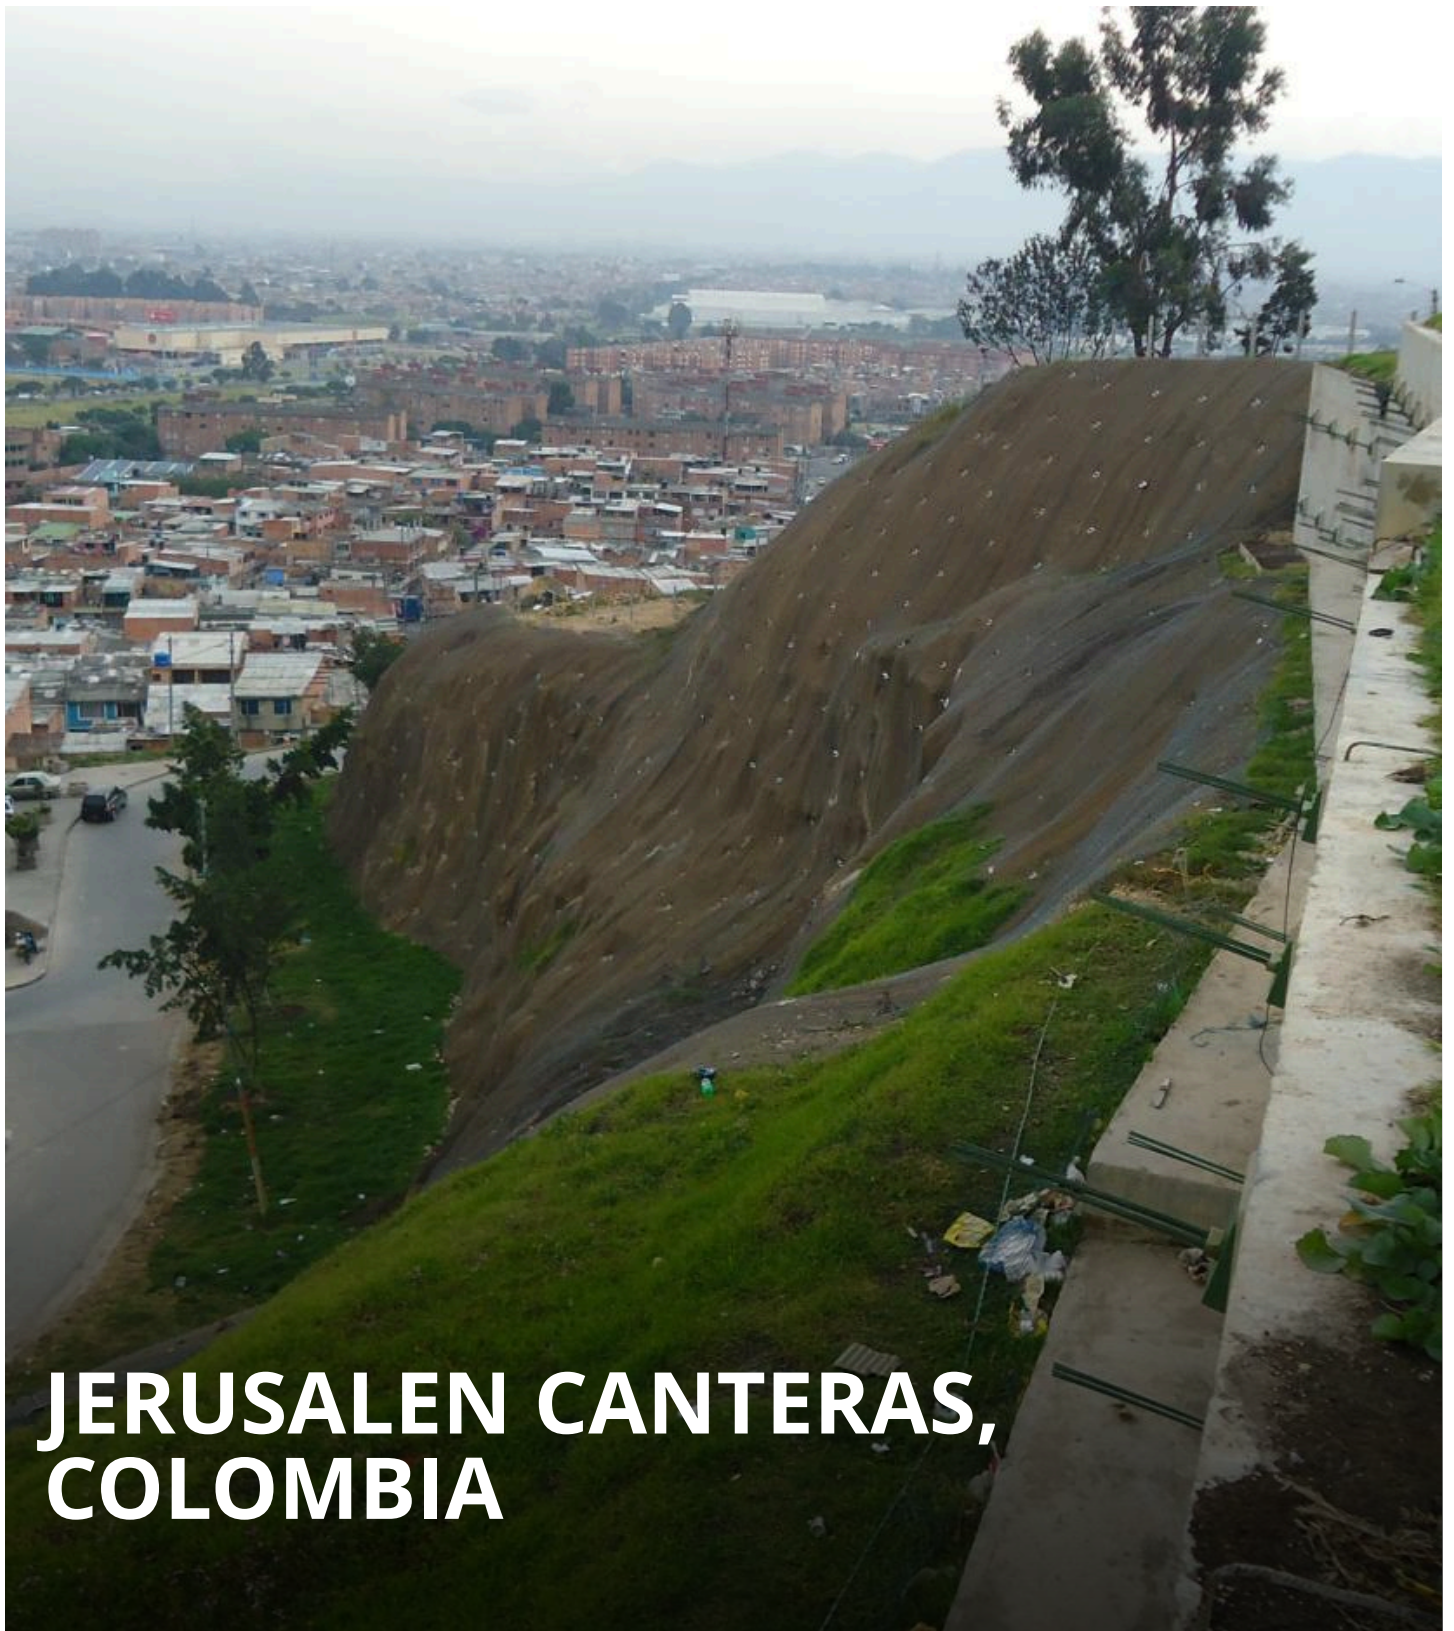
Protected object	Road, Building, Mine / Quarry, Residential area
Other installed applications	Underground & Open Pit Mining
Corrosion protection	GEOBRUGG SUPERCOATING
Geology	<ul style="list-style-type: none">• Meteorized layers of sandstone• Claystone
Stabilized area	10000 m²
Maximum slope height	40 m
Slope inclination	45 ° - 80 °
Greening	Yes
Erosion control mat	Yes
Exposition	North
