TRBOVLJE ROCKSLIDE PROTECTION, ESLOVENIA

Trbovlje rockslide protection

Proyecto	Trbovlje rockslide protection
Lugar	Trbovlje
País	Eslovenia
Año de instalación	2016
Cliente	Slovenian Infrastructure Agency (DRSI)
Ingeniería	EHO Projekt
Contratista	Kaskader
Situación inicial	<p>On 20th February 2016 over 500 cubic meters of rock and debris collapsed onto the district road between the county seat Trbovlje and Ljubljana. Not only was the important road blocked, the residents were also cut off from electricity and water.</p> <p>The debris removal on route R1-223 had to be completed in the shortest possible time, but first sustainable protection measures needed to be developed and installed. Site investigations and software analysis conducted by geologists and engineers indicate a significant hazard potential. The heavily fractured residual rock mass at the mountain top cannot be taken down as it could damage an important nearby railway. However, parallel to the site investigation and software analysis, limited rock scaling was also being performed.</p>

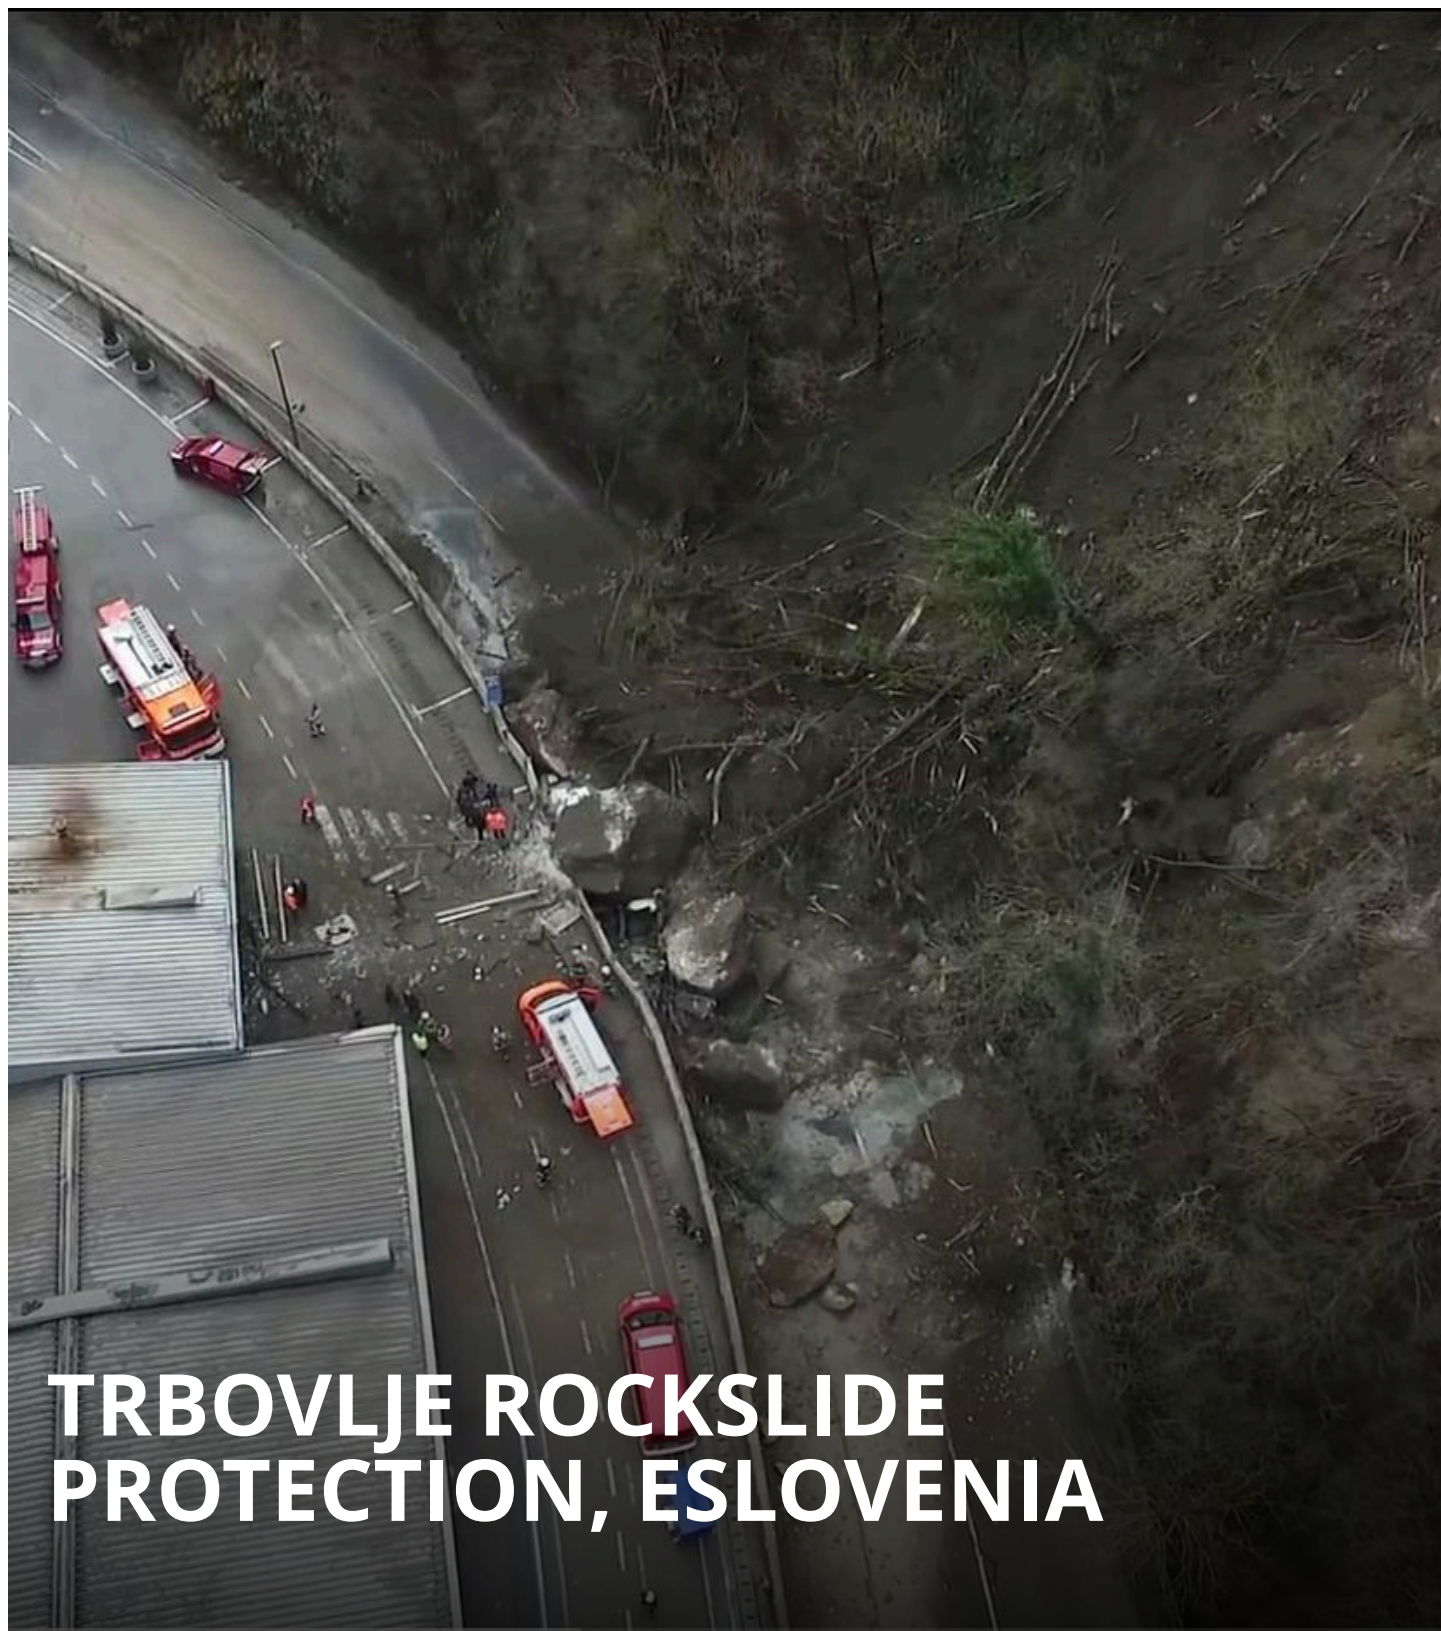
Descripción	<p>Construction commenced on March 8th with rock drilling to install anchors and base plates for the barrier's post foundations. Based on the study results national authorities decided to apply a Geobrugg rockfall protection system from the RXE-Series. With its ring nets made of high-tensile steel wire the barrier design has been tested and approved to absorb impact energies of up to 8,000 [kJ]. Additionally, two GBE-500A systems were selected to protect the lower part of the slope.</p> <p>The posts, ringnet's ropes and accessories produced and pre-assembled in Romanshorn, Switzerland, were already delivered to Trbovlje by mid-March. The biggest helicopter of the Slovenian Armed Forces delivered the four preassembled ring net bundles along with the five posts, weighing almost 2 metric tons, to the heavily inaccessible terrain. Despite high winds the helicopter crew made the decision: "We're flying!" The experience of the entire ground and helicopter crew was needed to connect the posts to the base plates within a millimeter of accuracy. The mega-barrier technical acceptance inspection took place on April 4th, the same day officials, stakeholders and the public are welcomed to the inaugural reopening of the newly repaired and secured road.</p>

Objeto protegido	Carretera
Protección contra la corrosión	Galvanizado, GEOBRUGG SUPERCOATING
Capacidad de absorción de energía	500 kJ, 8000 kJ
Altura del sistema	3.0 m, 8.0 m
Longitud del sistema	- 40 m
