# Taming Chapman's Peak

An international geotechnical solution promises to finally tame hazardous slopes on South Africa's scenic Cape Peninsula. By *David Poggiolini*.

**Project:** Slope stabilisation  
**Value:** Still to be determined  
**Location:** Western Cape, South Africa  
**Contractor:** Penny-Farthing Engineering  
**Consulting engineer:** Melis & Du Plessis  
**Client:** Western Cape Government,  
Department of Transport and Public Works

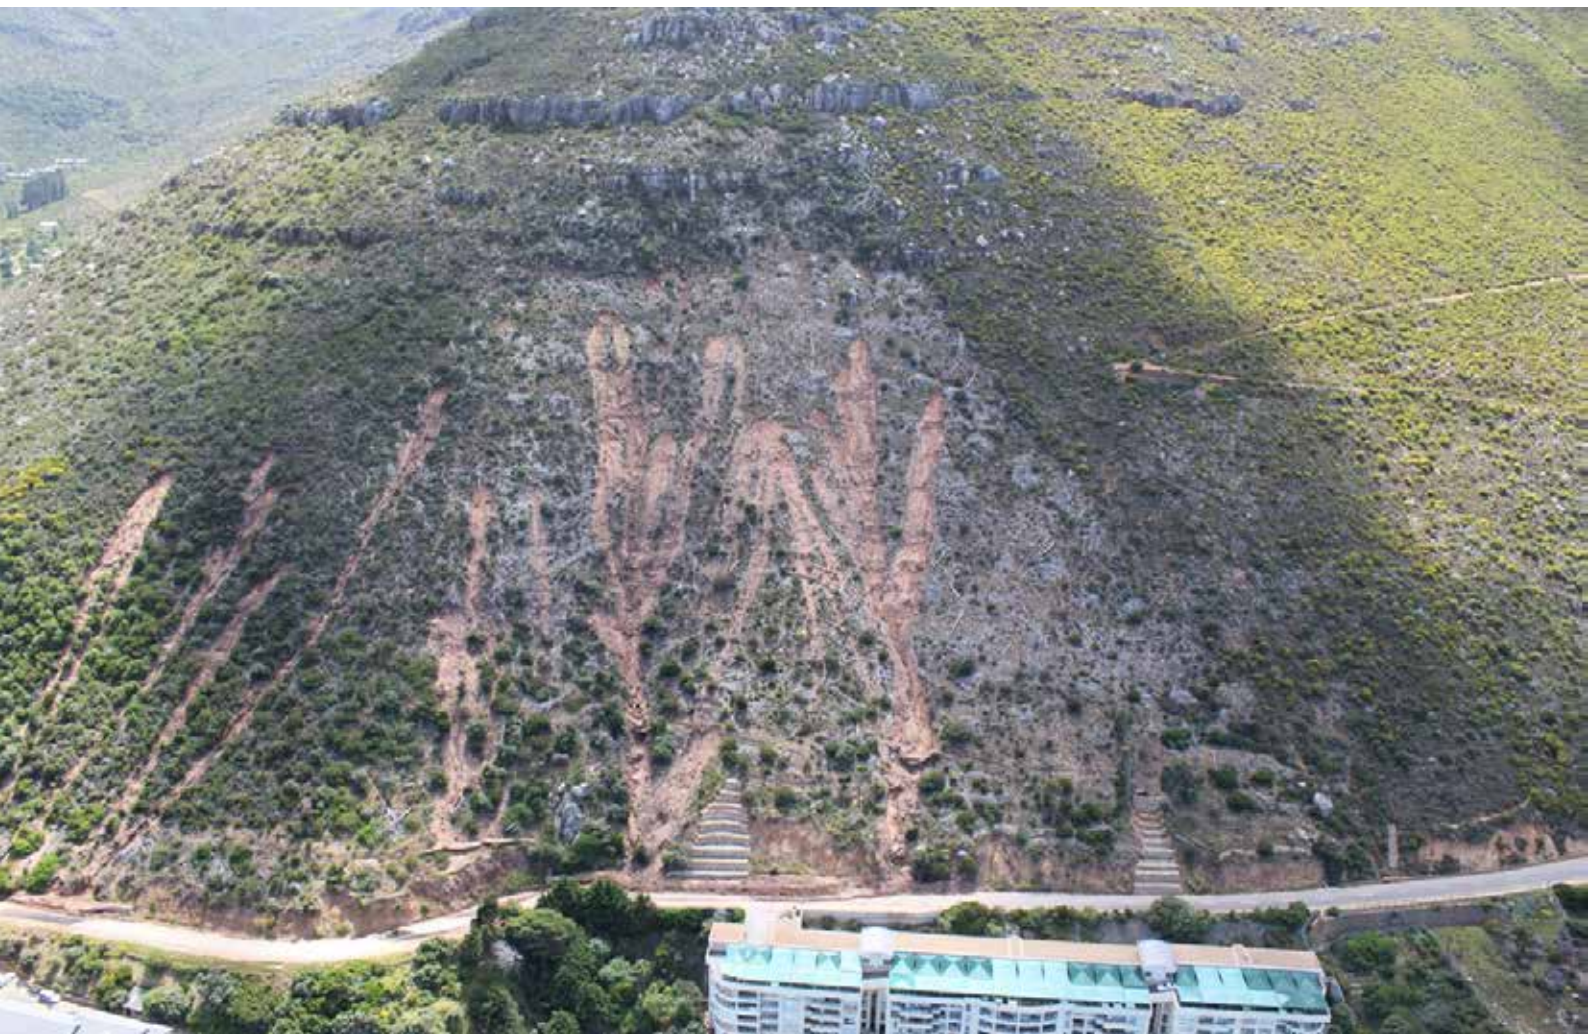
Melis & Du Plessis

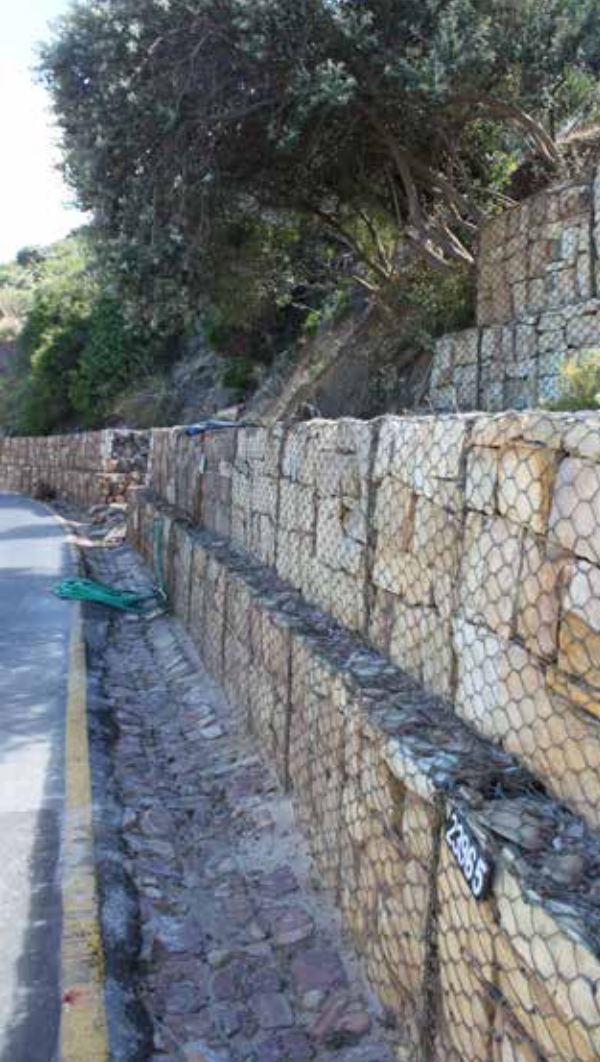
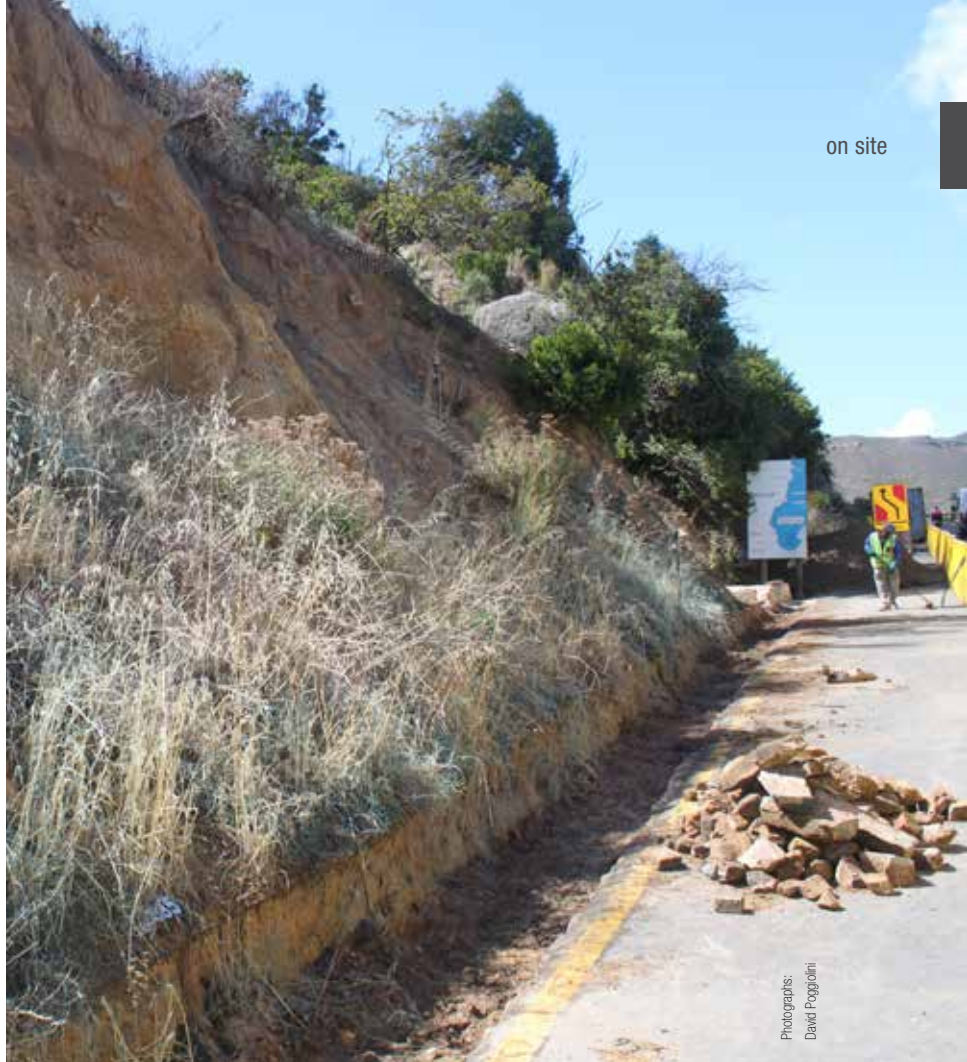
### Damage done

A more advanced method of stabilising this section of the mountain is needed to avoid a repeat of the incident in November 2013.

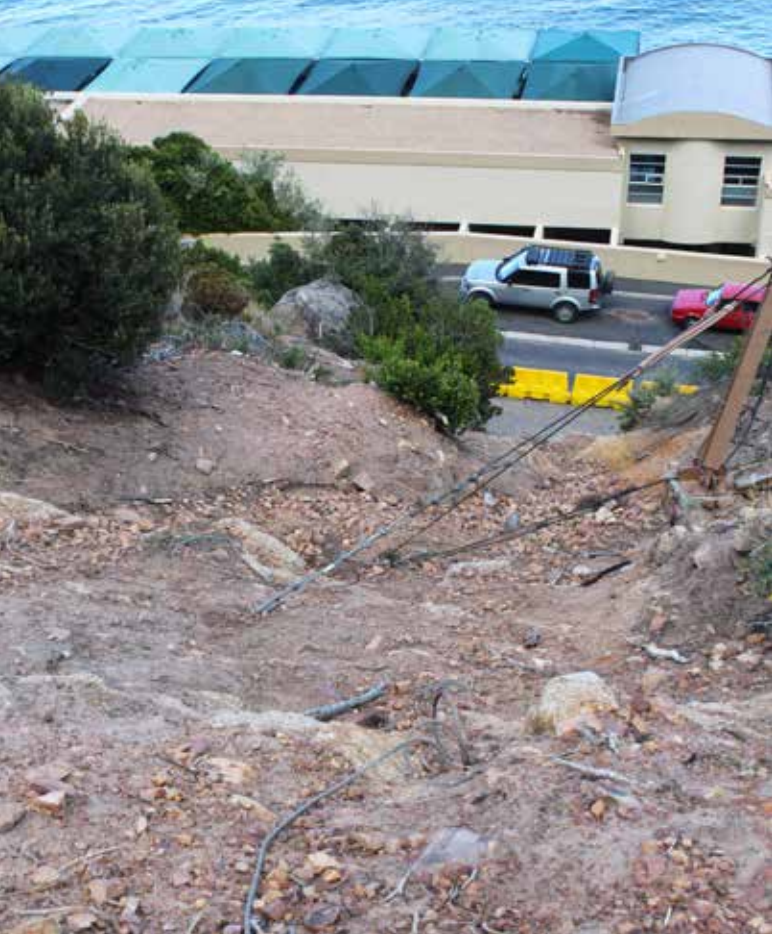
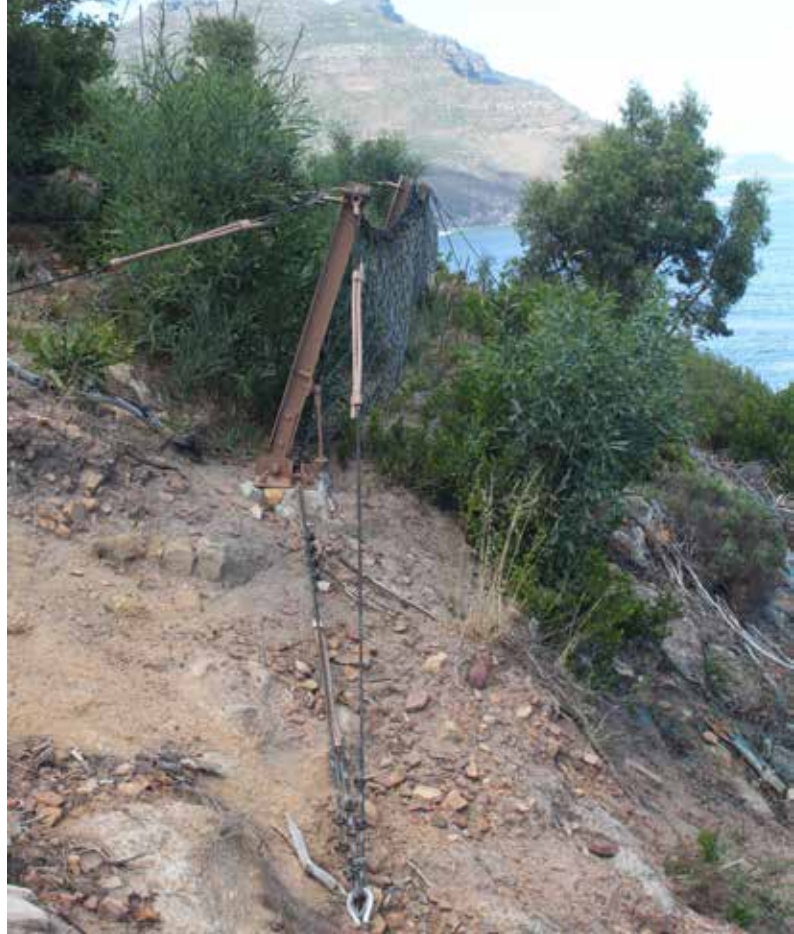
### The mesh presses against the slope surface, preventing deformations, slips and breaking out.

Developed and tested in Switzerland, Geobruigg's Tecco stabilisation system comprises high-tensile steel wire mesh used in combination with soil and/or rock nails to stabilise steep slopes in unconsolidated material and any rock liable to slip and break out. The wire mesh has a tensile strength of 1 770 Newton per square millimetre (N/mm<sup>2</sup>).

Schoevaerts explains that the surface is first cleaned, levelled and shaped, and then covered with the mesh. The mesh is fastened by ground or

rock nails and pre-stressed with a defined force against the nails with special spike plates.

Reacting to this, the mesh presses against the slope surface preventing deformations, slips and break-outs. He says this external pre-stress increases the safety and efficiency of the system.

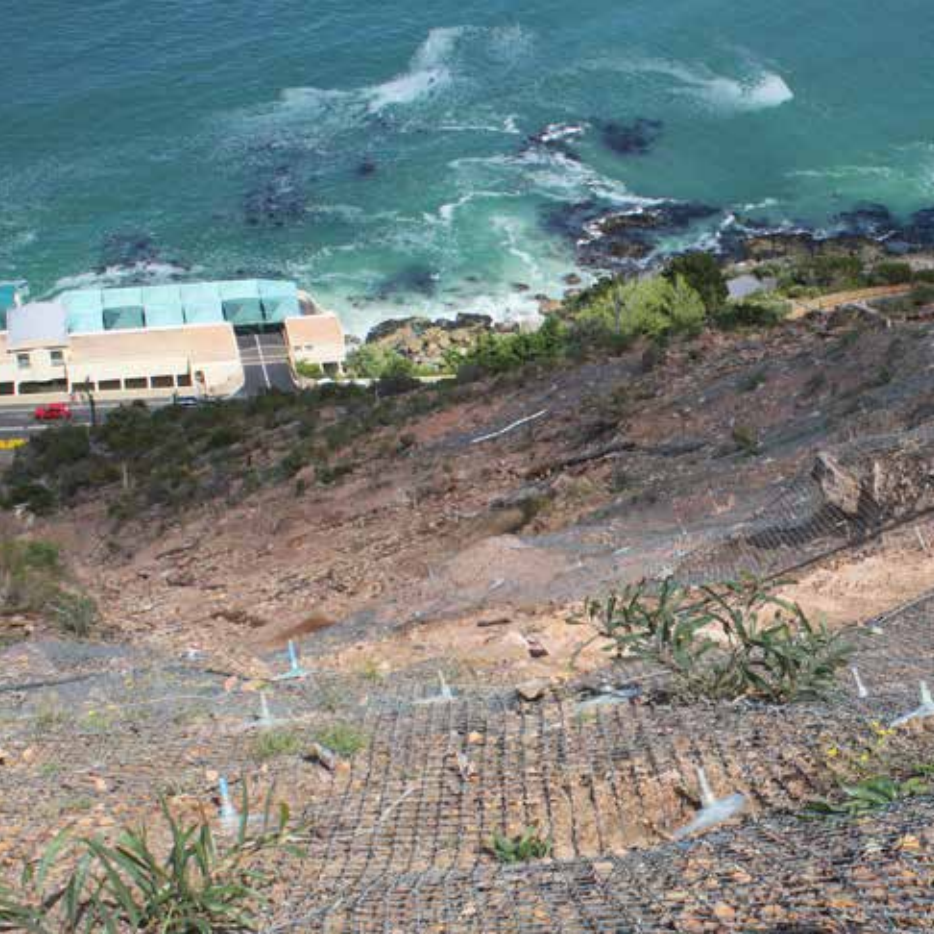
He says that there is an array of challenges facing the professional team. One of these is the extremely sensitive working environment. "Environmental approval of the works has been a key issue on the project. Plant species have been assessed and where necessary marked for protection," says Van der Merwe. "Plant species are marked weekly, and every effort is made by the professional team to avoid damaging them."

Leon Oosthuysen, site agent for Penny-Farthing Engineering, says that a major challenge on this project has

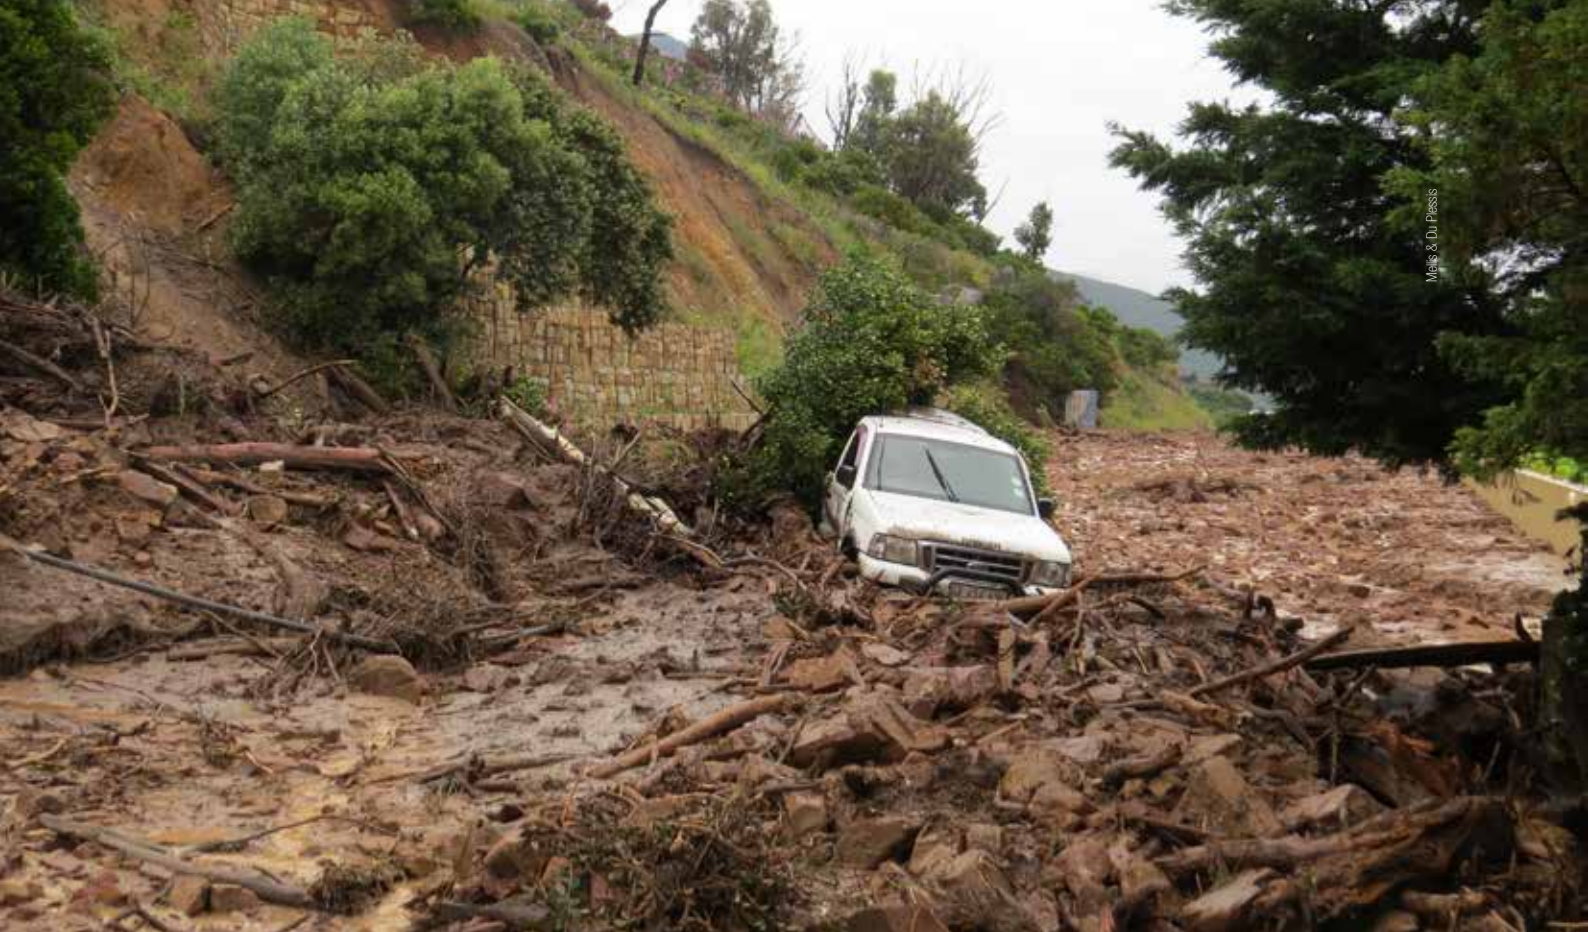
### Taming a mountain

The more recent episode occurred at the end of November 2013 when exceptionally heavy and intense rainfall destabilised a 600m section of mountain slope, resulting in severe rock debris and mudslides and wreaking havoc on the Hout Bay side of the drive from Chapman's Peak.
