Remote Monitoring of flexible protective Structures against natural Hazards – Increasing Safety and Reducing Costs

Hélène Hofmann, M.Sc. Geol, Geobruigg AG, Romanshorn, Schweiz

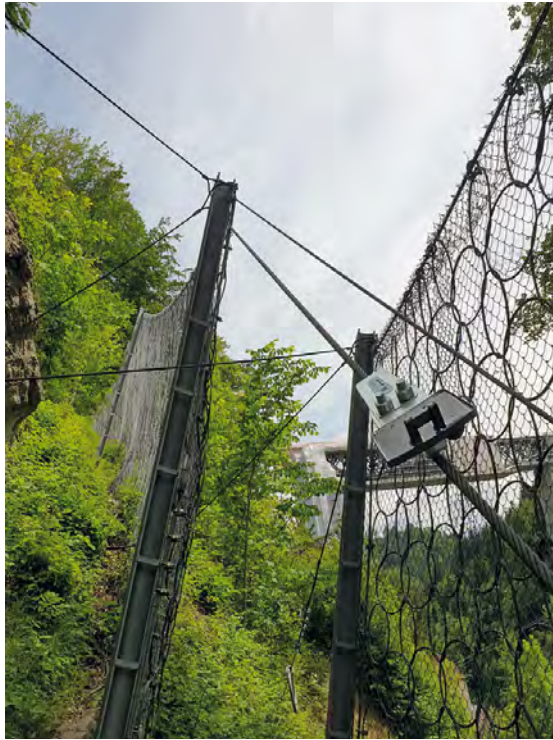
Fig. 1: Rockfall barrier with sensor device

Protective structures are mainly built in the mountains, or on sea coasts. The systems are usually located in rough terrain. They are therefore often difficult to reach and cannot be visually monitored. In recent decades, the inspection and maintenance of such facilities has in many places been neglected. The Swiss company Geobruigg AG has therefore developed a new type of sensor device, the Geobruigg Guard: It simplifies monitoring and makes maintenance plannable (Fig. 1).

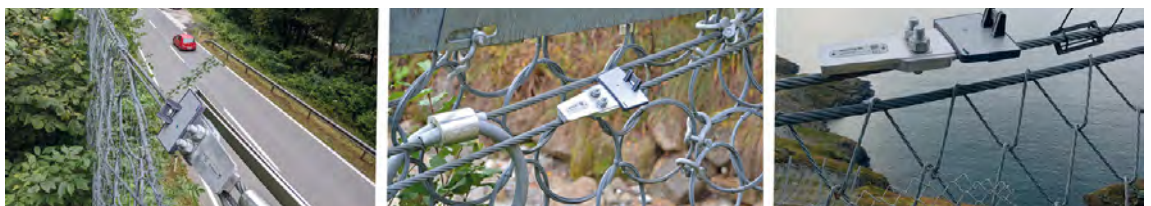
Fig. 2: Sensors on different components of rockfall barriers

To document events and corrosion in-situ at the barrier, the GeobruGG Guard sensor device monitors protective structures around the clock. The sensor devices can be installed in a short time on different components of barrier systems from different manufacturers (**Fig. 2**). Thanks to their independent energy supply, they operate for up to ten years without on-site checks.
