# MONSERRATE WALKING PATH, PROJECT STAGE 2, COLOMBIE

Protection contre les chutes de pierres

<b>Projet</b>	Monserate Walking path, Project Stage 2
<b>Ville</b>	Bogota Monserate Walking Path
<b>Pays</b>	Colombie
<b>Année d'installation</b>	2017
<b>Client</b>	IDIGER (Instituto distrital de gestion del Riesgo)
<b>Entrepreneur</b>	National Army of Colombia
<b>Situation de départ</b>	<p>The sanctuary of Monserate is adjacent to Bogota and an important recreation area for the city. The bush fire in 2015 destroyed the vegetation and the soil cover. Thus blocks of rock were exposed and the danger of accidents rose.</p> <p>Due to this threat, the road was completely closed. A solution that would provide safety, comfort, and durability had to be found to protect the over 2 million people mounting up the hill throughout the year.</p>
<b>Description</b>	<p>EL IDIGER institute evaluated systems to control the rock falls in order to re-open the path. WARCO SAS and Geobrugg advised during the design and provided the rockfall barriers. Finally five barriers were installed along the trail to cover the exposed areas. Installed RXE-3000 barriers are 4 m high and have a total length of 215 m.</p>

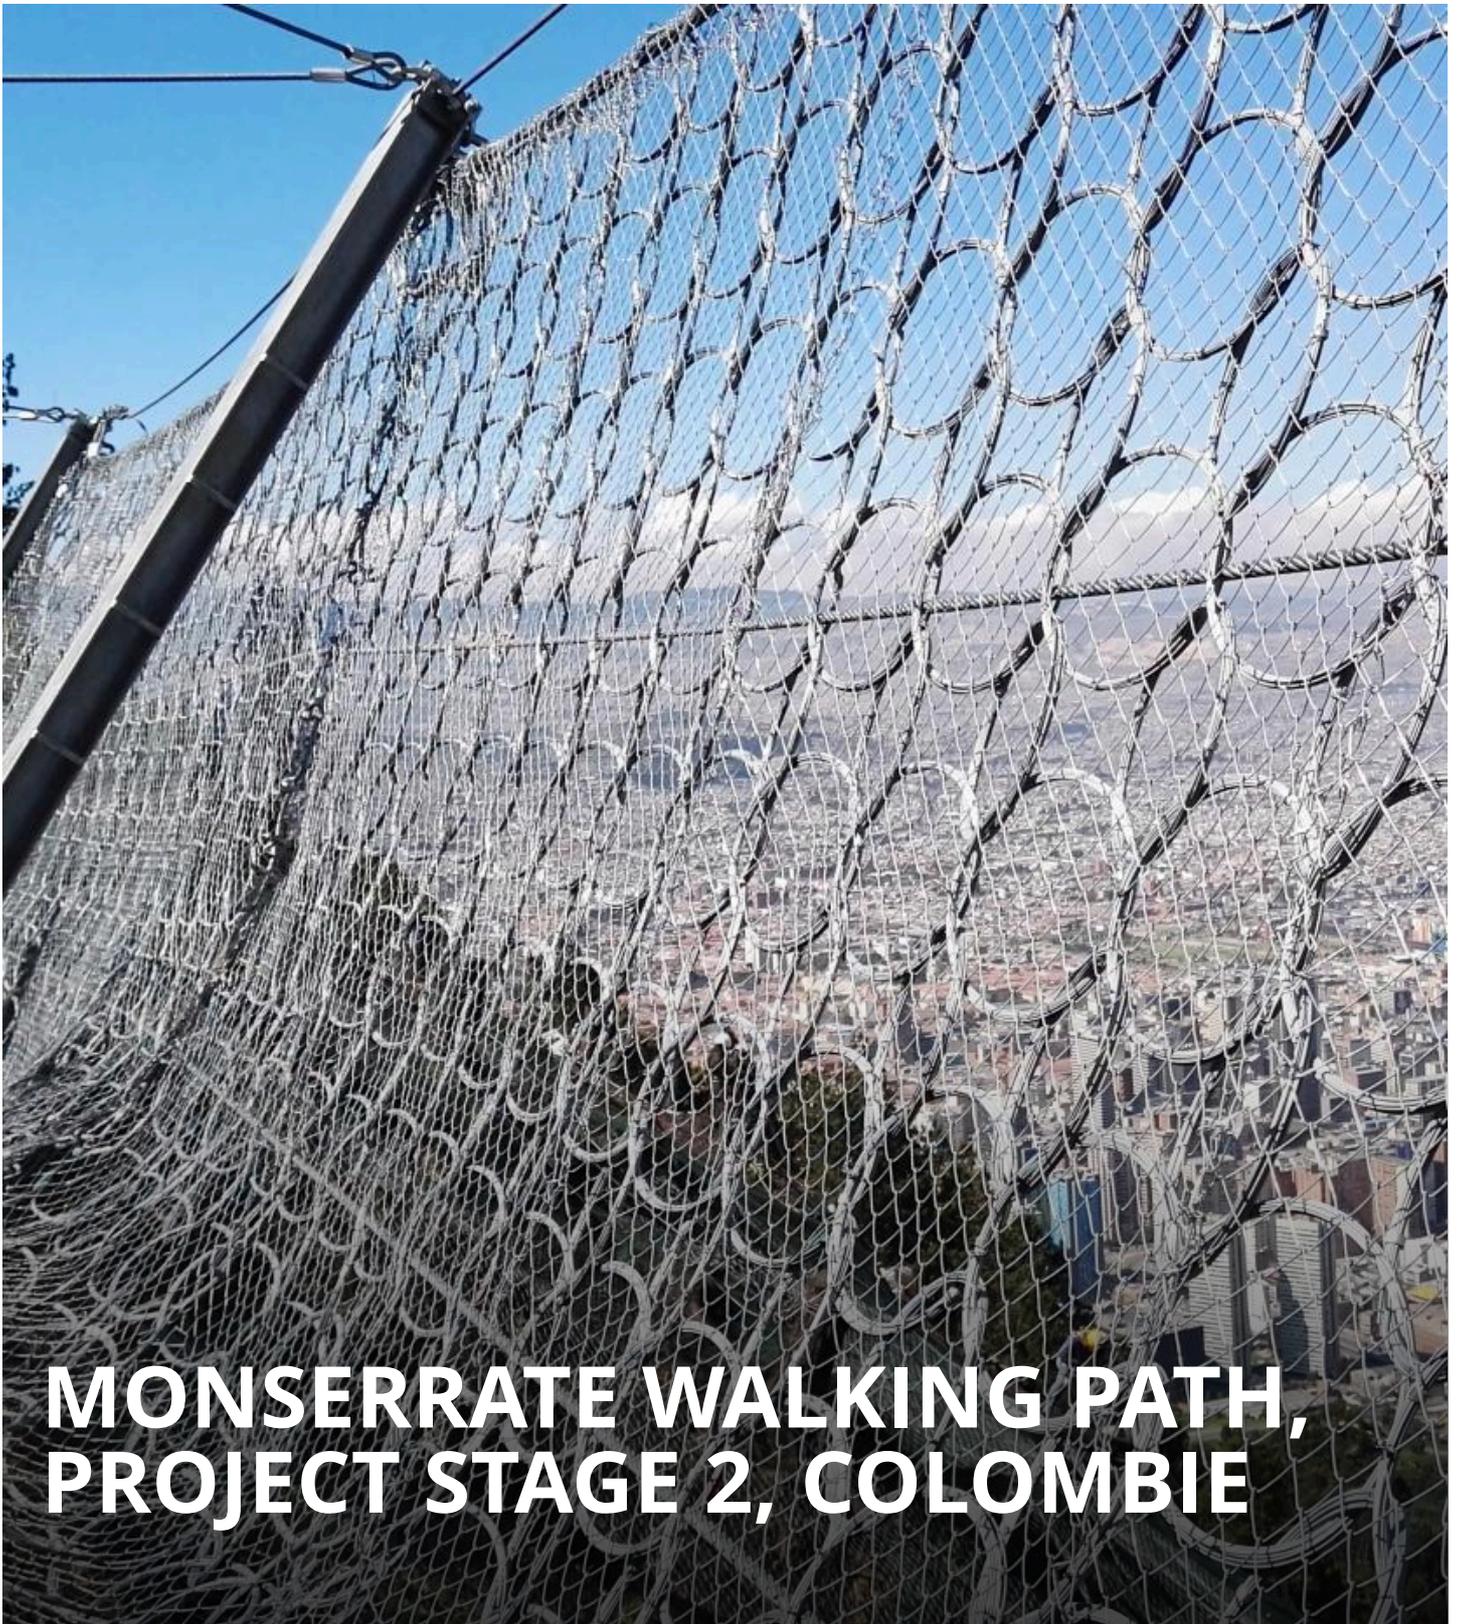
<b>Site protégé</b>	Infrastructure touristique
<b>Protection anticorrosion</b>	galvanisé, GEOBRUGG SUPERCOATING
<b>Classe d'énergie (kJ)</b>	3000 kJ
<b>Hauteur du système</b>	4.0 m
<b>Longueur du système</b>	35 m - 70 m
