# REST AND BE THANKFUL - A83 RABT, ROYAUME-UNI

Laves torrentielles et coulées de boue

Projet	Rest and Be Thankful - A83 RabT
Ville	Arrochar
Pays	Royaume-Uni
Année d'installation	2012
Client	Transport Scotland
Ingénierie	Geobrugg / BAM Ritchies
Entrepreneur	BAM Ritchies / BAM Nuttall Ltd.

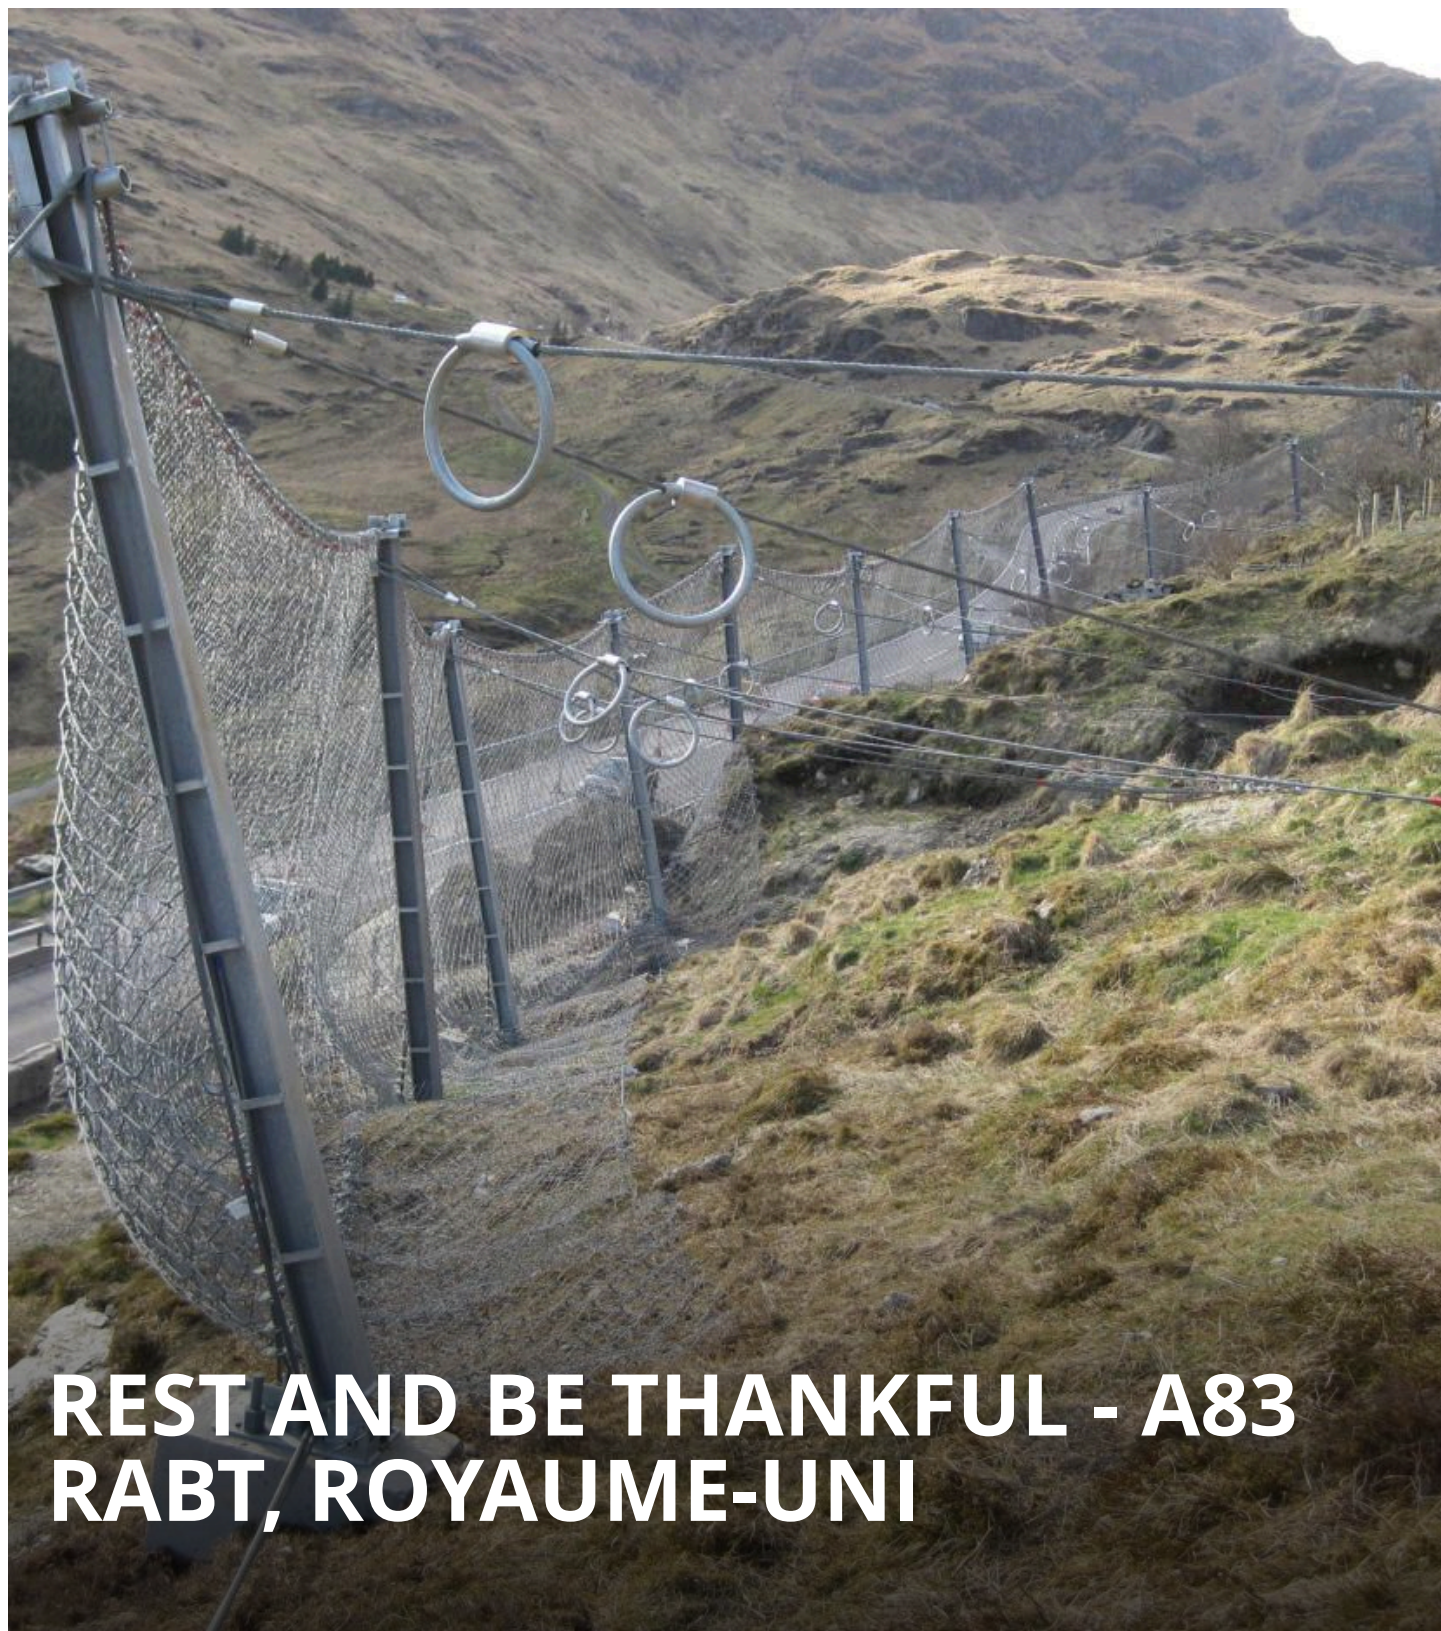
Description	BAM Ritchies, working closely with Geobrugg and Scotland Transerv, developed a solution of an eighty meters long, 4 m high shallow landslide barrier and 15.0 m wide VX 'in-channel' barrier nearby. These were installed in 2010. In 2012 a second phase of works saw the installation of a further 83.0 m of shallow landslide barrier at 3.5 m high. Another channel saw the installation of both 25.0 m by 5.0 m UX debris flow barrier above 9.0 m by 2.0 m VX debris flow barrier.
-------------	--

During storm Desmond that affected most parts of the UK a substantial landslide occurred at the A83 *Rest and be Thankful*. This is an area that has suffered numerous large landslide over the years and as such has numerous landslide and debris flow barriers have been installed. During the daytime on the 5th an event estimated at 150m<sup>3</sup> struck a Geobrugg SL-150 barrier, the barrier successfully held the landslide and there was no need to close the road. A further 100m<sup>3</sup> event struck the barrier overnight and over the next few days residual small movement led to a total of ~300 m<sup>3</sup> being held by the barrier. The barrier held all of this material without failure or damage, brake rings were activated as designed and the posts and bases suffered no damage. Thanks to the Geobrugg SL-150 barrier the A83, a major transport route in this area remained open.

Site protégé	Route/Rue
Protection anticorrosion	galvanisé, GEOBRUGG SUPERCOATING
Hauteur du système	2.0 m, 3.5 m, 4.0 m, 5.0 m
Longueur du système	9 m - 83 m
Nombre de barrières	5
Capacité de rétention	- m <sup>3</sup>
