# ANA CHOSICA - 22 BARRIERS FOR NINE VALLEYS, PERÙ

Protezione contro frane e colate detritiche

Progetto	ANA Chosica - 22 barriers for nine valleys
Luogo	Chosica
Paese	Perù
Anno di installazione	2016
Cliente	ANA Chosica
Progettazione	TDM S.A.
Contraente	TDM S.A.

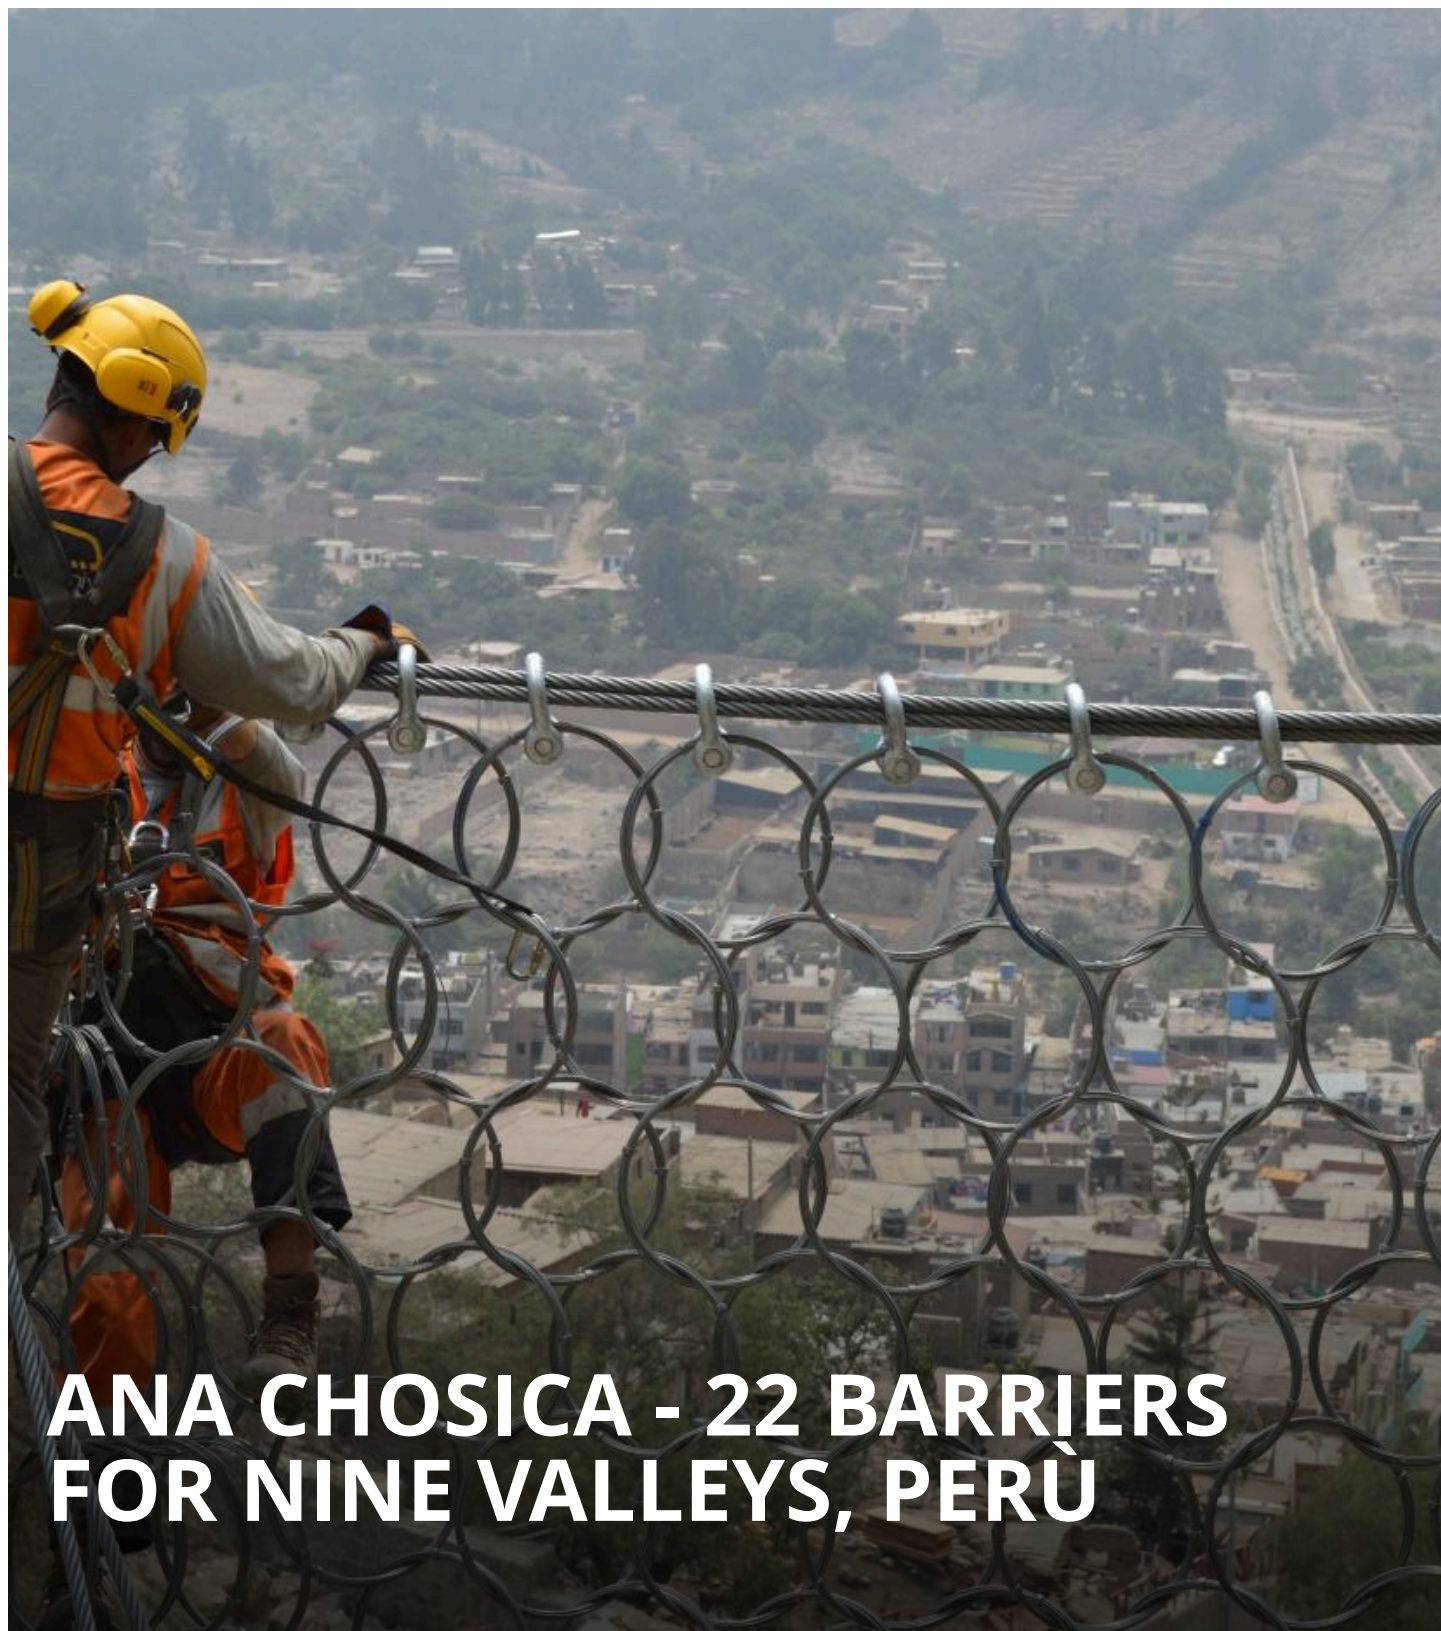
The 22 barriers have functioned reliably. One of the images shows a 55 meters stretch as one of the 4 levels of the barrier system. Two of these barriers are filled to 95 percent capacity, which is a volume of 10,000 m³. The multilevel design allows an increased retention volume, meaning that there is still capacity in the downstream barriers. The most important thing is that the residential area has not been damaged and there have been no deaths or injuries.

The following pictures illustrate 2016, 2017 and 2018.
