JERUSALEN CANTERAS, КОЛУМБИЯ

Укрепление склонов

Проект	Jerusalen Canteras
Место	Bogota
Страна	Колумбия
Год установки	2014
Клиент	Unidad Administrativa e Especial de Mantenimiento Vial
Проектировщик	Geocing
Подрядчик	HN Ingenieria
Ситуация	<p>Jerusalen Canteras is a former quarry in the township Ciudad Bolivar in Bogota. The predominant material is meteorized layers of sandstone and claystone.</p> <p>The quarry was abandoned and a neighborhood grew up around this slope. With little stabilization, the area was in dangerous condition.</p> <p>Rockfall menaced the road and the houses at the foot of the slope. Additionally grew the risk of slope sliding. In the crown of the cut, the access road to the upper neighborhoods plus the houses at the top were in danger.</p>
Описание	TECCO® was installed in combination with anchors - 8 m long, 32 mm in diameter. The system was combined with anchored walls. To control erosion TECMAT® was implemented underneath the TECCO® mesh.

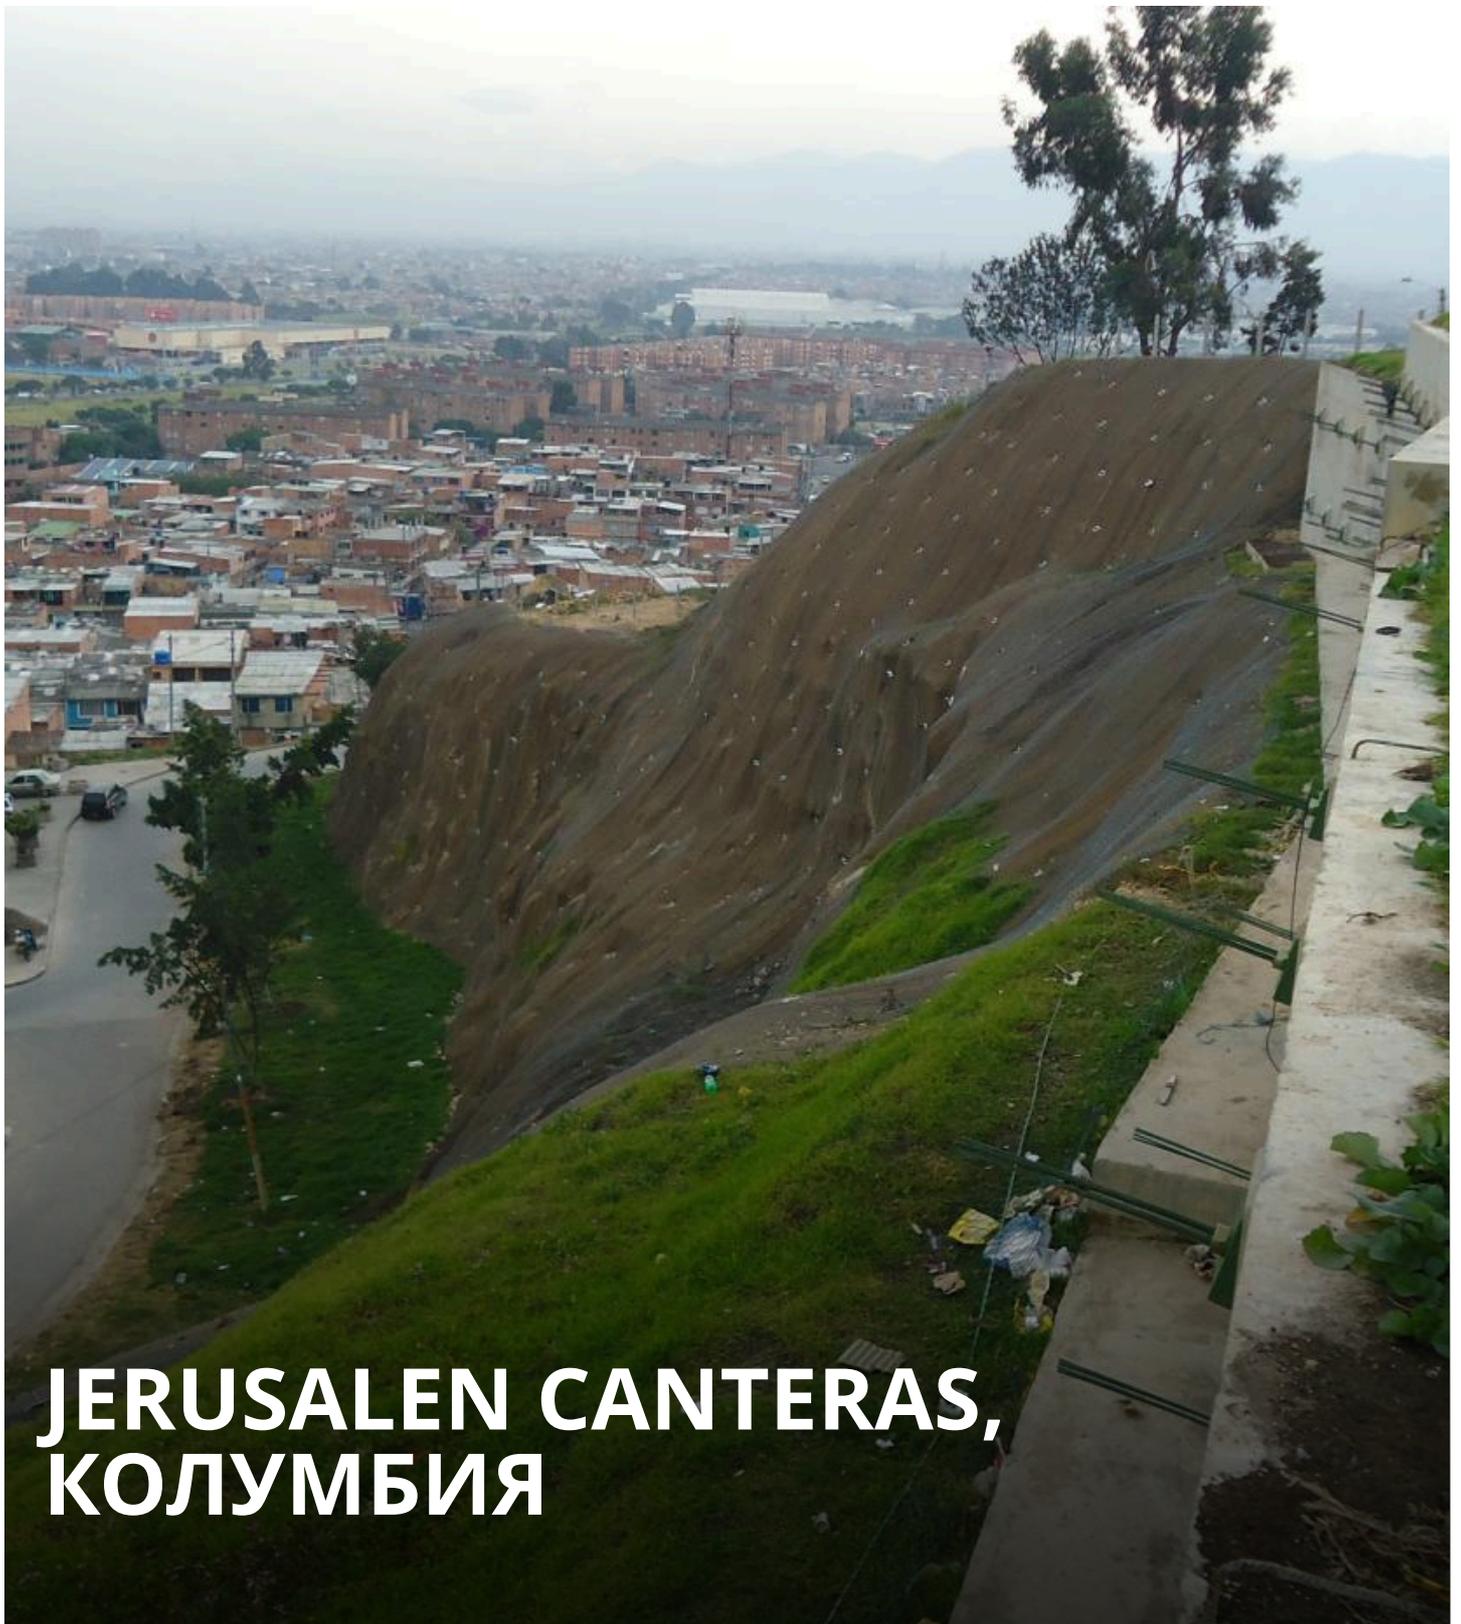
Защищаемый объект	Дорога, Строительство, Карьер / Шахта, Жилой район
Другие конструкции	Горнодобывающая промышленность / Туннели
Защита от коррозии	GEOBRUGG SUPERCOATING
Геология	<ul style="list-style-type: none">• Meteorized layers of sandstone• Claystone
Площадь укрепления	10000 m ²
Высота склона	40 m
Уклон	45 ° - 80 °
Озеленение	да
Противоэрозионный мат	да
Экспозиция	Север
