SAMPHIRE HOE IN DOVER,

Samphire Hoe in Dover

2015

Network Rail Ltd.
Fairhurst - Consulting Structural and Civil Engineers
CAN Geotechnical Ltd.

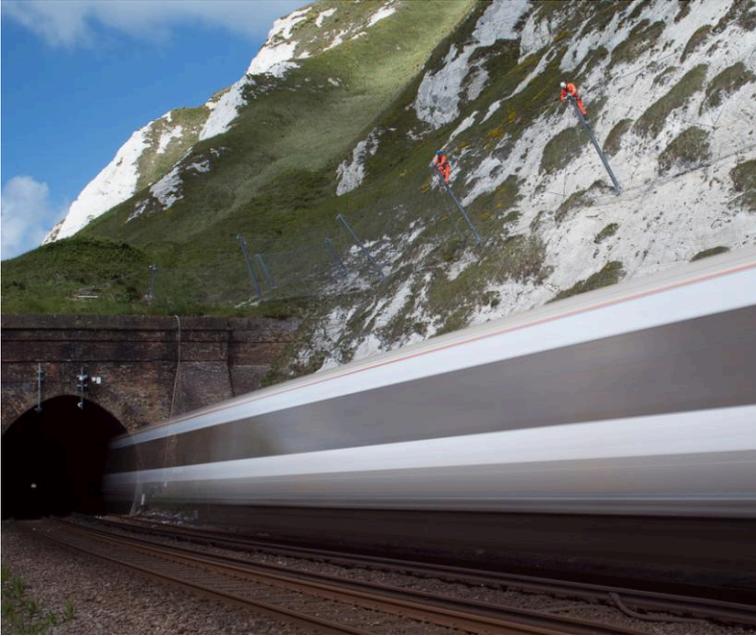
Train passing under one of the GBE-1000A (for 1000 kJ) rockfall barriers while under going its final inspection.

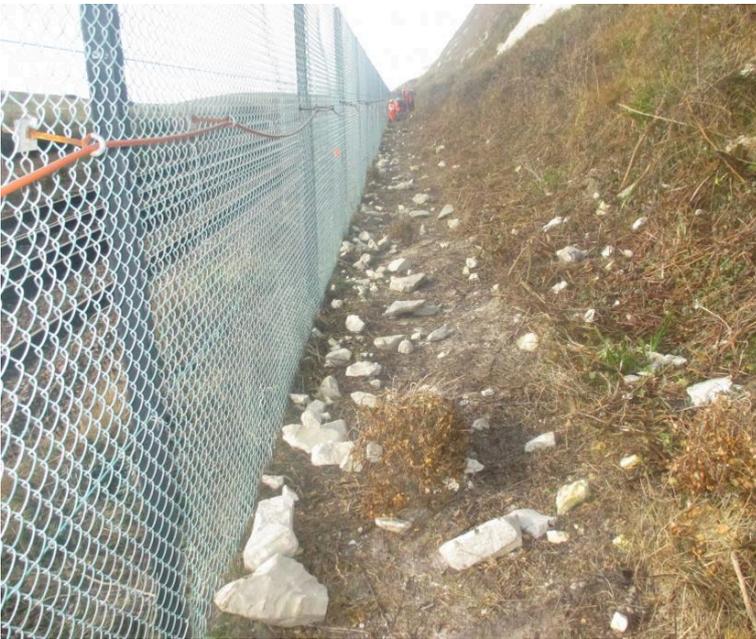
Evidence of rock fall below the cliffs before any remedial measures were taken. Visible is a normal chain link fence, which has previously been breached leading to track closures.

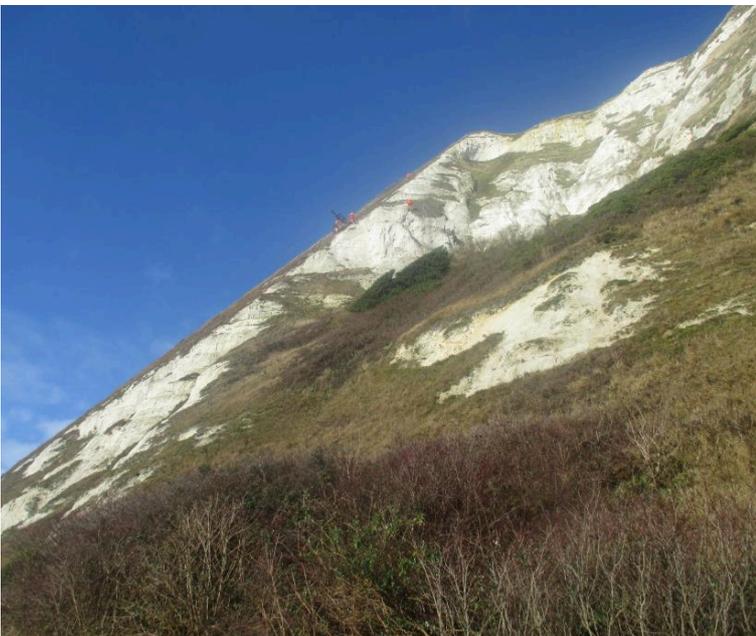
Cliffs during TECCO® SYSTEM³ stabilization works.

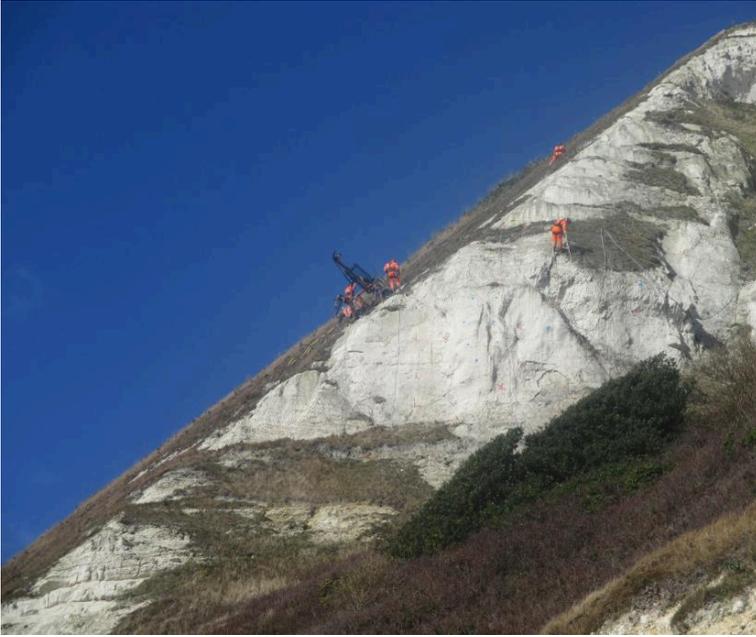
Rope access techniques in use for drilling and installation of the TECCO® SYSTEM³ stabilization.

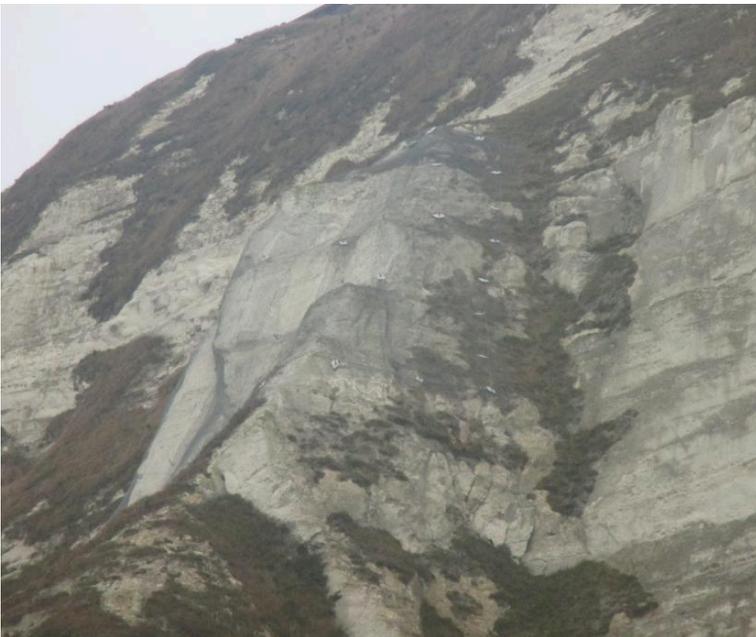
Cliff area stabilized with the TECCO® SYSTEM³. Rockfalls triggered here could over top the rockfall barriers below.

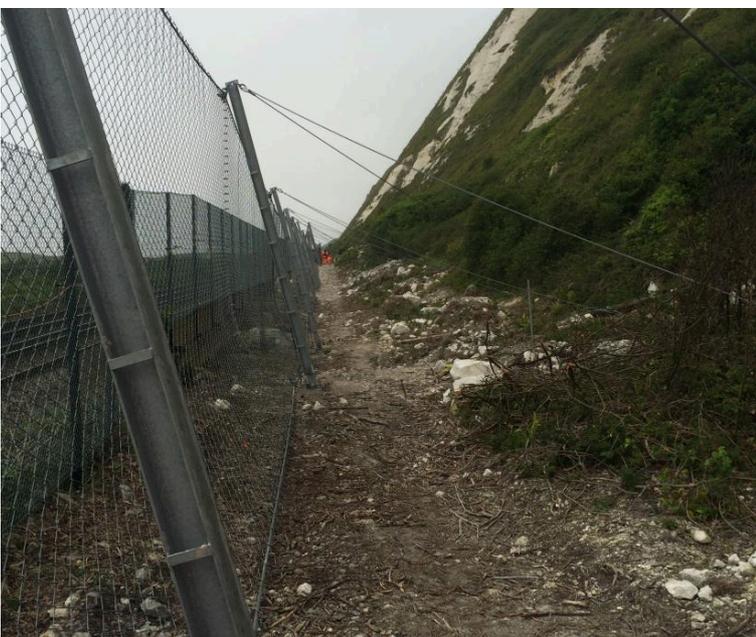
GBE-500A (for 500 kJ) rockfall barrier below the cliffs. Note the evidence of small rockfalls already stopped by the barrier.

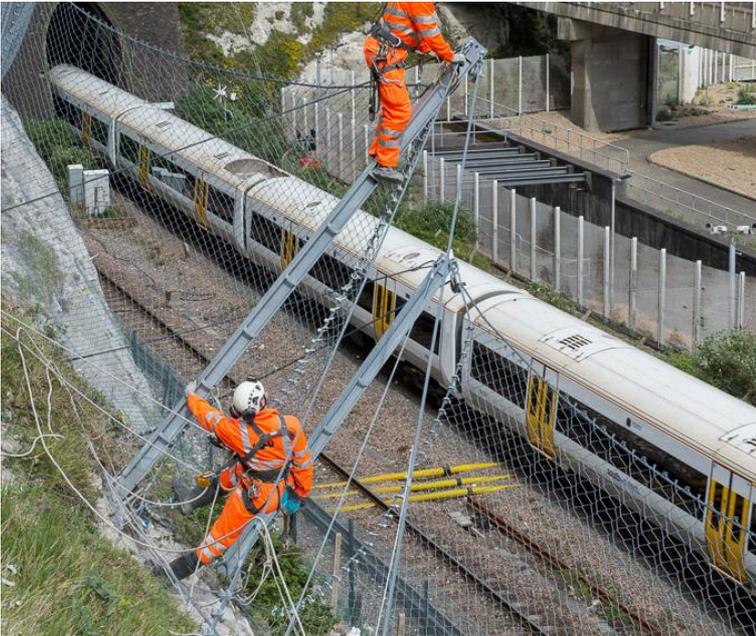
GBE-1000A (for 1000 kJ) rockfall barriers during installation. Here you can see the final adjustments to the vertical ropes.

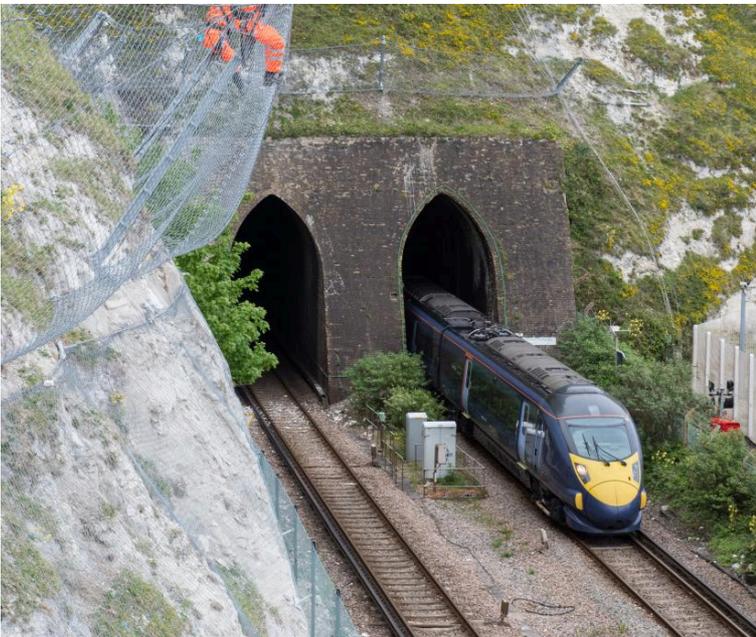
Final checks on GBE-1000A rockfall barrier line. Cliff below stabilized with TECCO® SYSTEM³.

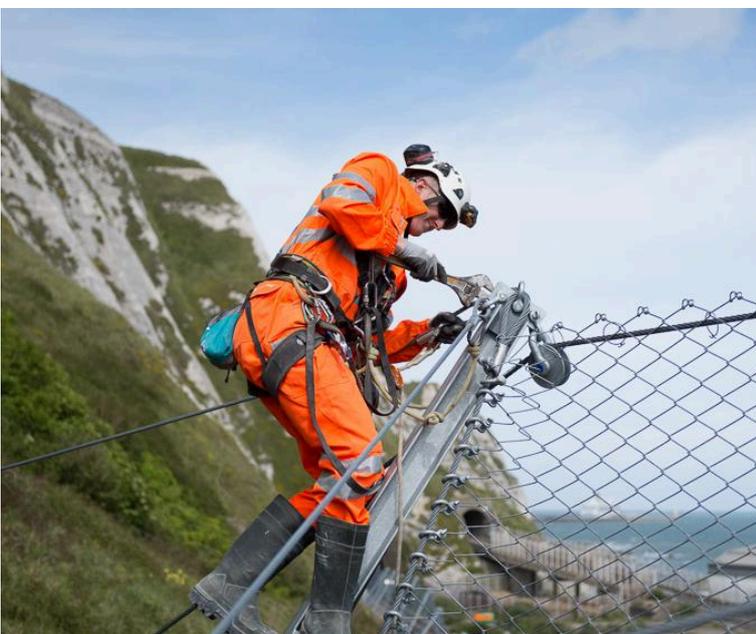
Final adjustments on the GBE-1000A rockfall barrier. This barrier offers unbeatable installation simplicity.

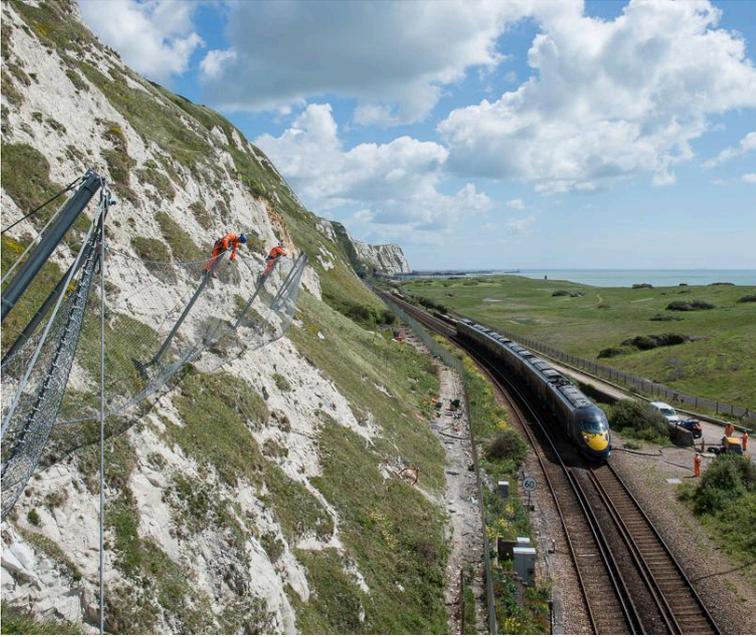
Another line of GBE-1000A rockfall barriers during final inspection.

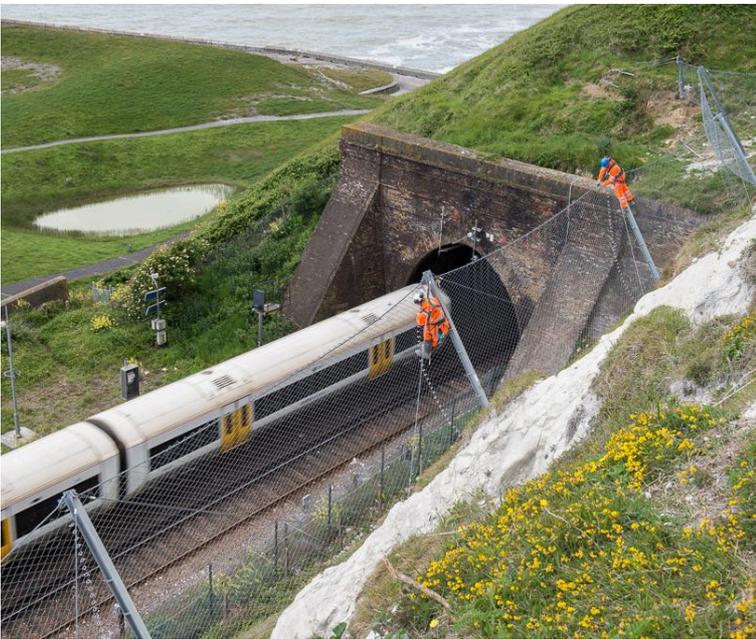
Another view of GBE-1000A rockfall barriers during final inspection.
