DIANA FALLS,

Diana Falls
Haast

2014

NZTA
Geovert
Opus & Sicon Fergusson

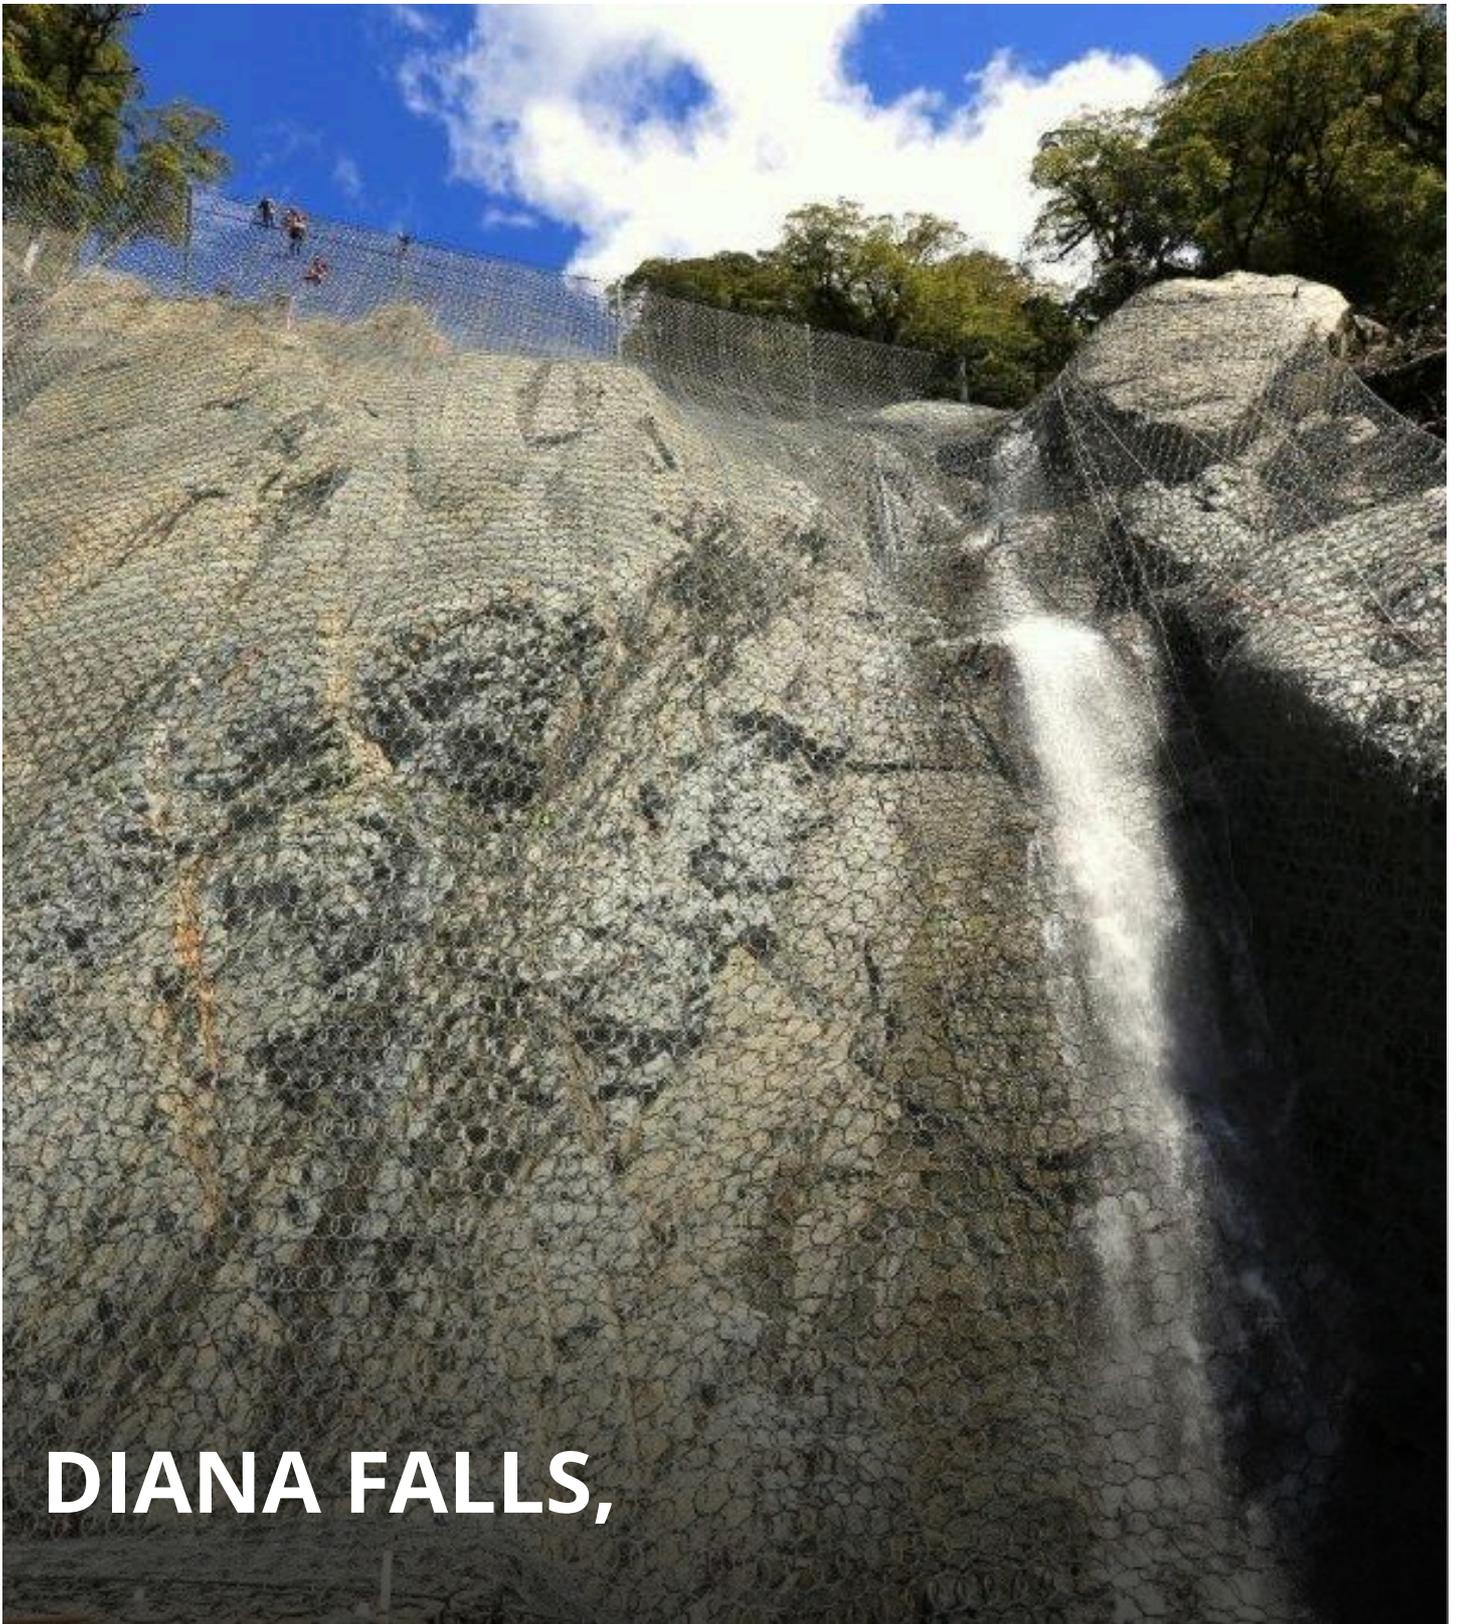
Geovert was awarded the contract to design and build a bespoke rockfall protection solution above the State Highway to actively control the frequent high energy rockfalls. The best solution for the site was the construction of a 5m high 3000 kj and two 6 m high 5000 kj Geobrugg attenuator barriers. The 3000 kj system was installed over 250m above the highway, the first of the 5000 kj system was installed 150 m up and the final and largest barrier was installed around 50 m above the road. The bottom rockfall attenuator was a massive structure with a 35 t high tensile steel ROCCO ring net drape to control and channel the falling rocks and debris to the roadside for the maintenance crew to clear.
