Lockstein
Berchtesgaden

2017

Markt Berchtesgaden Community
Dipl.-Ing. Bernd Gebauer Ingenieur GmbH
HTB Baugesellschaft m.b.H.

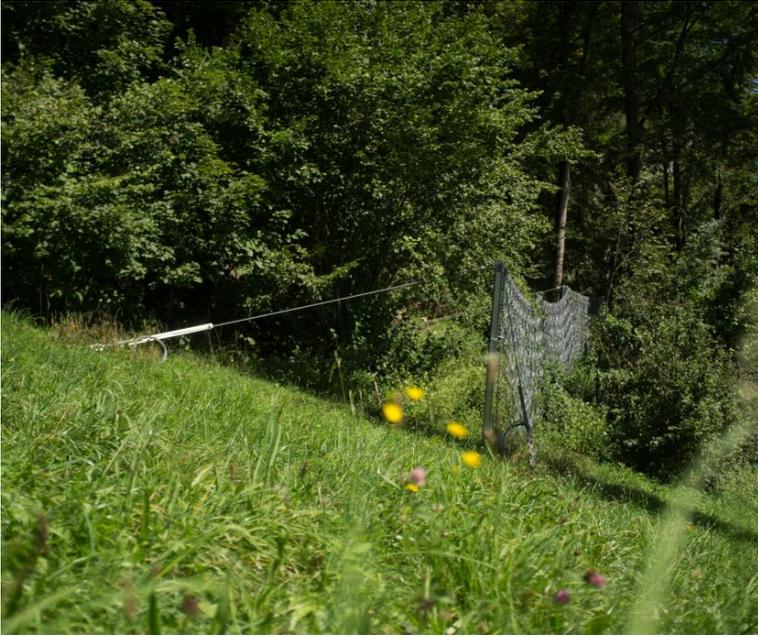
The installed RXE-500-LA barrier

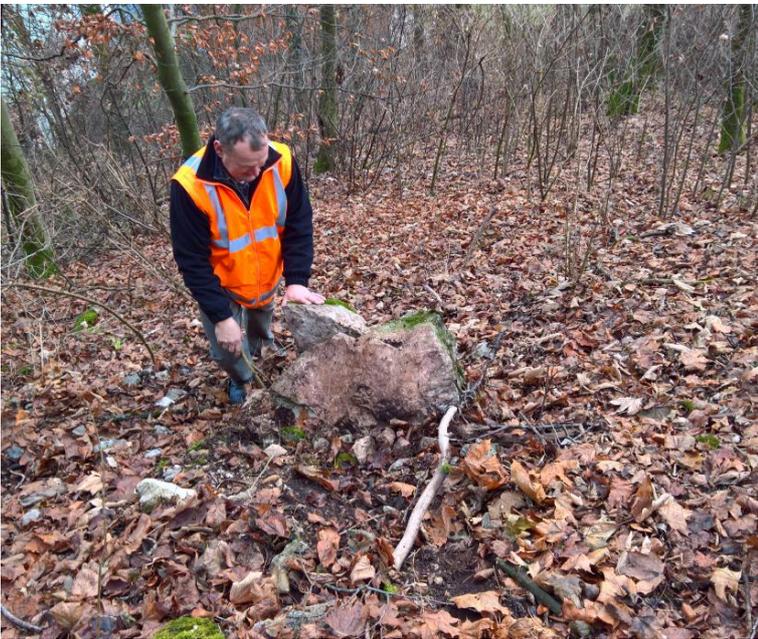
Example of boulder size in a possible rockfall

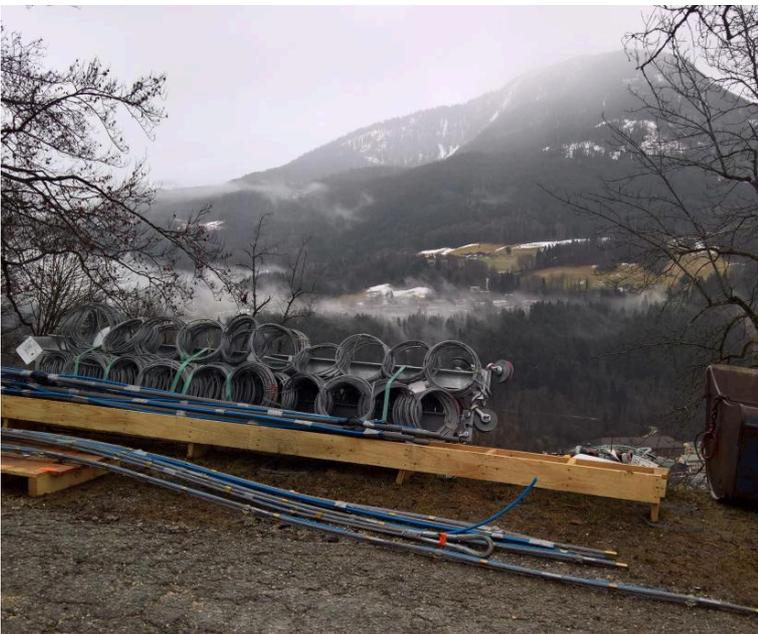
The low weight is a huge advantage when constructing barriers, particularly if, as in this case, the use of heavy machinery is not possible

Due to the conditions described above, the barriers were installed by hand without machinery.

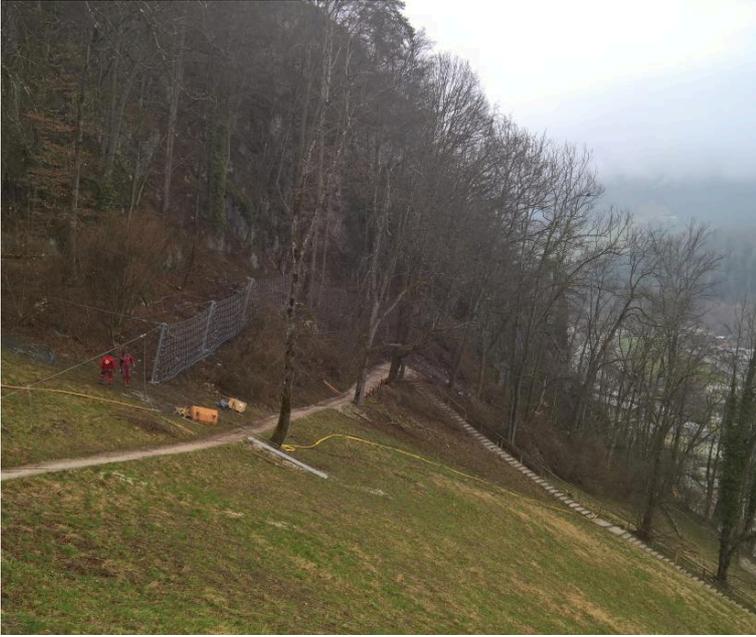
Final work on the RXE-500-LA rockfall barrier. Drilling work was performed by a walking excavator with a drilling rig

Anchoring: wire rope anchors 5 m long (lateral) and 4 m long (support anchors) were used. In the looseened rock area, for the lateral anchor rope on the west side flex heads were used instead of wire rope anchors.

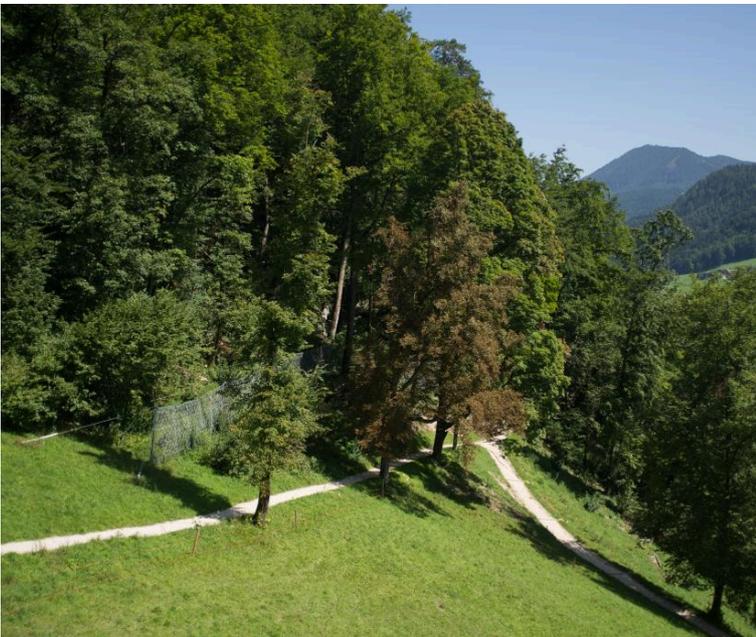
Overview of the fully installed RXE-500-LA rockfall barrier couple of months after installation. Visible protected touristic route

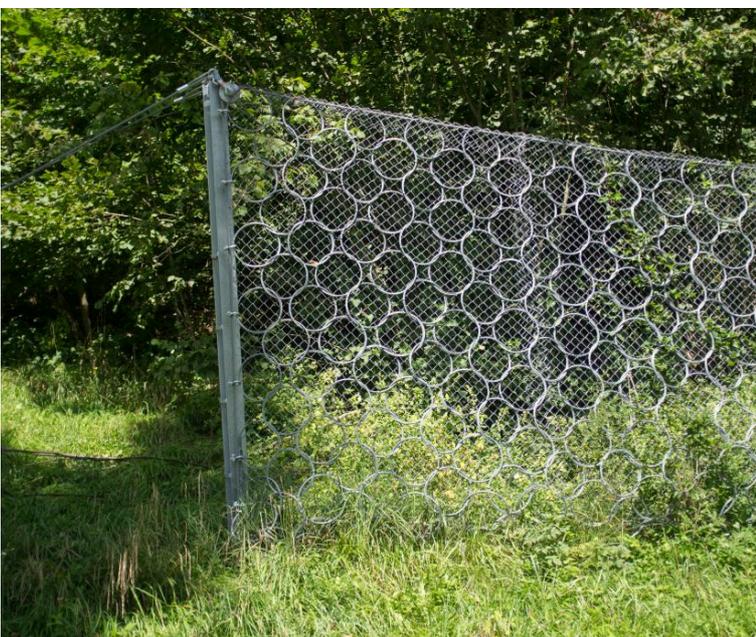
RXE-500-LA with a unique rope guide - the upper support rope serves as a vertical rope

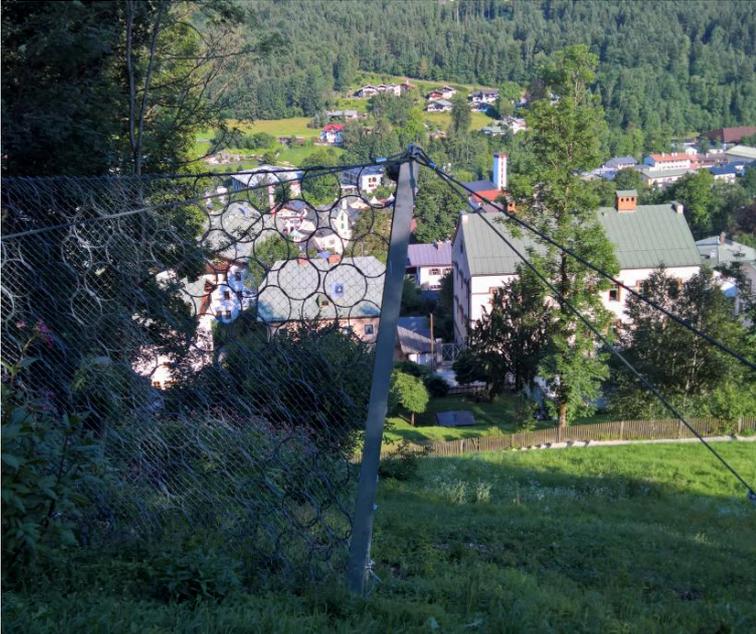
Due to the growth of the natural vegetation, the barrier is hardly noticeable any more in this tourist area. One of the protected buildings in the valley is the kindergarten, which was previously threatened by rockfall

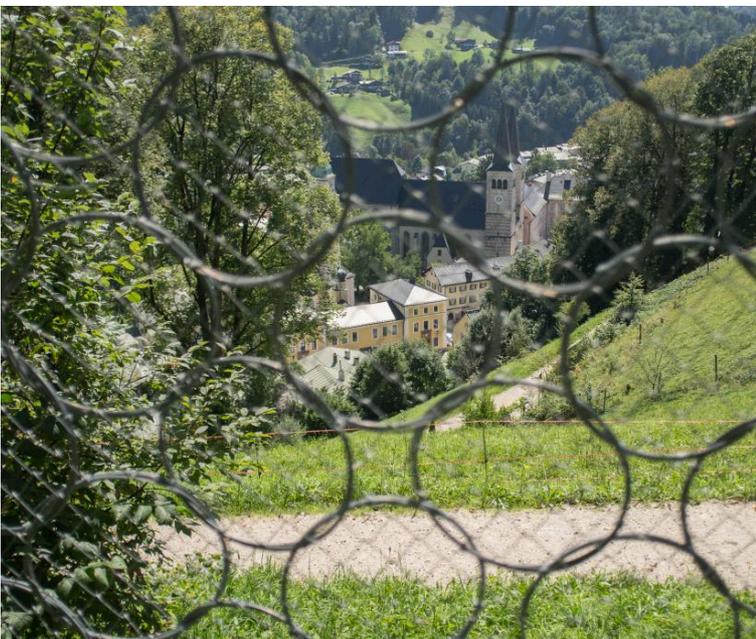
The barrier is not only lightweight, but also has the highest protective function in its energy class

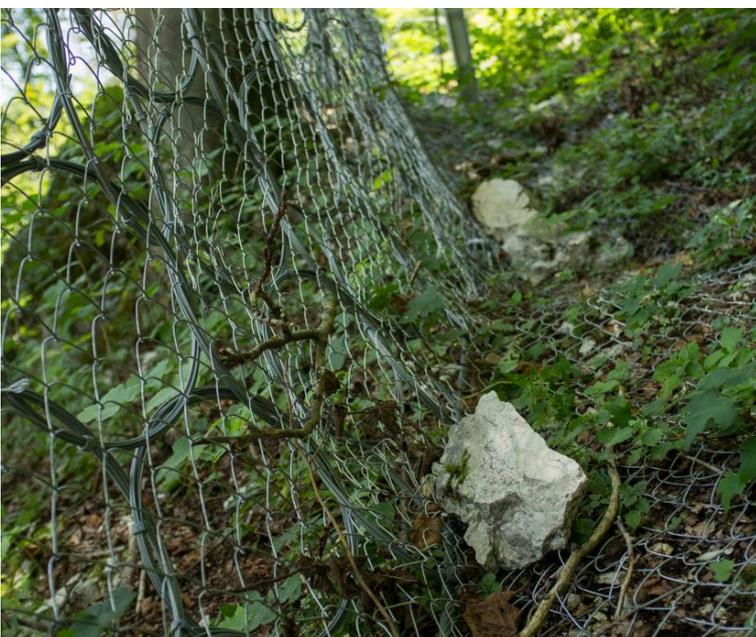
The barrier already proves its worth shortly after installation. Rockfall of different magnitudes occurs regularly

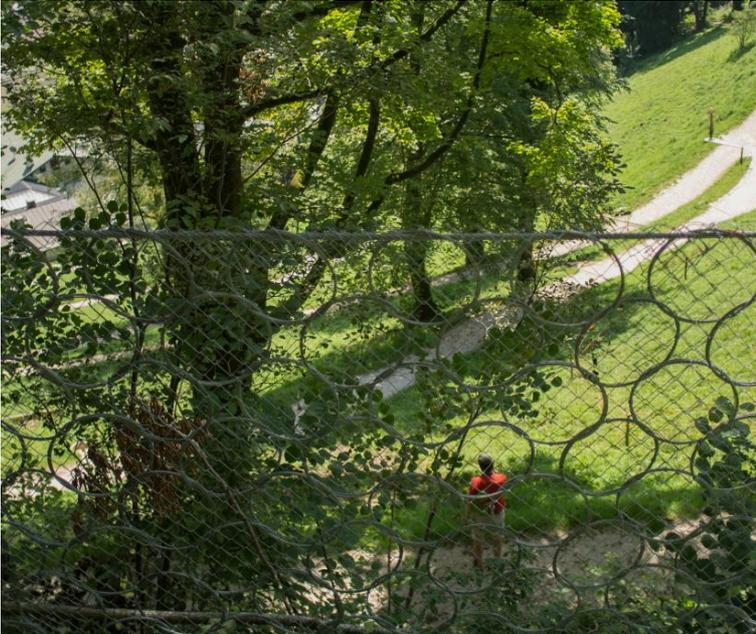
The Emmaus circular trail as a tourist attraction is now completely protected from rockfall
