GRASBERG MINE,

Rockfall hazard from the natural slopes above the mill area within the Grasberg mine had to be mitigated. After several incidents with boulders hitting buildings and infrastructure a fast and reliable solution had to be found.

The RXE-8000 rockfall barrier was installed across a very active gully on the east side of the mill area. Several rockfall incidents with boulders up to 2 meters in diameter had affected the mill infrastructure before. To ensure safe operation of the mill area below the gully, the barrier was installed approximately 140 meters above office buildings and ore processing facilities.

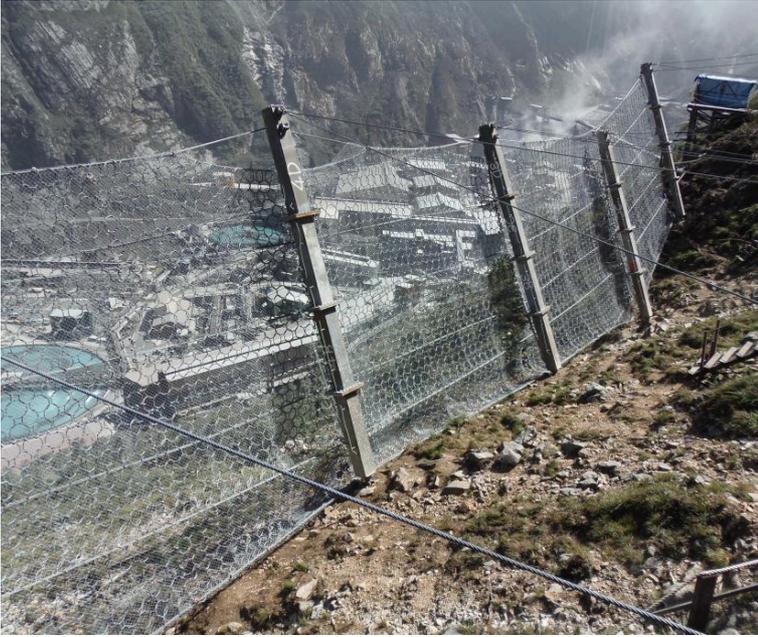
RXE-8000 rockfall barrier protecting mill facility in the background

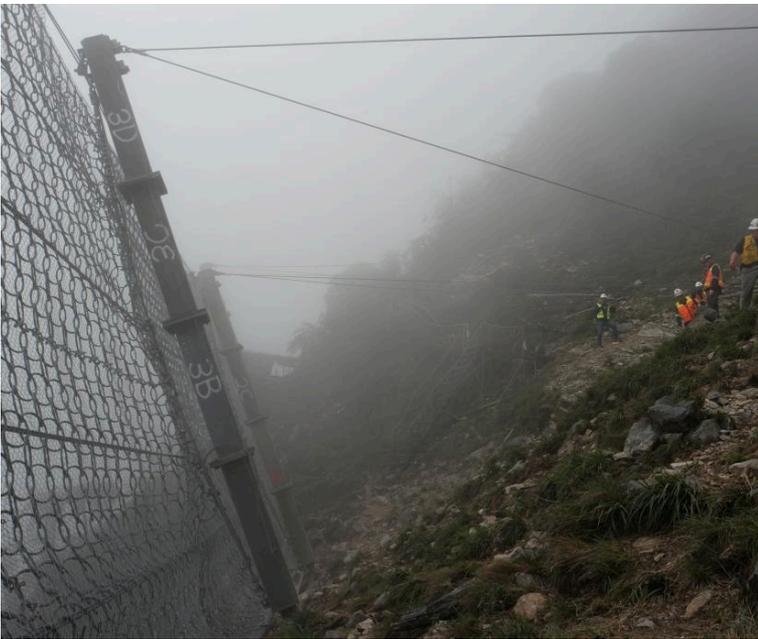
Installation works in progress - visible special combined posts allowing helicopter transport

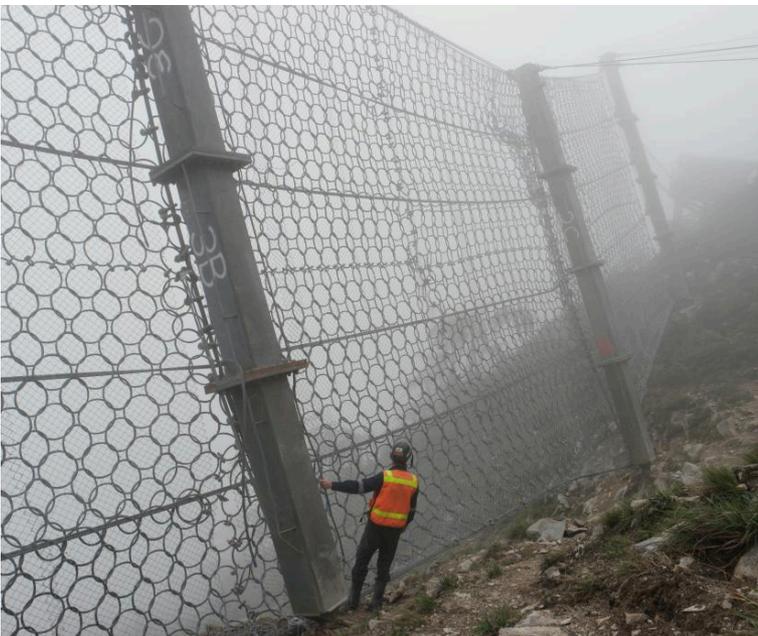
Slope morphology required reliable protection against 8000 kJ rockfalls and a height of 9 meters

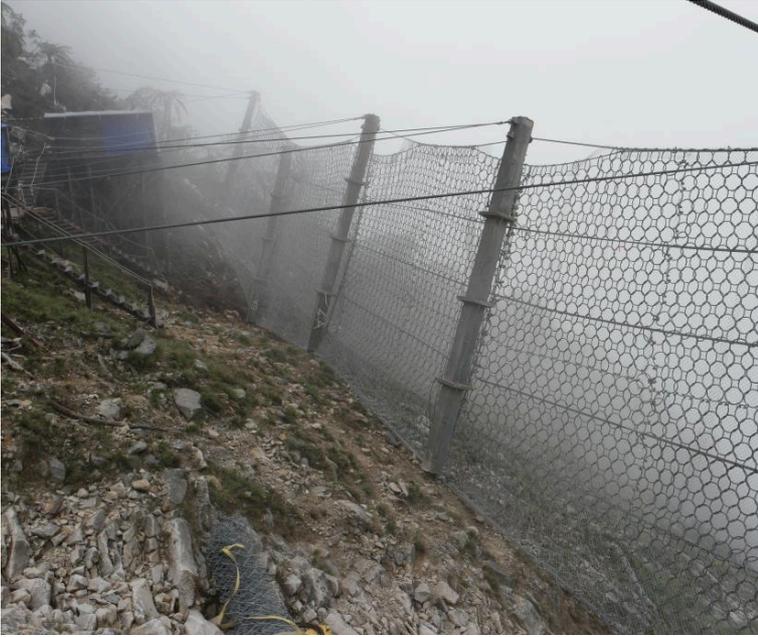
Finally, a 50 meters long rockfall protection was installed

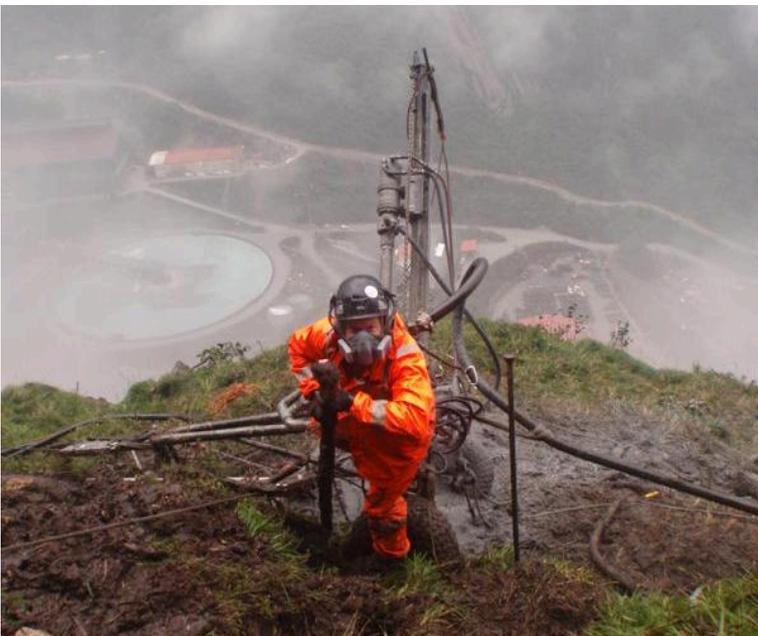
Drilling works required good preparation and special equipment suspended on ropes

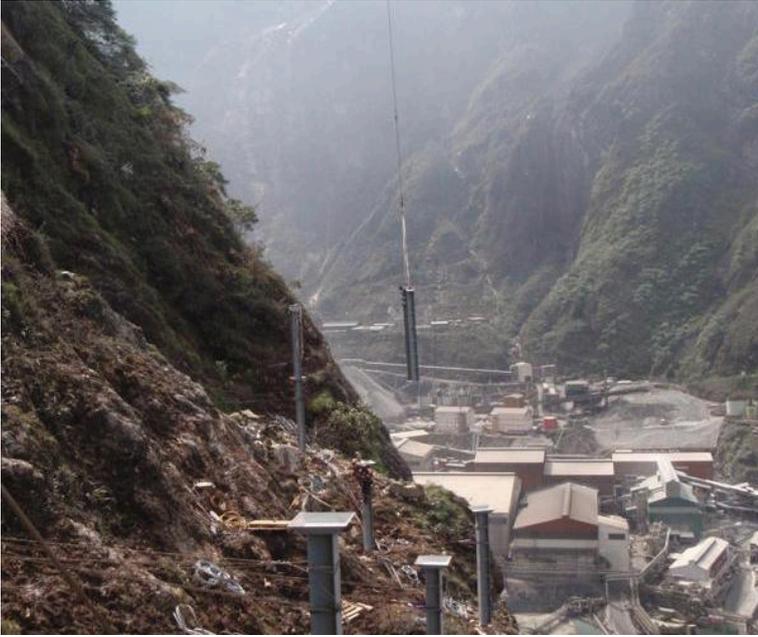
Because of the size and helicopter transportation limits, posts were delivered in pieces, being screwed together directly on site

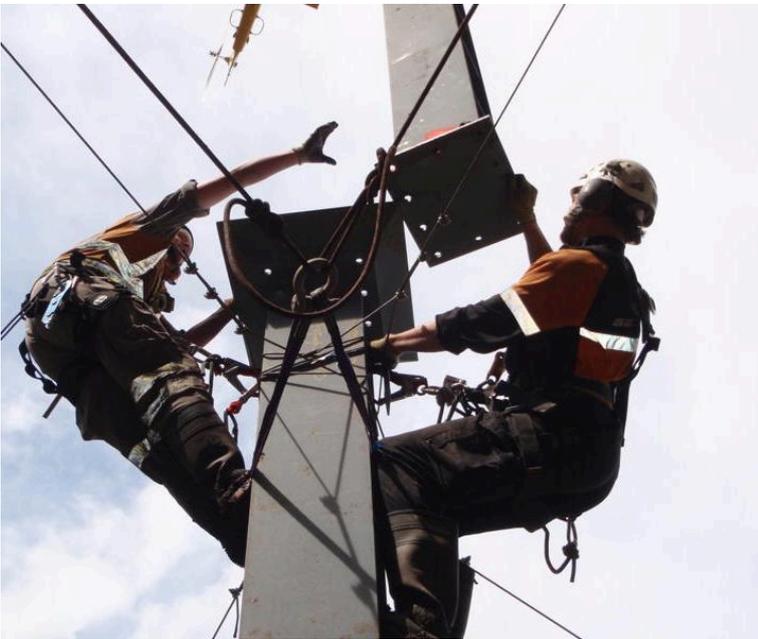
RXE-8000 middle post pieces being transported by the helicopter - visible project specific screw flanges

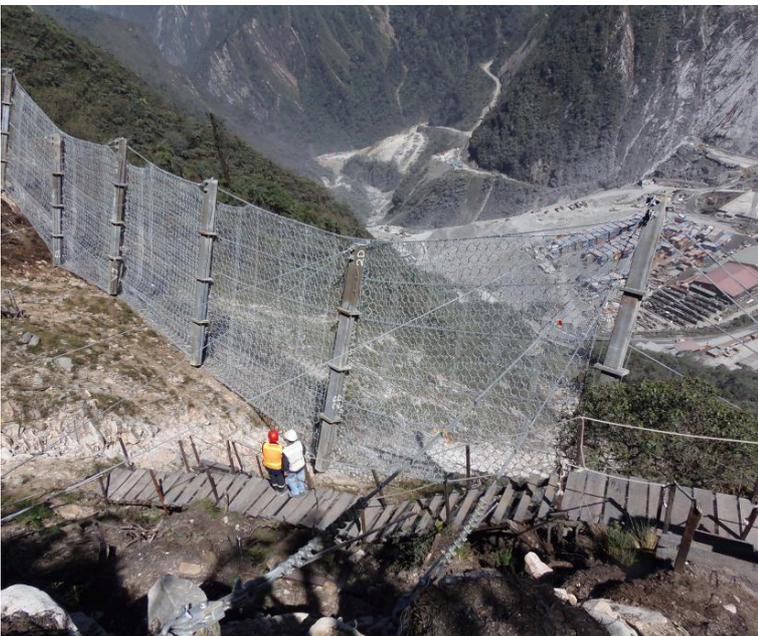
9 meters high RXE-8000 rockfall barrier installed across a natural gully
