## BRUGG Geobrugg

## TECHNICAL DATA SHEET

## High-tensile steel wire mesh DELTAX® G80/3

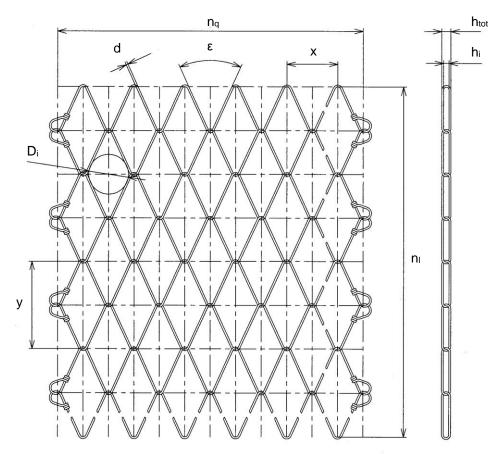
DELTAX® high-tensile steel wire mesh		
Mesh shape:	rhomboid	
Diagonal:	$x \cdot y = 102 \cdot 177 \text{ mm (+/-3\%)}$	
Mesh width:	$D_i = 80 \text{ mm (+/-3\%)}$	
Angle of mesh:	ε ca. 49 degrees	
Total height of mesh:	$h_{tot} = 12.5 \text{ mm (+/-1.5 mm)}$	
Clearance of mesh:	h <sub>i</sub> = 6.5 mm (+/-1.5 mm)	
No. of meshes longitudinal:	$n_l = 5.6 \text{ pcs/m}$	
No. of meshes transversal:	$n_{a} = 9.8 \text{ pcs/m}$

DELTAX <sup>®</sup> mesh	
Roll width:	b <sub>Roll</sub> = 3.9 m
Roll length:	I <sub>Roll</sub> = 30 m
Total surface per roll:	$A_{Roll} = 117 \text{ m}^2$
Weight per m <sup>2</sup> :	$g = 1.45 \text{ kg/m}^2$
Weight per mesh roll:	G <sub>Roll</sub> = 170 kg
Mesh edges:	mesh ends knotted
