SAFER MARITIME WORKPLACES

Snapback Protection Systems

The first validated solution against mooring line failure transforms maritime safety and prevents injury during a Snapback event.

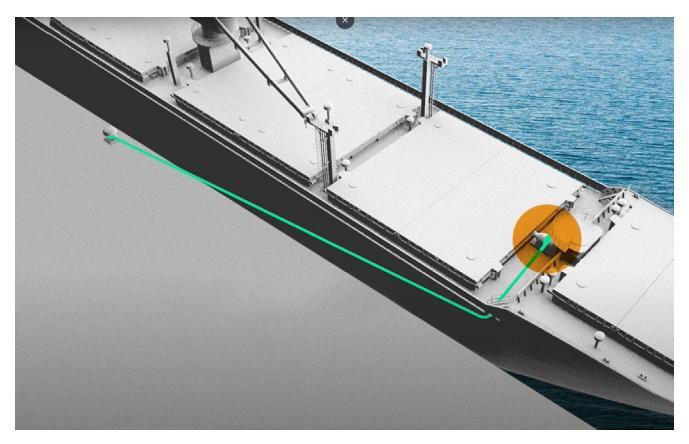
A typical mooring configuration carries dangers of mooring line snapback. More details in the video: geobrugg.com/snapbackdanger

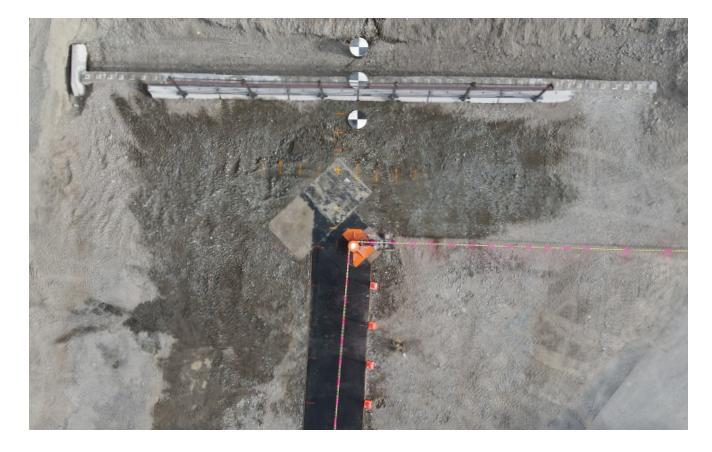
Dynamic impact testing

Together we developed a full-scale test that accurately replicated snapback events in a controlled, repeatable way - a world first. The data gave real insight into snapback behaviour and helped develop safer snapback protection fences. More details in the case study video: geobrugg.com/snapbackcasestudy

The full-scate testing undertaken in cooperation with Holmes Solutions is a first-of-its-kind and has given a unique insight into the behaviour of ruptured lines. Full-scale, real-world testing is essential when designing for high-risk industries where safety is crucial. From adventure rides to roadside barriers and rockfall protection, the detailed data gained from this type of testing is key to the success of life-safety products.

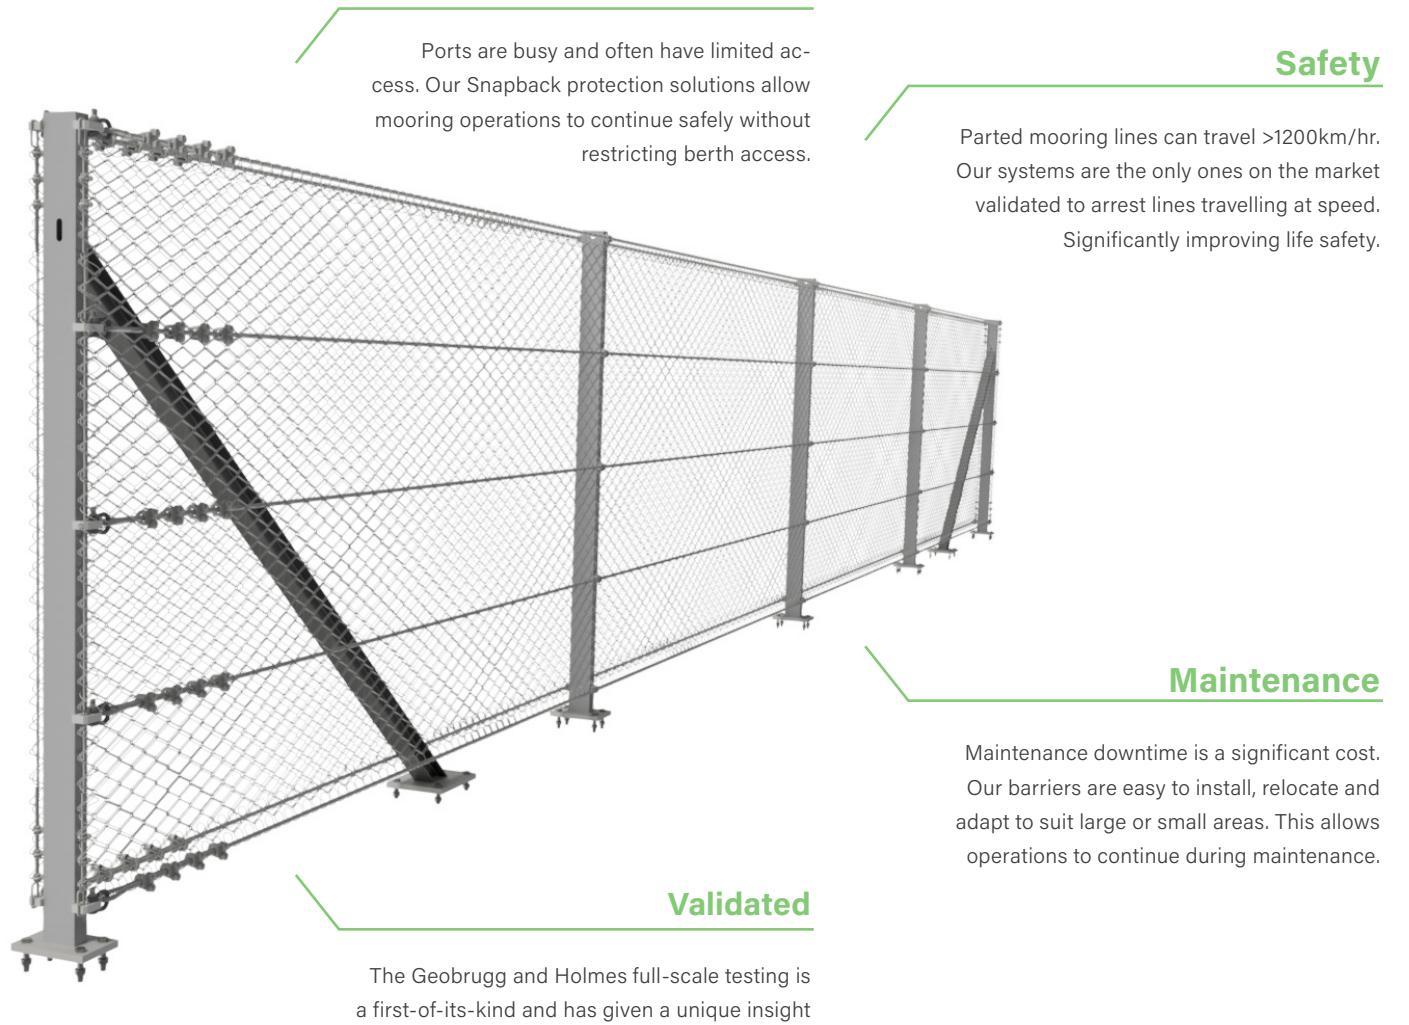
Flexible and modular Snapback Protection Systems

Permanent Protection Systems are installs for larger footprints and single-use terminals to protect mooring staff, crew, passengers and visitors as they access the area without disrupting operations.

Workzone Protection Systems allow temporary maintenance work to be undertaken within large or small areas with varying geometry and difficult access, enabling operations to continue with minimum downtime.

Mobile Protection Systems are flexible installs for smaller footprints and multi-use terminals.

Rigid Protection Systems can be retrofitted to existing structures such as a hook or dolphin cages or for ship loader cabin protection, where the envelope for deflection is limited.

Vessel Protection Systems developed specifically for on-vessel operations to protect crew from vessel side Snapback risk.
