# ALTENA, DISTRICT ROAD B236, GERMANY

**Rockfall Protection**

<b>Project</b>	Altena, district road B236
<b>Location</b>	Altena
<b>Country</b>	Germany
<b>Year of installation</b>	2013
<b>Customer</b>	Road Administration North Rhein - Westfalia
<b>Engineering</b>	ILG Giessen
<b>Contractor</b>	Feldhaus Bergbau GmbH

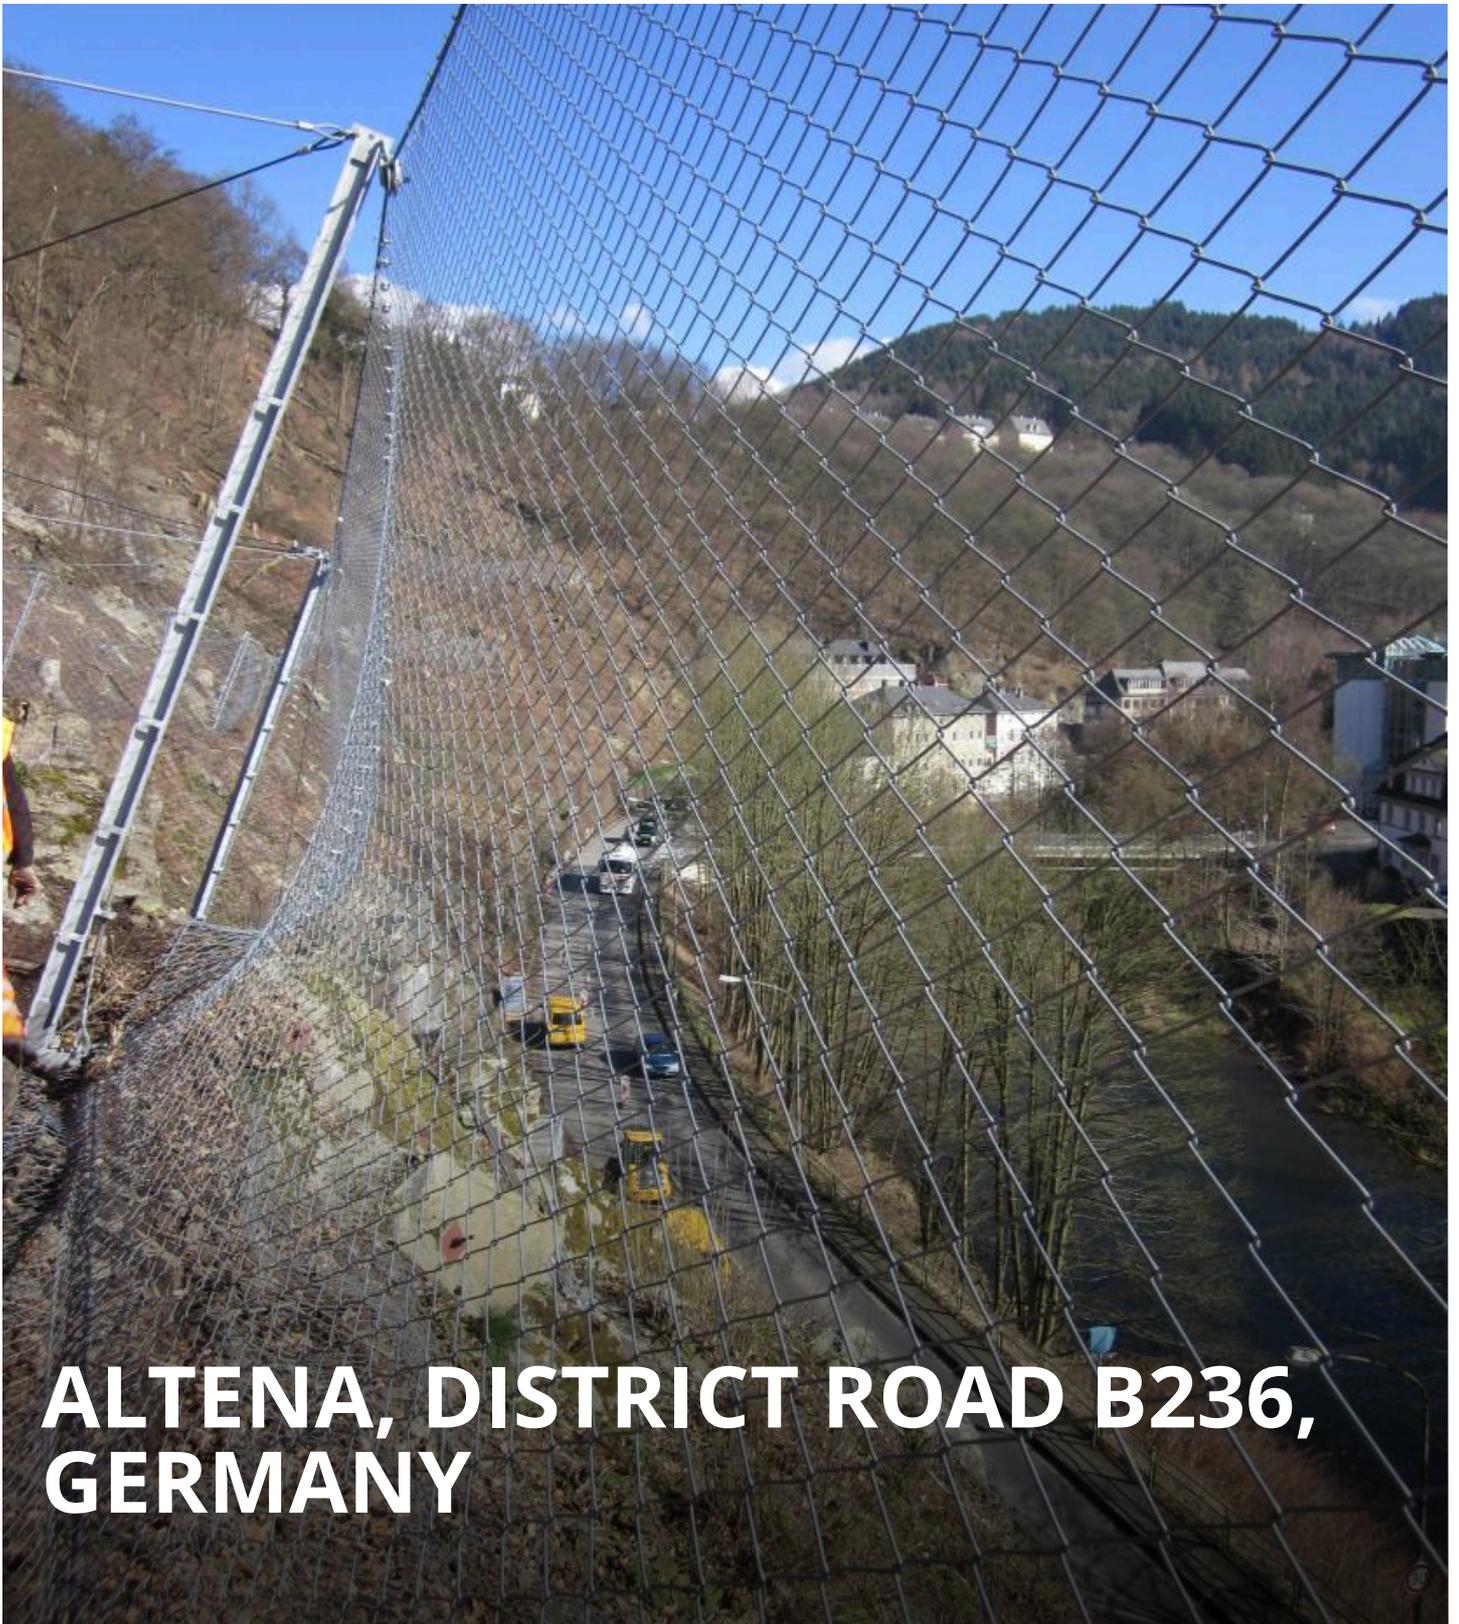
**Description** The existing fence was a system of 260 meters. It was torn down, and Geobrugg installed a total of five fences GBE-500A and GBE1000A with a length of more than 300 meters. Additionally, single securing systems were installed to reduce forces acting on the system (anchoring and concrete plug). Three sections of about 60 meters in length were covered with TECCO®.

<b>Protected object</b>	Road
<b>Energy absorption capacity</b>	500 kJ, 1000 kJ
<b>System height</b>	3.0 m, 4.0 m
<b>System length</b>	335 m
