# RAHOVEI 20, CLUJ-NAPOCA, ROMANIA

**Slope Stability**

**Project** Rahovei 20, Cluj-Napoca  
**Location** Cluj-Napoca  
**Country** Romania

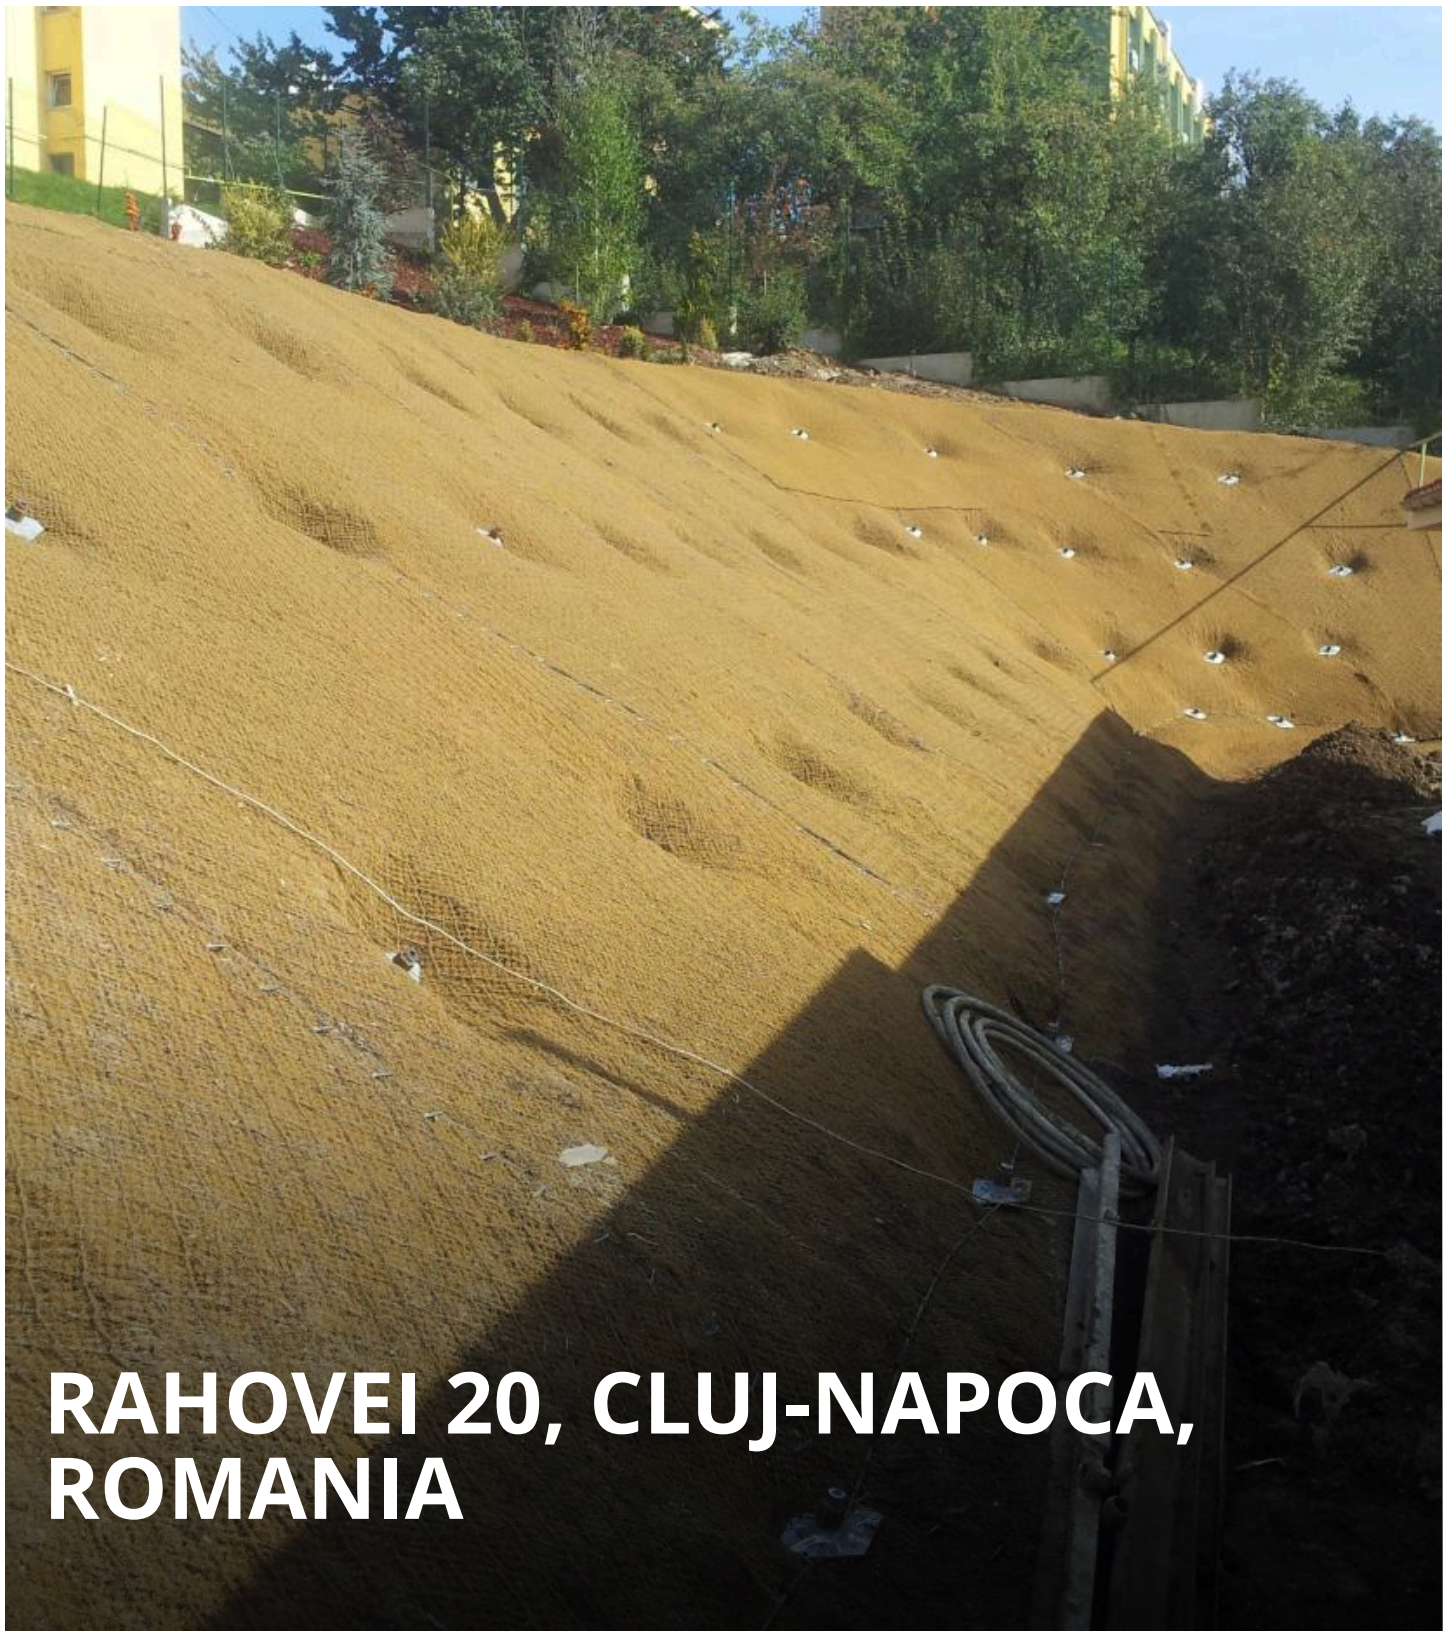
**Description** Geobrugg designed and delivered a complete protection system. The solution was a standard soil nailing together with GREENAX® mesh. A total of 229 m² were stabilized using 40 soil nails R32. They were installed in the pattern of 2.50 x 2.20 m.
