BLUDENZ-UNTERSTEIN, AUSTRIA

Rockfall Protection

Project	Bludenz-Unterstein
Location	Bludenz
Country	Austria
Year of installation	2015
Customer	die.wildbach Wildbach- u Lawinenverbauung
Initial situation	Four buildings on Untersteinstrasse in Bludenz were endangered by an overhanging rock. The steep slope with a gradient of up to 150 percent had to be secured by our rockfall protection system.
Description	Two RXE rockfall protection barriers were installed: The first system is a RXE-1000 (5 meters in height, 40 meters in length), the second system is a RXE-1000 (5 meters in height, 44 meters in length), in combination with a RXE-500 (4 meters in height, 36 meters in length). The installation on the rough terrain was a challenge: Even a helicopter was required to transport the 300 kilogram posts up in the air. Two men received the posts, while two colleagues attached them to the ground plates – practically with one foot in the abyss. It really took them only 30 minutes to place and install the posts. The Geobruigg systems are flexibly used even on slopes that are difficult to access, they are installed quickly and easily – an efficient solution no matter how tricky the situation is

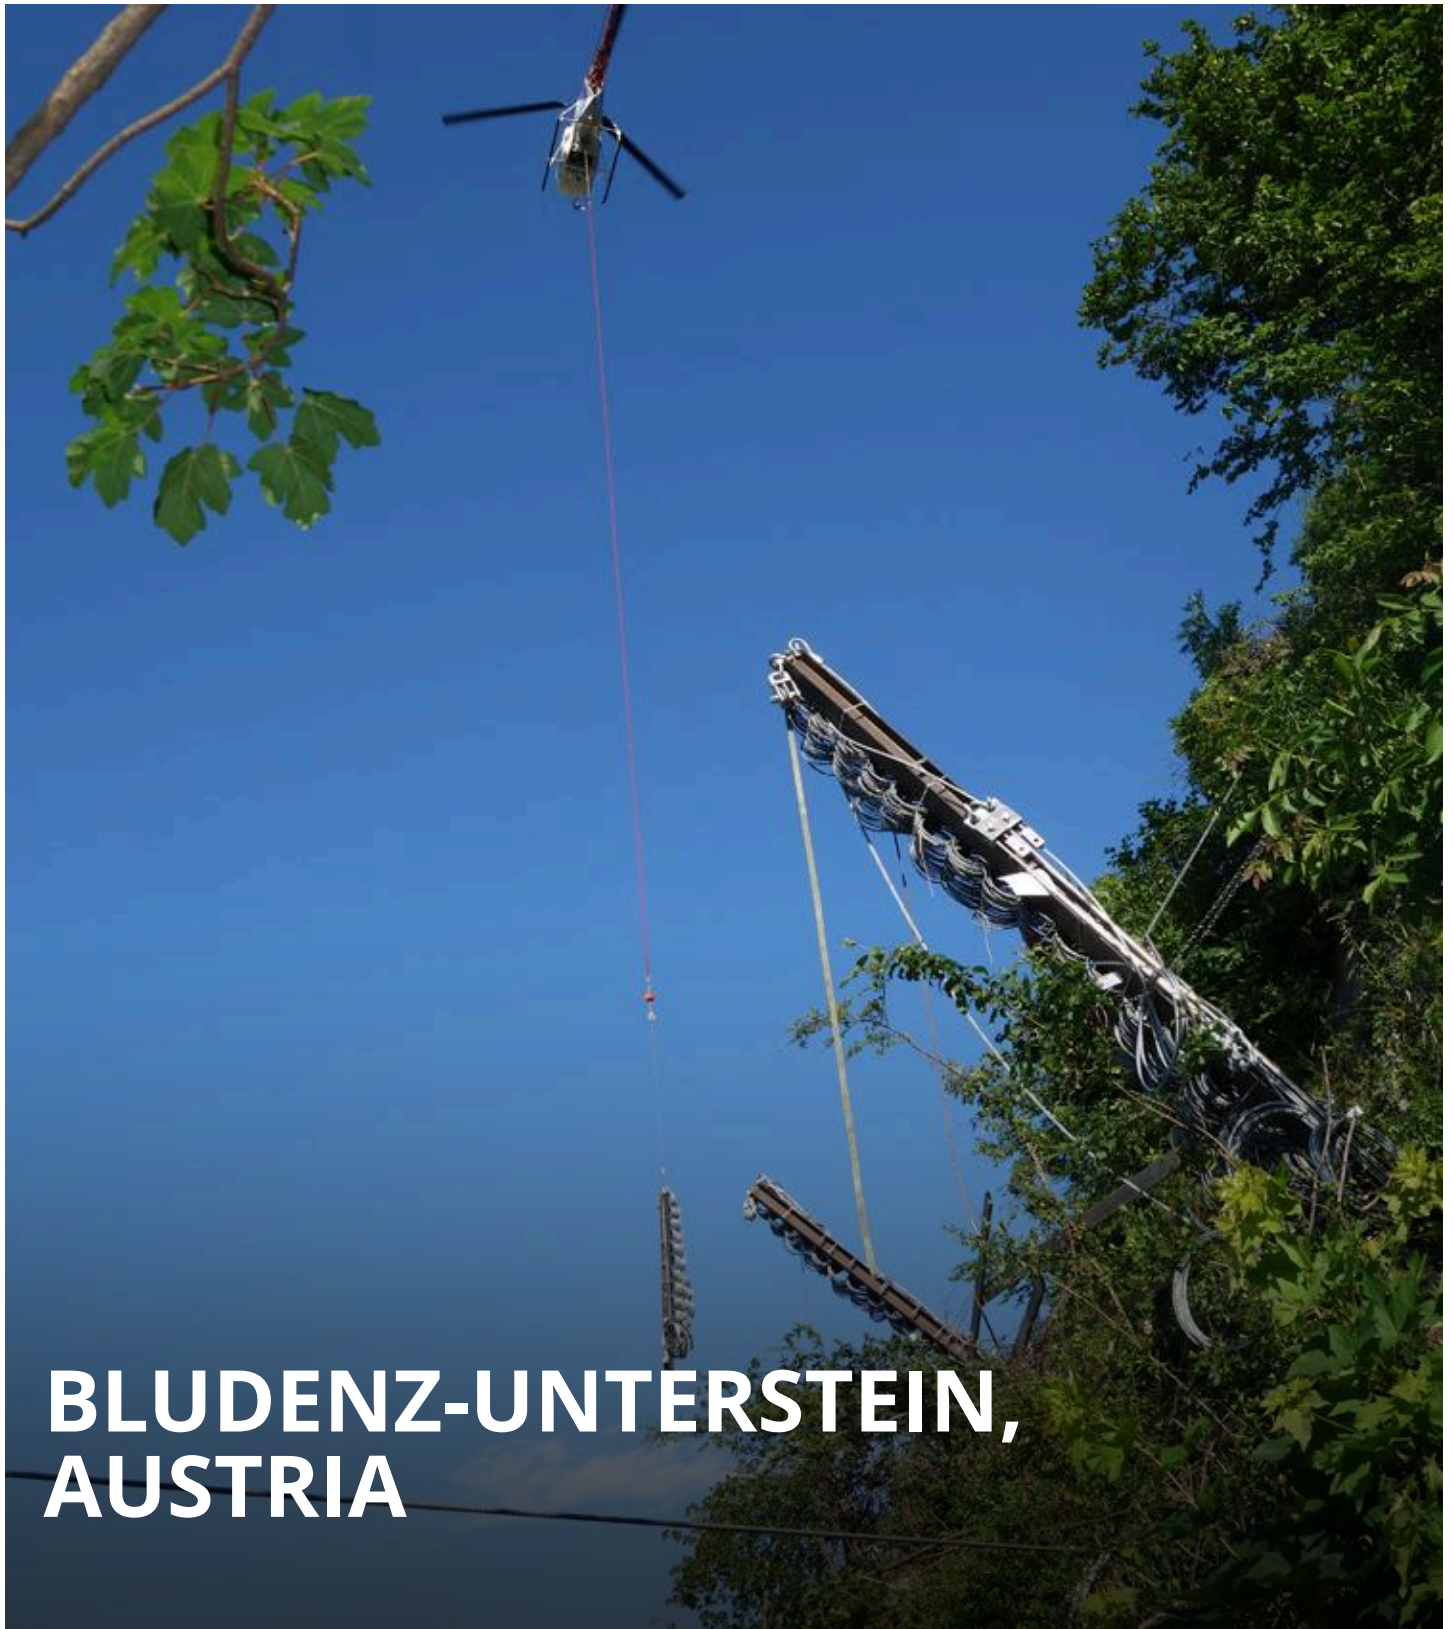
Protected object	Building
Energy absorption capacity	500 kJ, 1000 kJ
System height	4.0 m, 5.0 m
System length	40 m - 80 m
