DIANA FALLS, NEW ZEALAND

Rockfall Protection

Project	Diana Falls
Location	Haast
Country	New Zealand
Year of installation	2014
Customer	NZTA
Engineering	Geovert
Contractor	Opus & Sicon Fergusson

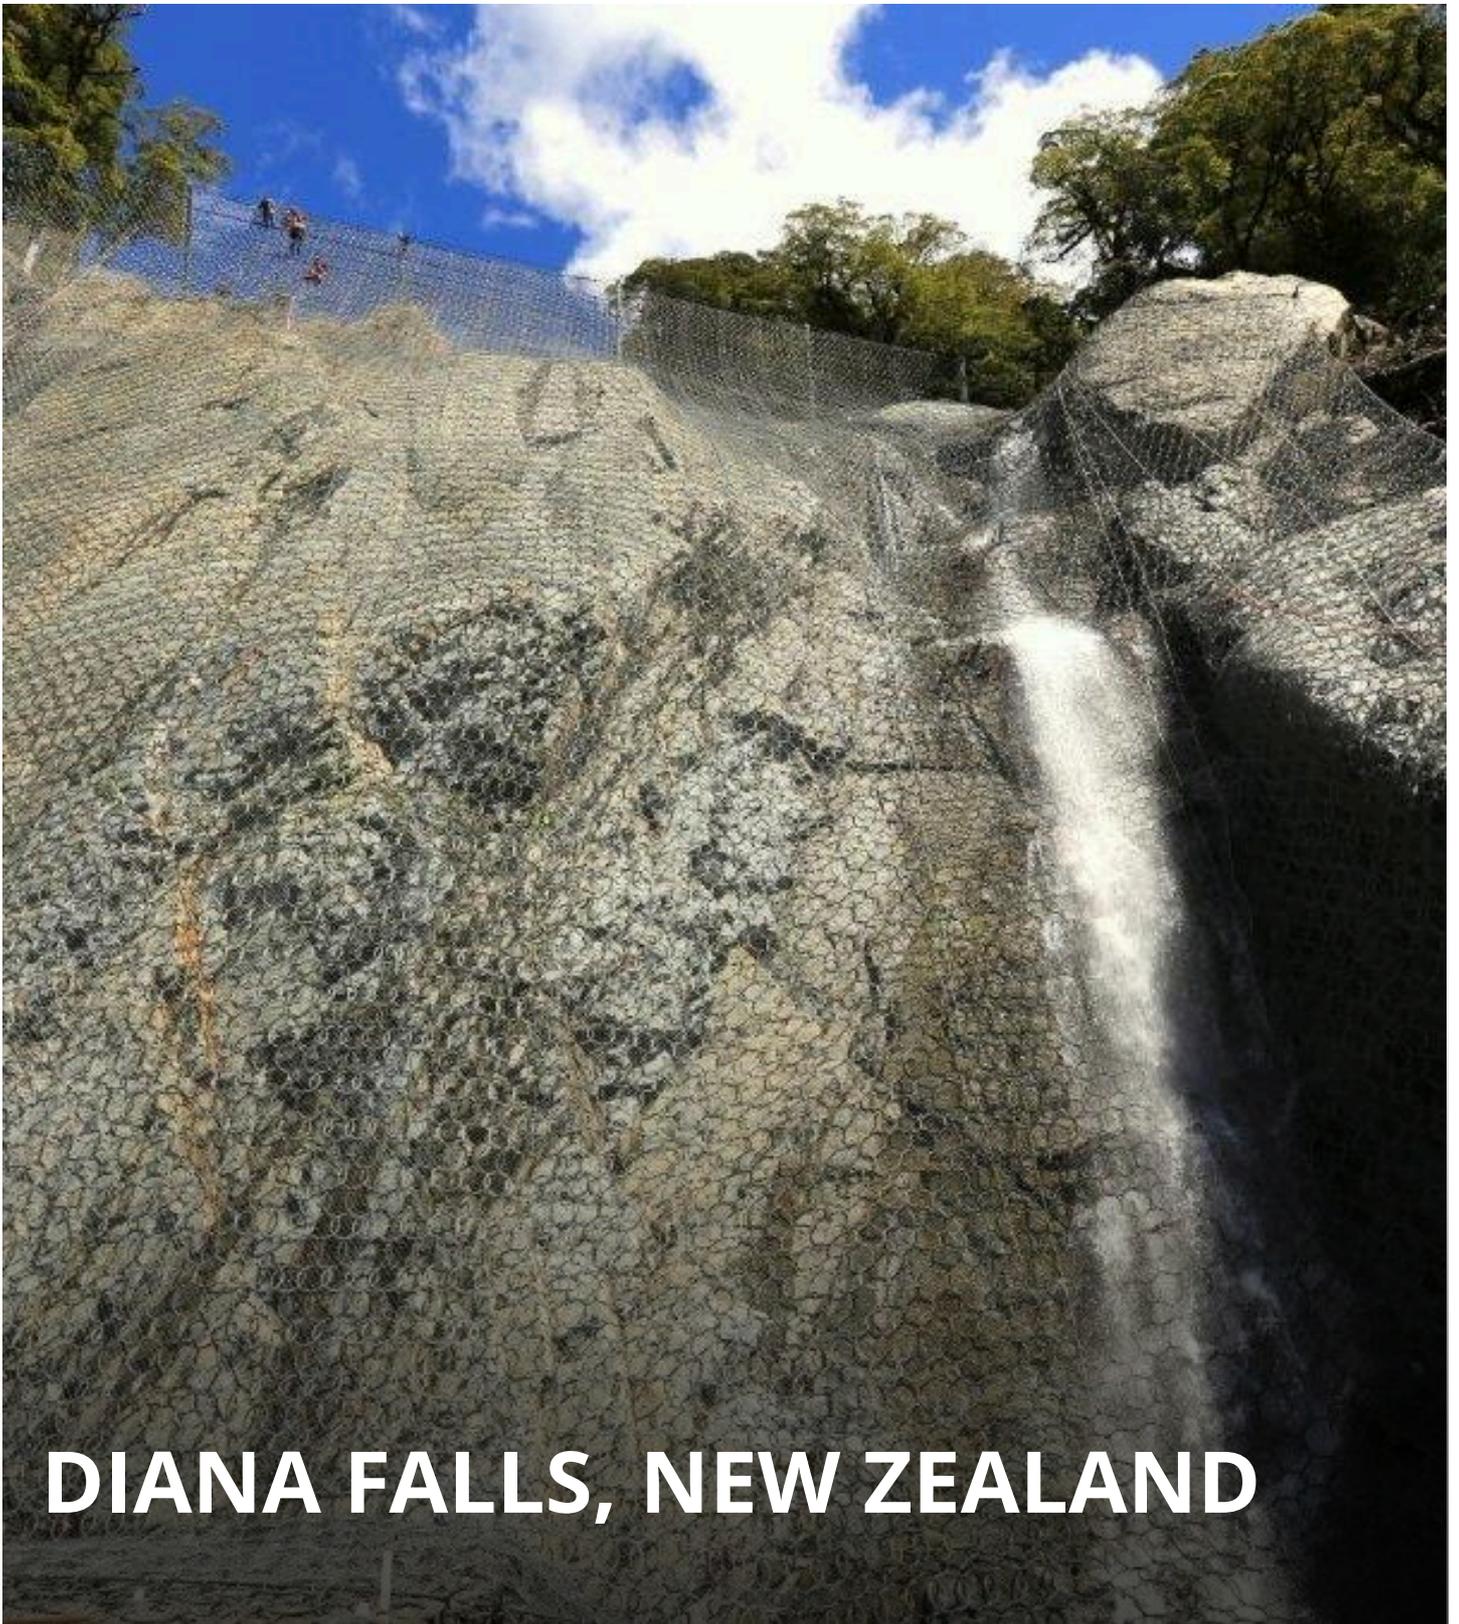
Description Geovert was awarded the contract to design and build a bespoke rockfall protection solution above the State Highway to actively control the frequent high energy rockfalls. The best solution for the site was the construction of a 5m high 3000 kJ and two 6 m high 5000 kJ Geobrugg attenuator barriers. The 3000 kJ system was installed over 250m above the highway, the first of the 5000 kJ system was installed 150 m up and the final and largest barrier was installed around 50 m above the road. The bottom rockfall attenuator was a massive structure with a 35 t high tensile steel ROCCO ring net drape to control and channel the falling rocks and debris to the roadside for the maintenance crew to clear.

Protected object	Road
Energy absorption capacity	3000 kJ, 5000 kJ
System height	5.0 m, 6.0 m
System length	40 m - 60 m

Initial situation Heavy rain cause a 40'000 cubic metre slip to completely close SH6 for several weeks in September 2013. Once cleared the road remained closed at night due to the continued high risk of rockfall from over 250 m up the slip face. Some of the unstable rocks were larger than 20 foot shipping containers.
