MONSERRATE WALKING PATH, PROJECT STAGE 2, COLOMBIA

Rockfall Protection

Project	Monserate Walking path, Project Stage 2
Location	Bogota Monserate Walking Path
Country	Colombia
Year of installation	2017
Customer	IDIGER (Instituto distrital de gestion del Riesgo)
Contractor	National Army of Colombia

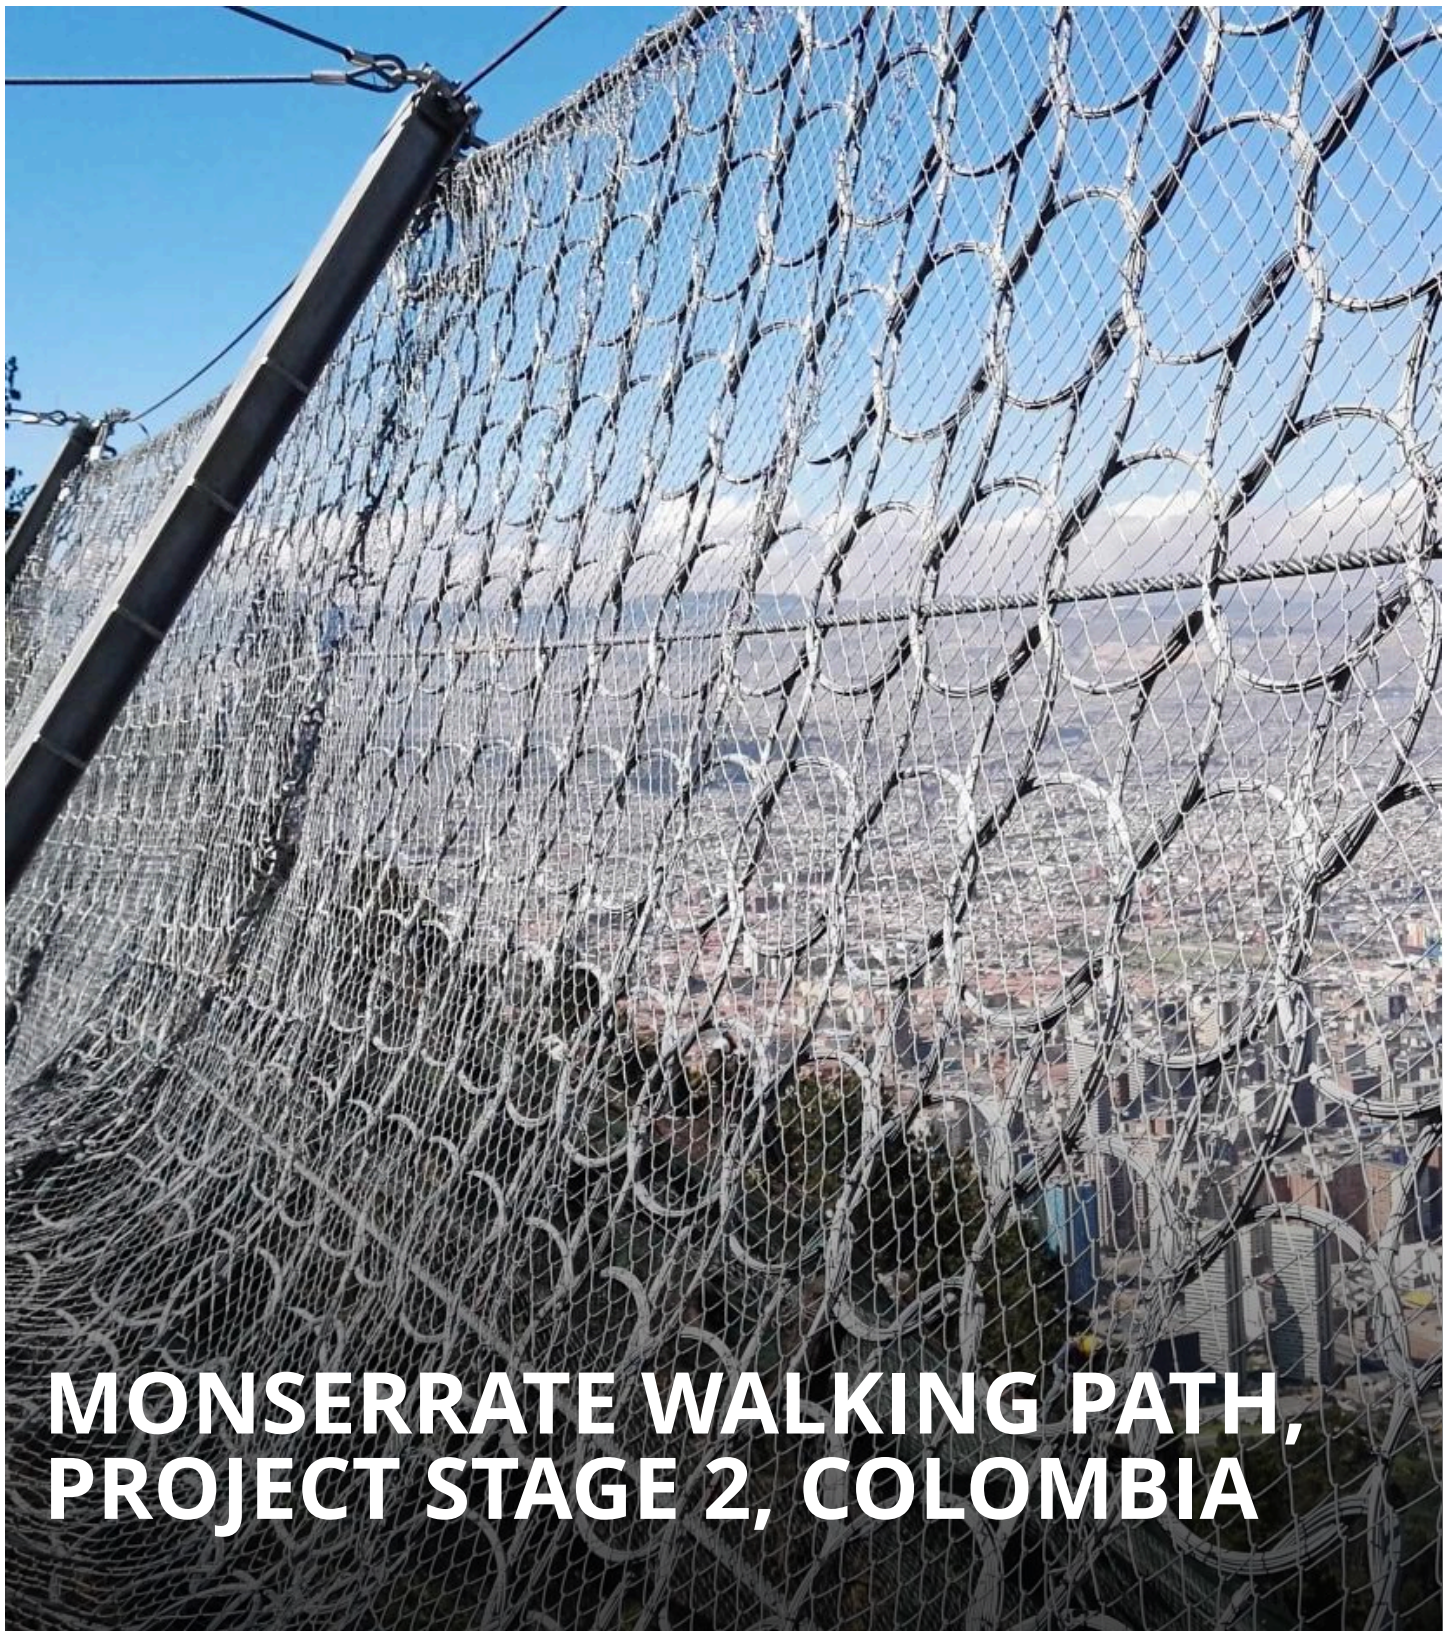
Description	<p>EL IDIGER institute evaluated systems to control the rock falls in order to to re-open the path. WARCO SAS and Geobrugg advised during the design and provided the rockfall barriers. Finally five barriers were installed along the trail to cover the exposed areas. Installed RXE-3000 barriers are 4 m high and have a total length of 215 m.</p>
--------------------	--

Protected object	Touristic infrastructure
Corrosion protection	Galvanized, GEOBRUGG SUPERCOATING
Energy absorption capacity	3000 kj
System height	4.0 m
System length	35 m - 70 m
