# AMBOLIGHAT, MAHARASHTRA, INDIA

**Slope Stability**

<b>Project</b>	Ambolighat, Maharashtra
<b>Location</b>	Ambolighat, Maharashtra
<b>Country</b>	India
<b>Year of installation</b>	2014
<b>Customer</b>	Public Works Department, Sawantwadi
<b>Contractor</b>	Pioneer Foundation Engineers Pvt. Ltd., Mumbai

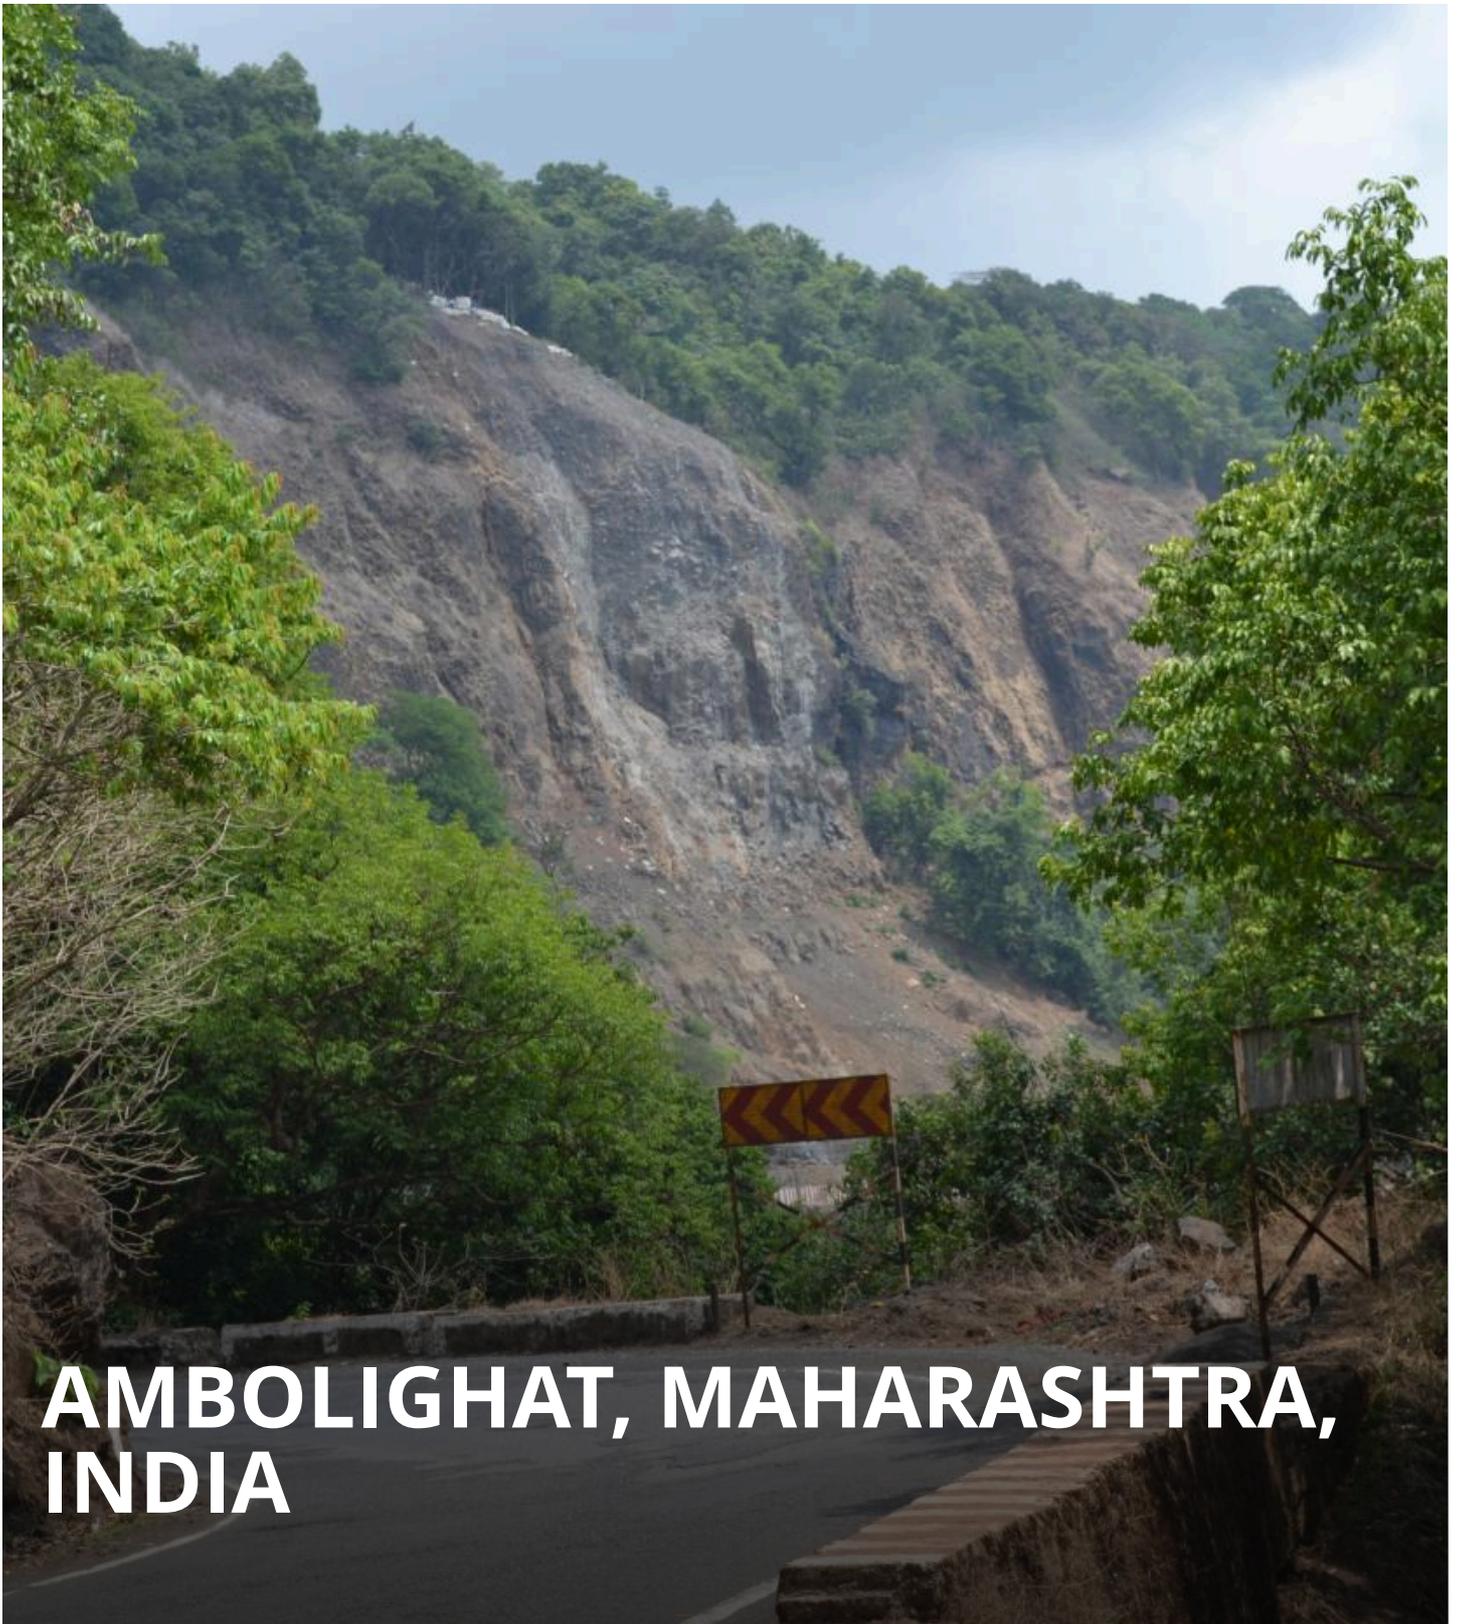
The consortium of Pioneer Foundation Engineers and Geobruigg AG was awarded the work for providing rockfall protection solutions using SPIDER® System providing active rock mass stabilization. The SPIDER® System was dimensioned using RUVOLUM® Online Tool. The contractor developed special drilling platform which was mounted through a winch and pulley system.

Approximate height of the nearly vertical slope was 95 m from the road level. The total number of 326 holes were drilled for 8 m long and with 32 mm diameter anchors were placed and fully grouted. A secondary chain link mesh was also placed below the SPIDER® S4-230 net to protect from smaller boulders. The complete work was carried out with the help of rope access technicians. A temporary protection mesh (barrier) was installed at the bottom of the slope to protect traffic from smaller boulders which disintegrated during drilling work. The SPIDER® mesh was pretensioned to the slope surface using system spike plates which were tightened as per the specific torque using a torque wrench.

<b>Protected object</b>	Road
<b>Corrosion protection</b>	GEOBRUGG SUPERCOATING
<b>Stabilized area</b>	1224 m <sup>2</sup>
<b>Maximum slope height</b>	95 m
<b>Slope inclination</b>	85 ° - 90 °
<b>Exposition</b>	North
