POINT BONITA LIGHTHOUSE PEDESTRIAN BRIDGE, UNITED STATES

Rockfall Protection

Project Point Bonita Lighthouse Pedestrian Bridge
Location Sausalito, CA
Country United States

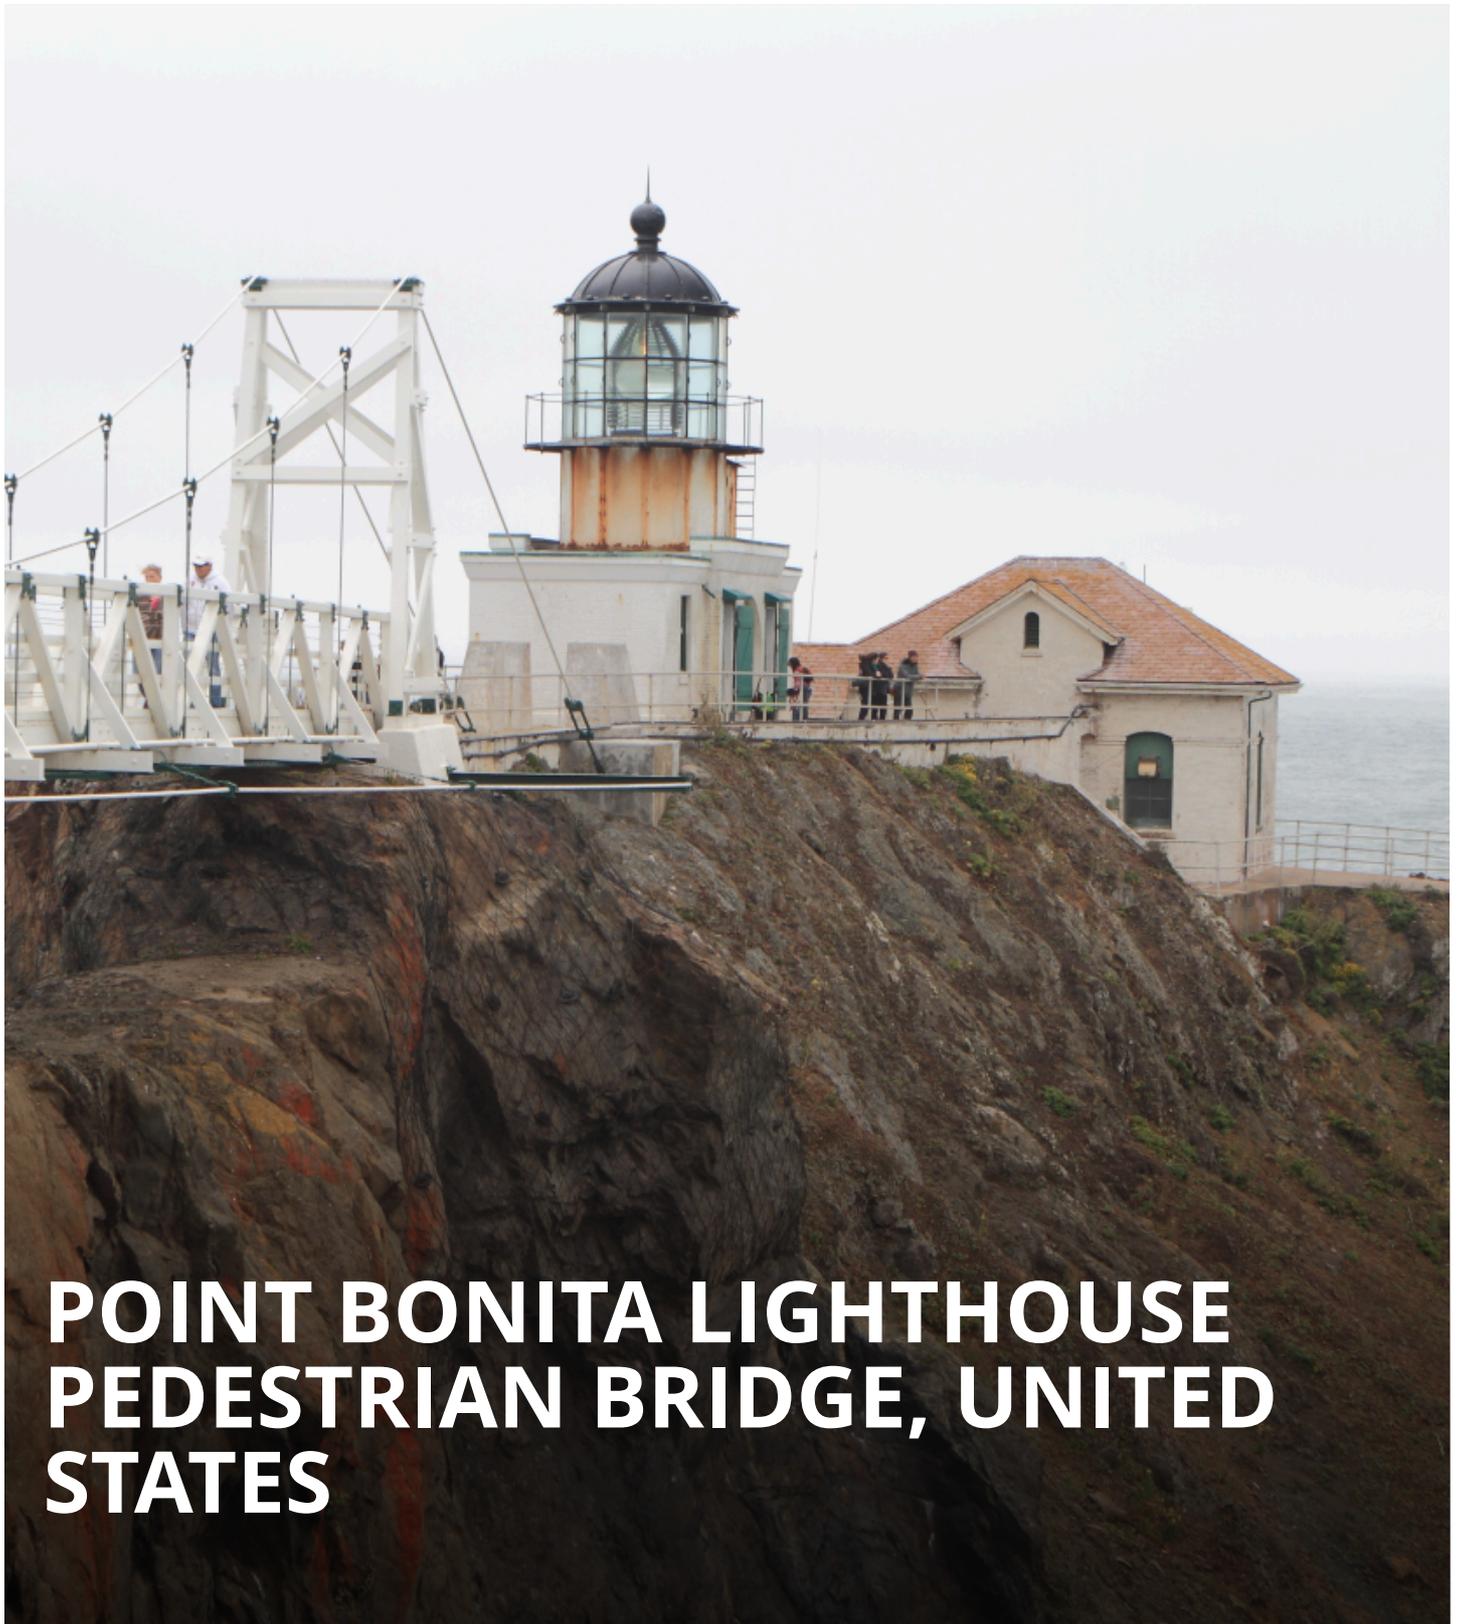
Description A stainless steel anchored SPIDER S4-230 mesh system was installed to stabilize the rock face. The diamond shaped net is comprised of three 4 mm wires twisted into a 1x3 strand, with tensile strength of 239 ksi and a diameter of 5/16 inches. As required by the National Park Service, the net was powder coated bronze to better blend with the natural color of the rock mass and further protect against corrosion.
The project won ENR California's Best Small Project — Construction award in 2012.
