TRES REYES, COLOMBIA

Slope Stability

Tres Reyes

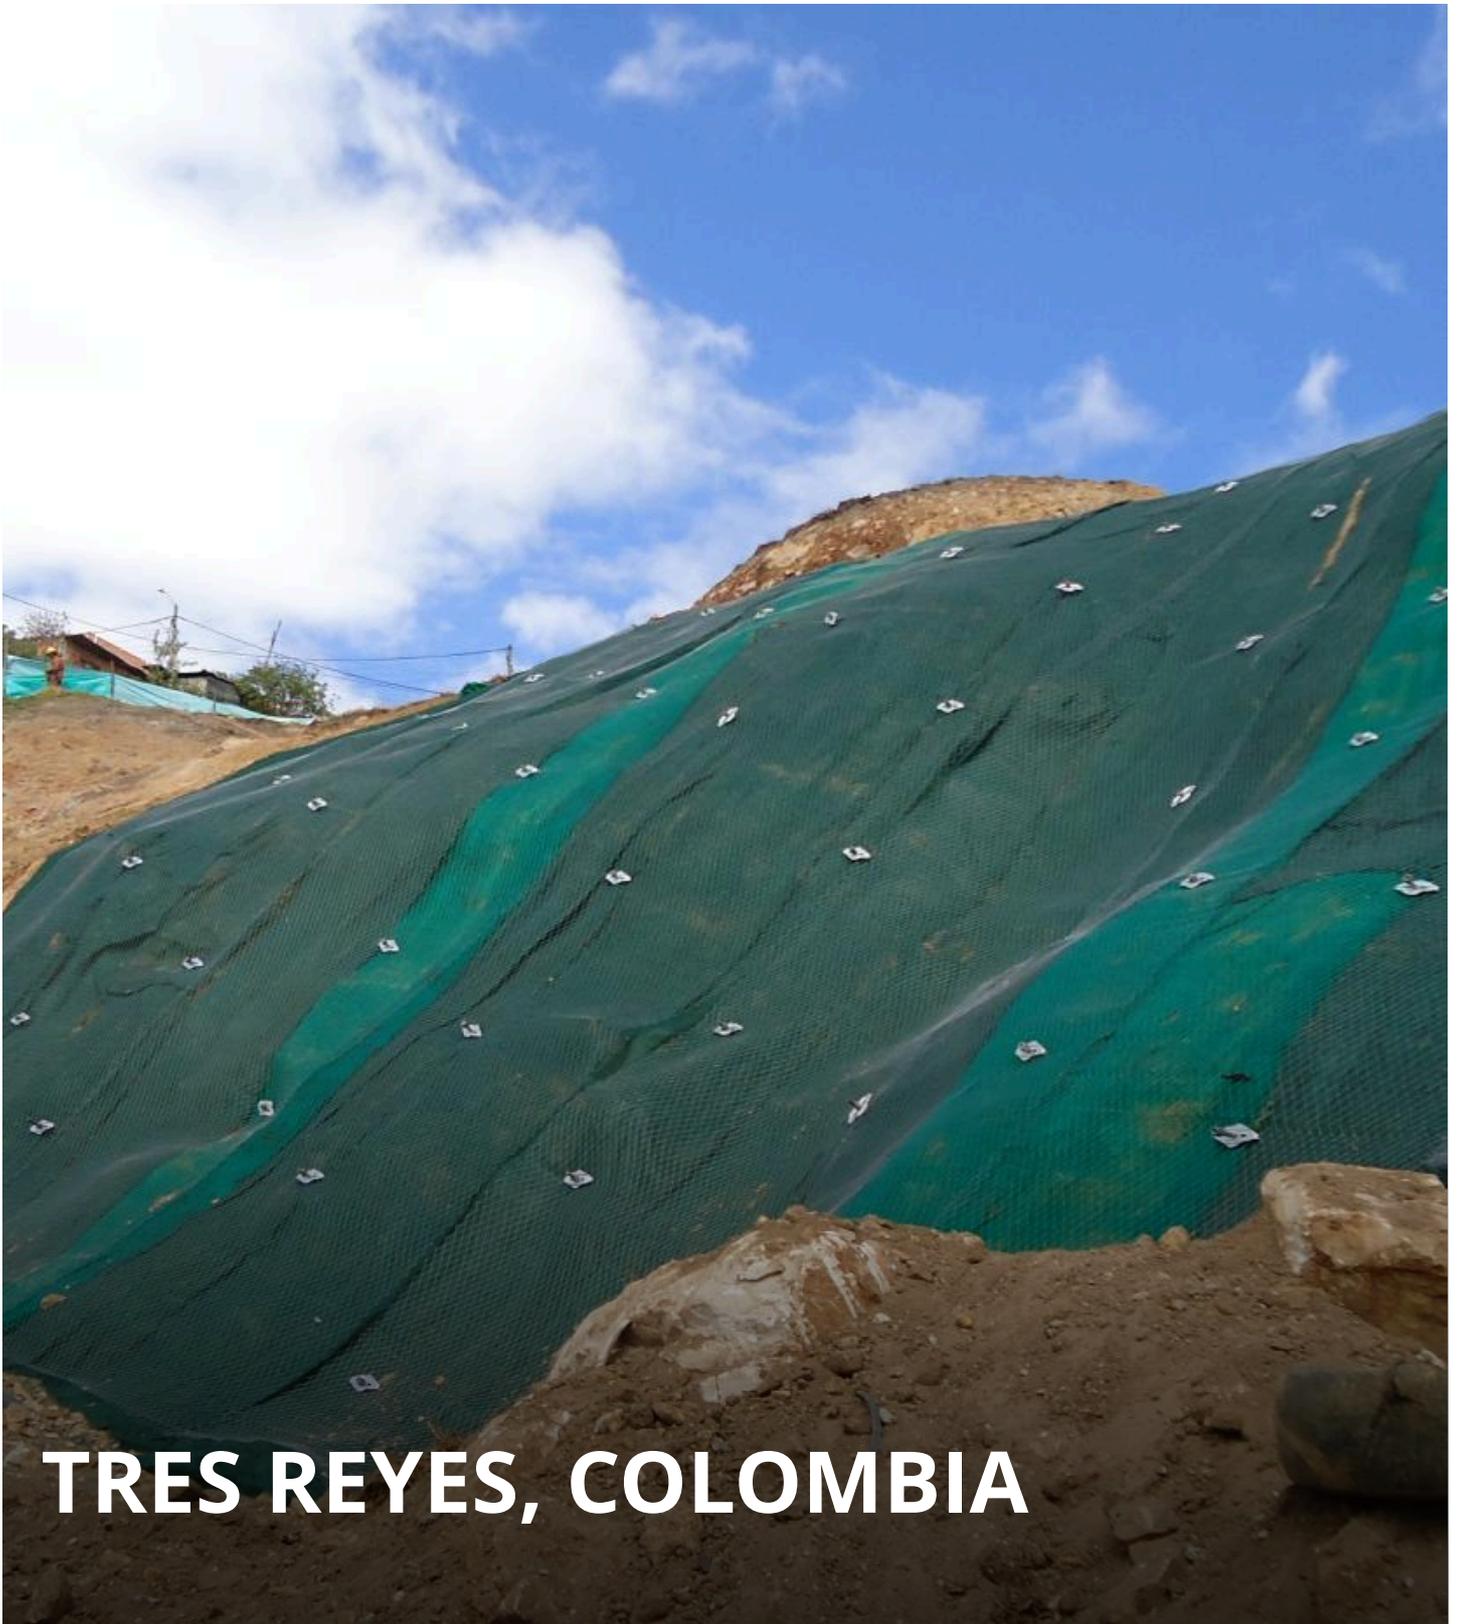
Description The areas at higher risk were identified and two types of solutions were proposed to stabilize the slope. In areas with fractured rock Geobrugg installed the SPIDER system in combination with anchor bolts. In areas having residual soil and weathered rock Geobrugg installed the TECCO® System in combination with anchor bolts. For improved erosion control a local mantle was added.

Initial situation The Tres Reyes neighborhood in the town of Ciudad Bolivar (southern district of Bogota) sits at one of the highest elevations in this area of the mountains. Strata embankments detached from sandstone, residual soil and weathered rock caused landslides that were affecting houses underneath.
