RINGELAIER LEITE ST 2127, ALEMANIA

Estabilización de taludes

Proyecto Ringelaier Leite St 2127
Lugar Ringelai
País Alemania

Año de instalación 2015

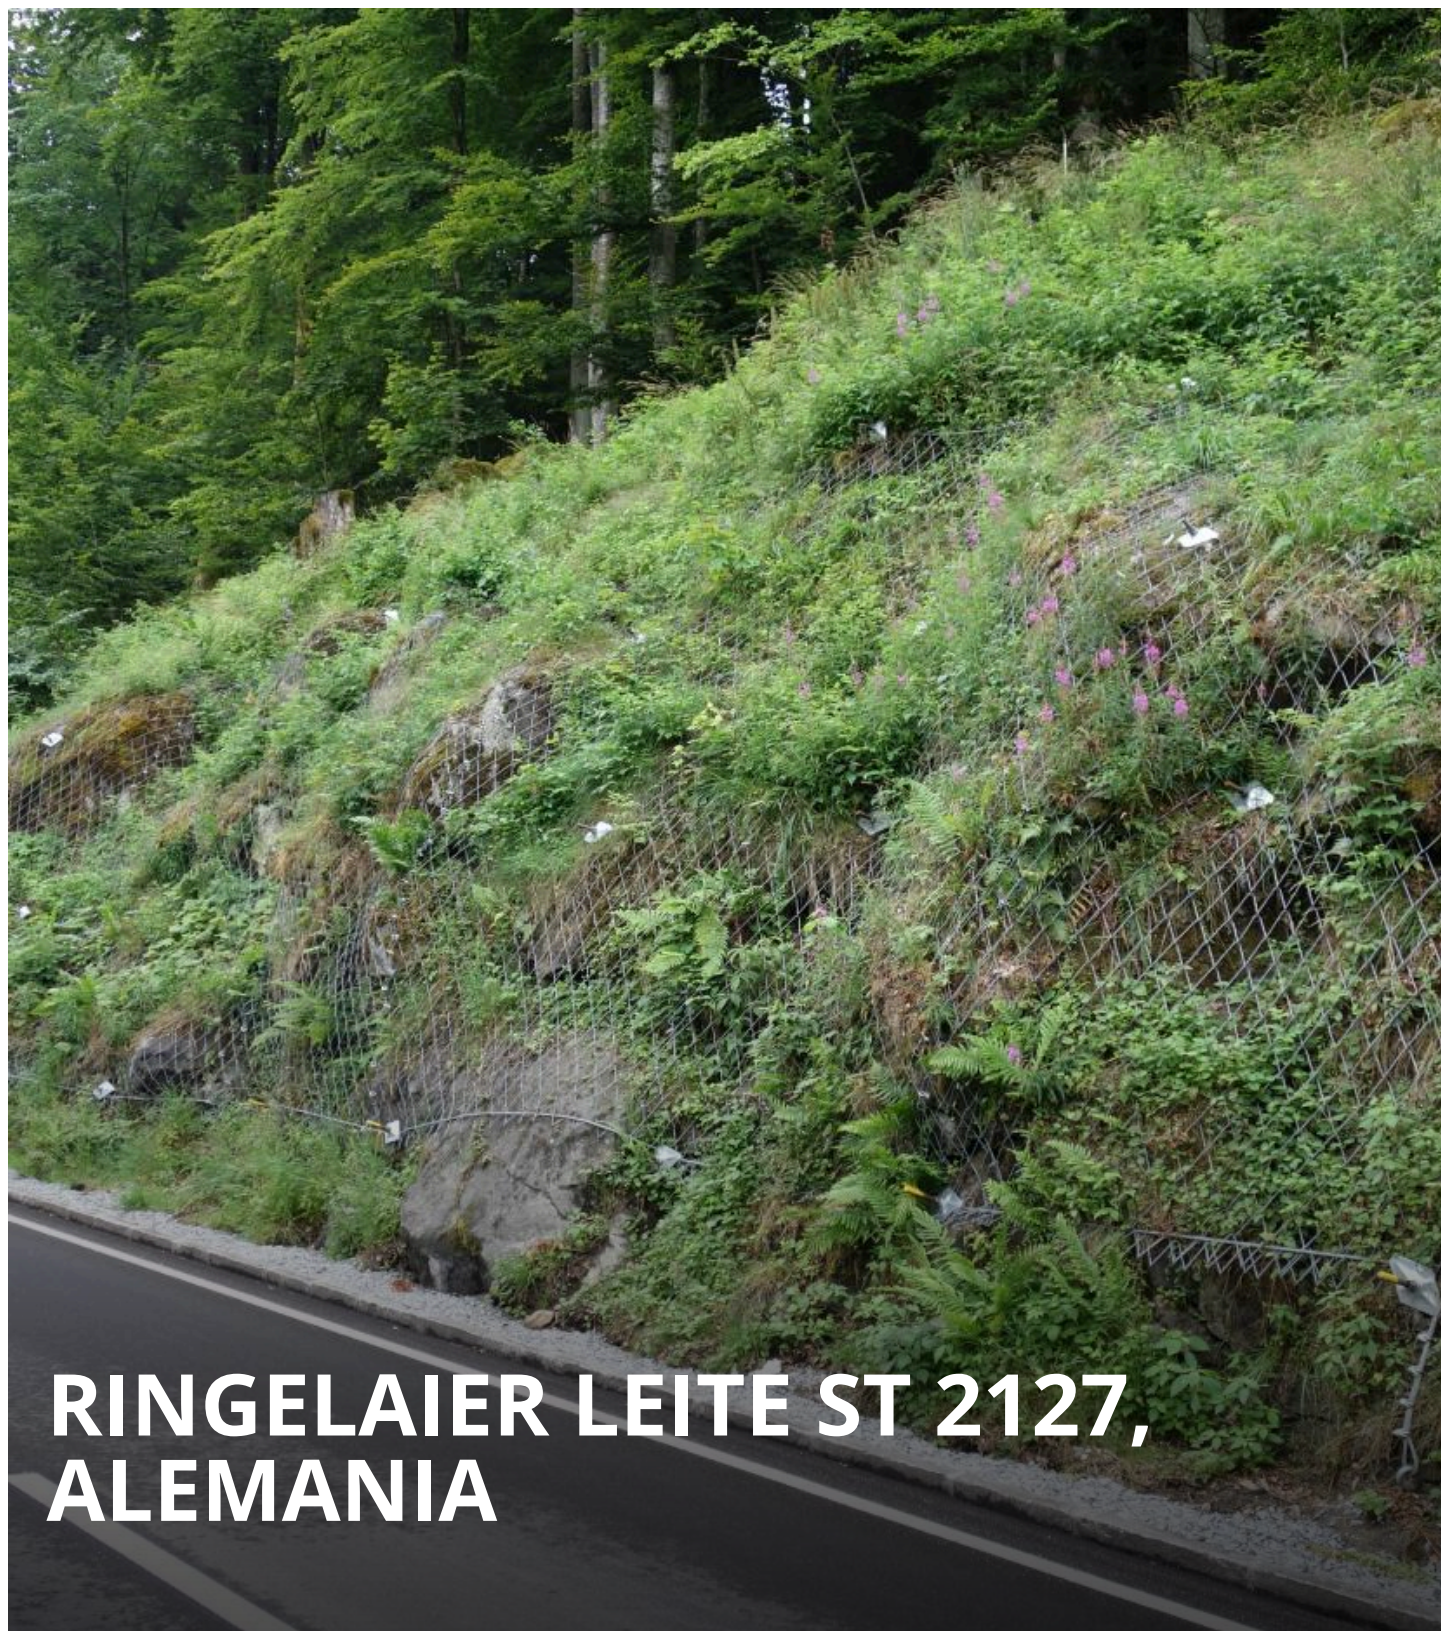
During rock scaling, those rocks with a volume of up to 6 m³ were removed. Critical sections with reduced stability are now being stabilized with the SPIDER[®] and TECCO[®] protection systems.
