ON THE MOVE

New Hampshire Department of Transportation Newsletter

Winter 2019

New Approach Used for Emergency Repair Project on NH 118 in Warren

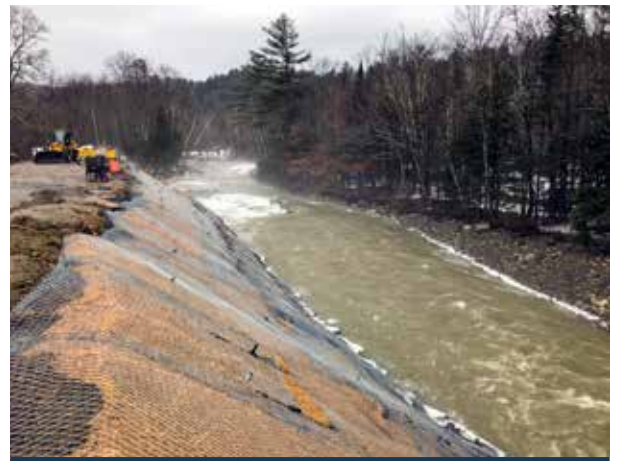
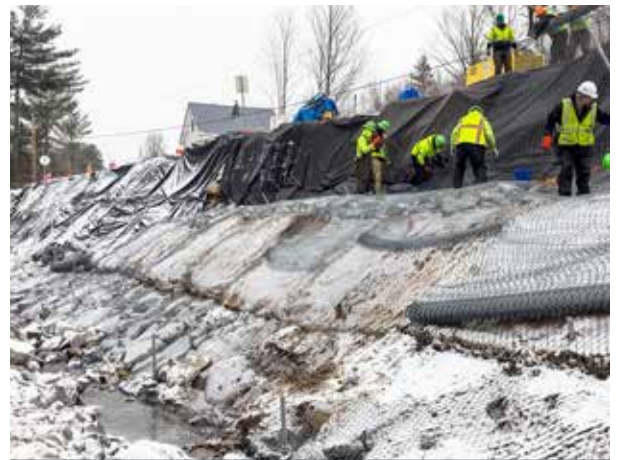
This new approach suggested by NHDOT geologist Krystle Pelham still involved using stone fill, but wrapping it in a heavy duty chain link fence-type blanket (TECCO) and also anchoring it into bedrock and the slope with soil nails. The soil nails are tensioned and locked into place with armor plates placed on the surface of the TECCO mesh blanket to tie it all together.”

The picturesque Baker River winds along parts of NH Route 118 in Warren. The usually peaceful river became a raging torrent during a storm in October 2017, washing away an embankment and an entire lane of NH 118 for about 100 yards.

The conventional repair would be to reconstruct the embankment, armor it with stone, and build a retaining wall in what is a tight location adjoining the river. But the NHDOT decided to take a different approach to be used for the first time in New Hampshire.

“It would have been very difficult to anchor stone into the river bed because of exposed bedrock and the smooth surface,” says Pete Stamnas, NHDOT’s Director of Project Development. “There was concern a typical repair utilizing a stone armored slope would be an ongoing issue, and we wanted to minimize the risk of further erosion.”
