GEO-FORENSICS —  
LESSONS LEARNED  
FROM FAILURES

# Flexible Rockfall Barrier Post Support Performance

# Deflection as a Positive Attribute

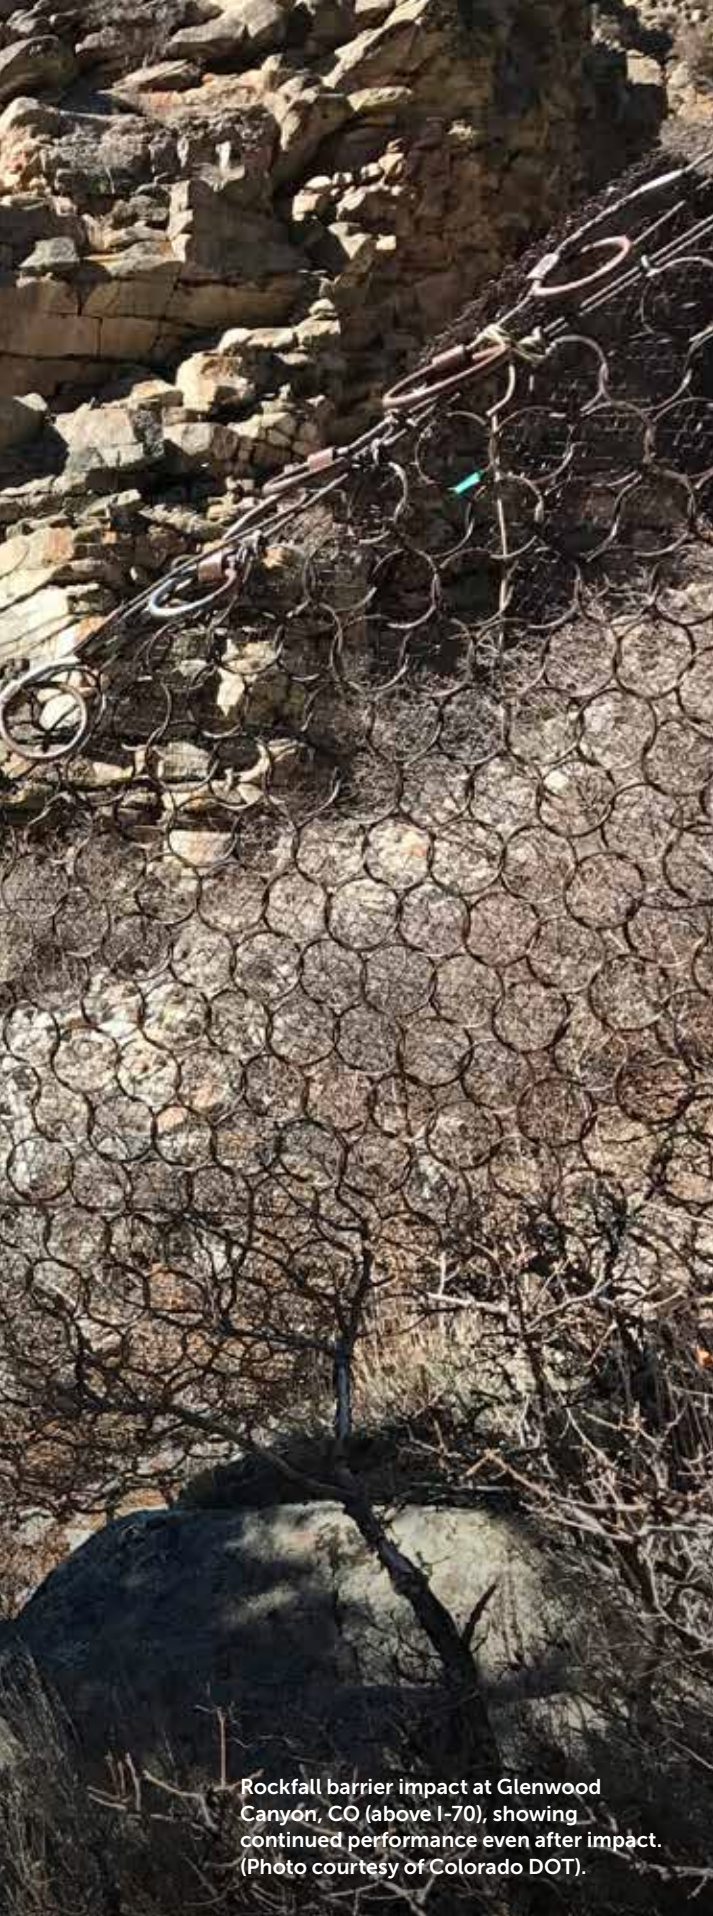
Rockfall barrier impact at Glenwood Canyon, CO (above I-70), showing continued performance even after impact. (Photo courtesy of Colorado DOT).

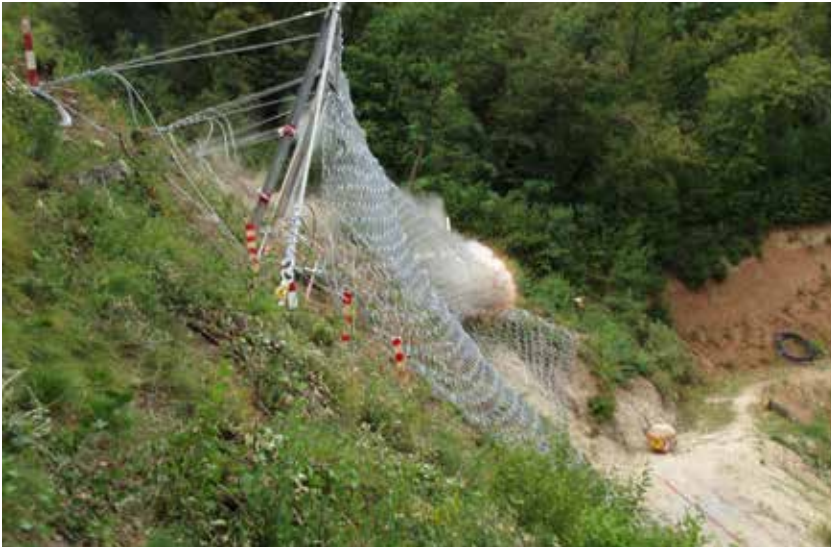
**Figure 1.** Flexible “hybrid” type rockfall barrier during testing. (Photo courtesy of Tom Badger, Golder Associates, Inc.)

barrier/fence line. These may also be referred to as “dynamic barriers.” Attenuators/hybrids (Figure 1) are essentially dynamic barriers with a draped mesh tail that redirects retained debris downslope. Finally, galleries (Figure 2) are specialized catchment fences constructed as canopies to protect features below the installation.

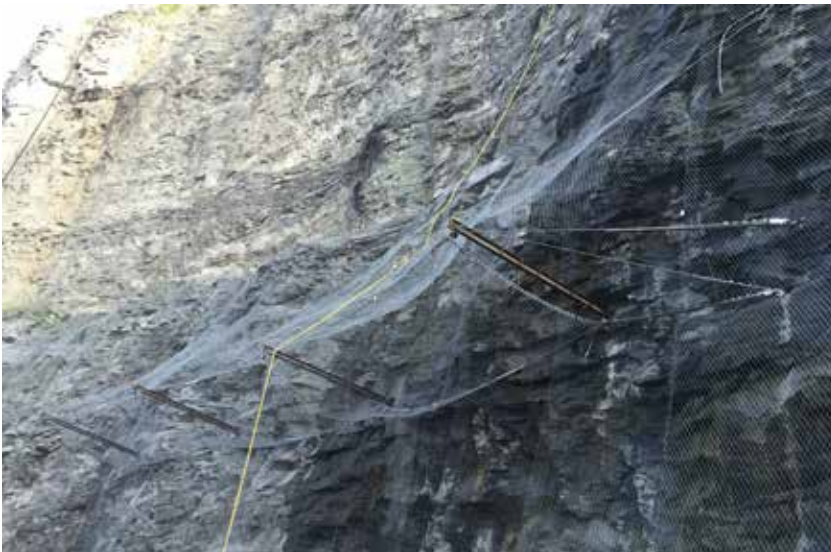
**Figure 2.** Temporary rockfall canopy above tunnel portal, Atlanta, GA. (Photo by Scarptec, Inc.)

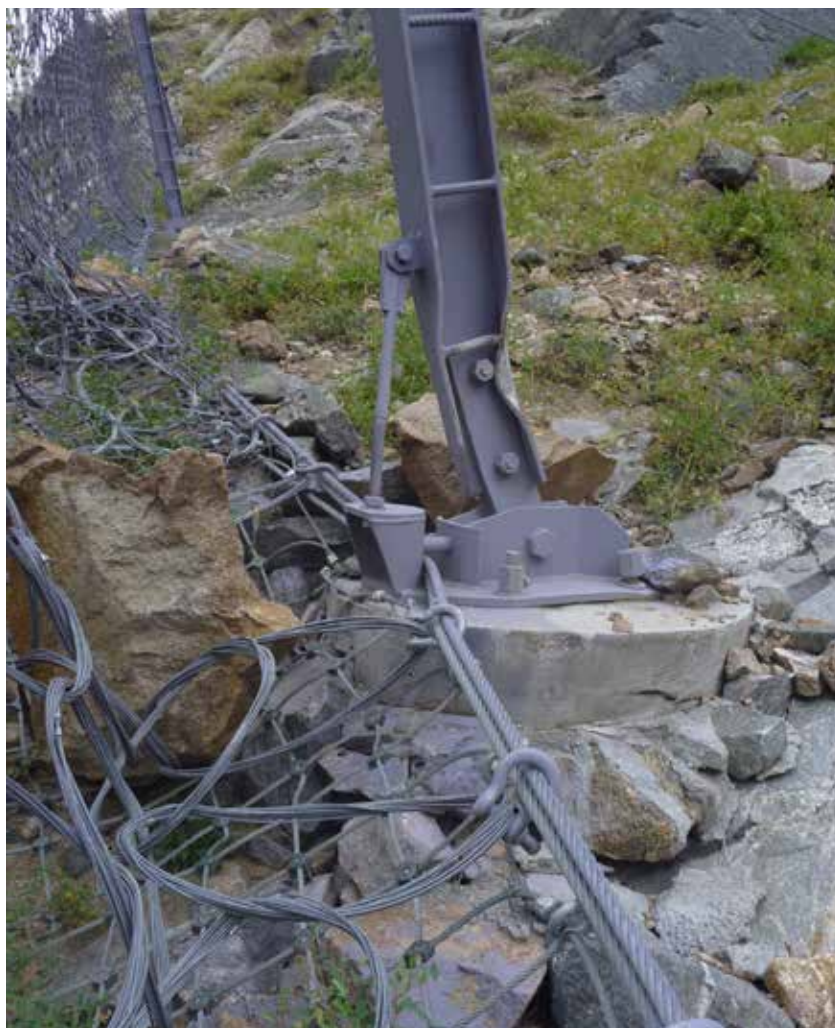
**Figure 3. Rockfall barrier post supported on bedrock at Georgetown Canyon, CO, showing continued post-strike performance. (Photo courtesy of Colorado DOT.)**

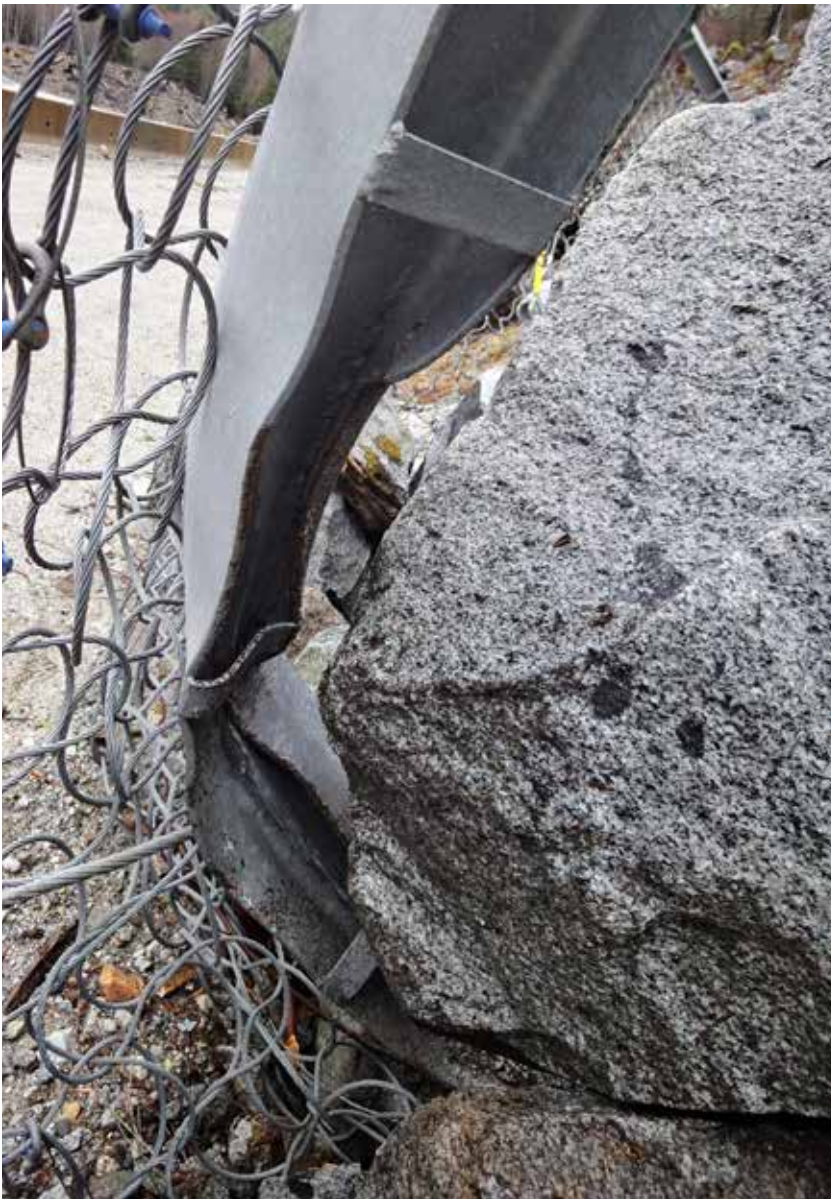
**Figure 4.** Rockfall barrier post impact in British Columbia, showing continued performance even after impact. (Photo courtesy of Trumer Schutzbauten Canada Ltd.)

A rockfall barrier in British Columbia rated for 1,000 kJ was impacted multiple times by events much larger than its capacity. In this case, a very small concrete leveling pad was used (i.e., 15 in. square by 49 in. deep) in combination with two, 16-ft-deep soil anchors to support the barrier. In two extreme rockfall events, the posts suffered direct impacts (Figure 4). The first impact caused significant deformation of the foundation, but all debris was contained. After the event, the fence was repaired, and a new post was set on the damaged foundation. A second, even larger, event occurred in an adjacent field, and once again the system held, but the impact completely destroyed a PBS. Even so, all of the

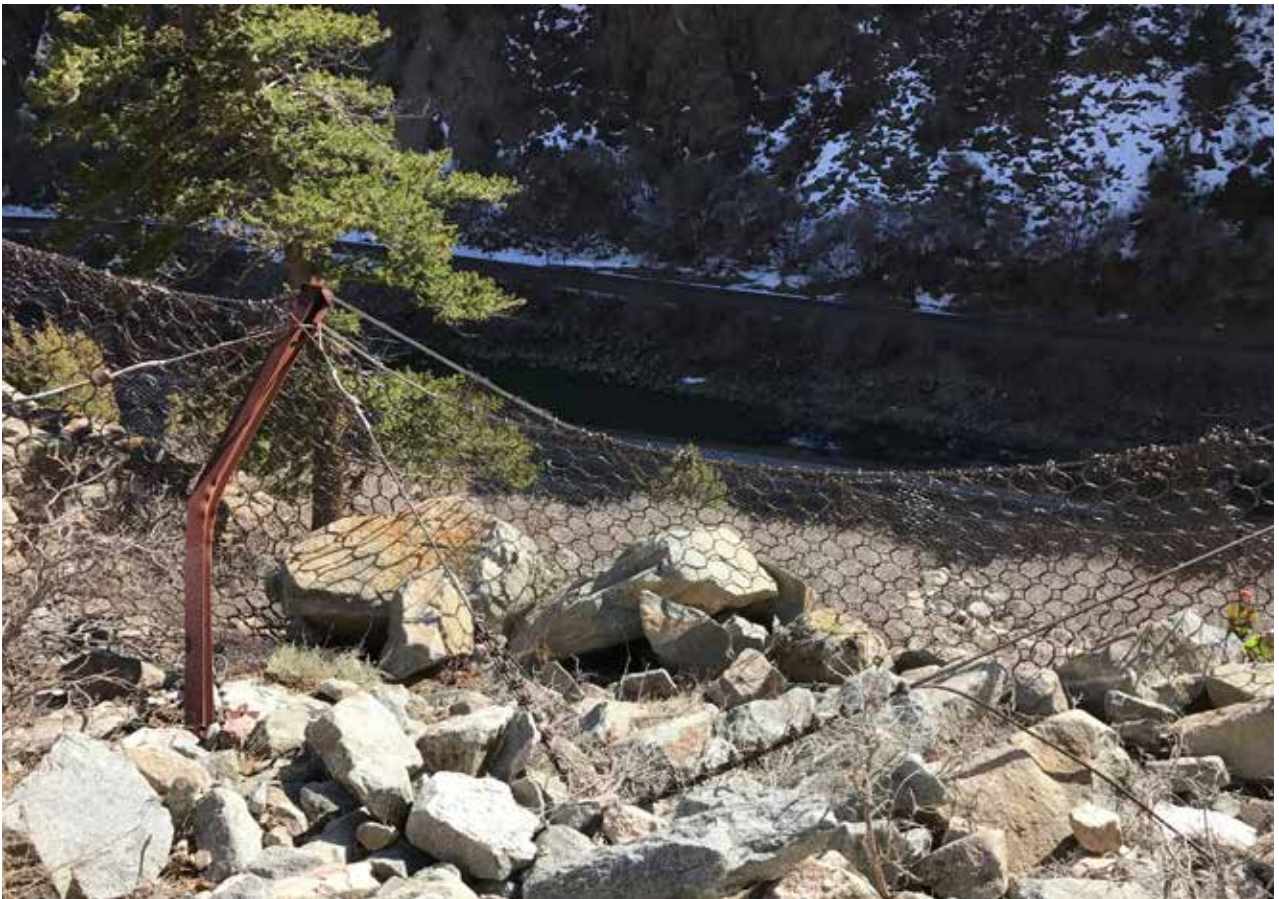
**Figure 5. Rockfall barrier impact at Glenwood Canyon, CO, showing continued performance even after impact. (Photo courtesy of Colorado DOT.)**

Successful performance of light to moderate post support elements can also be seen in an example from a flexible barrier impact in Colorado (Figure 5). A barrier rated for a maximum energy impact of 2,000 kJ was struck by an even larger event involving multiple blocks. This barrier was constructed with four #8 thread bar anchors supporting each post. The anchors were installed to depths of 2.4 to 3.1 m in a combination of soil and rock. The fallen rocks impacted the center of a net panel, and the system successfully retained everything. Due to the severe loading above the system's rated design capacity, one post, a section of net panel, and several braking elements within the impacted section deformed to their maximum design extent and required replacement. However, an inspection of the relatively light anchor system supporting the post revealed that the anchors were still serviceable, and a new post was simply installed on the original base plate during repairs.
