# PORTAL FUSCA, COLOMBIE

Stabilisation des pentes

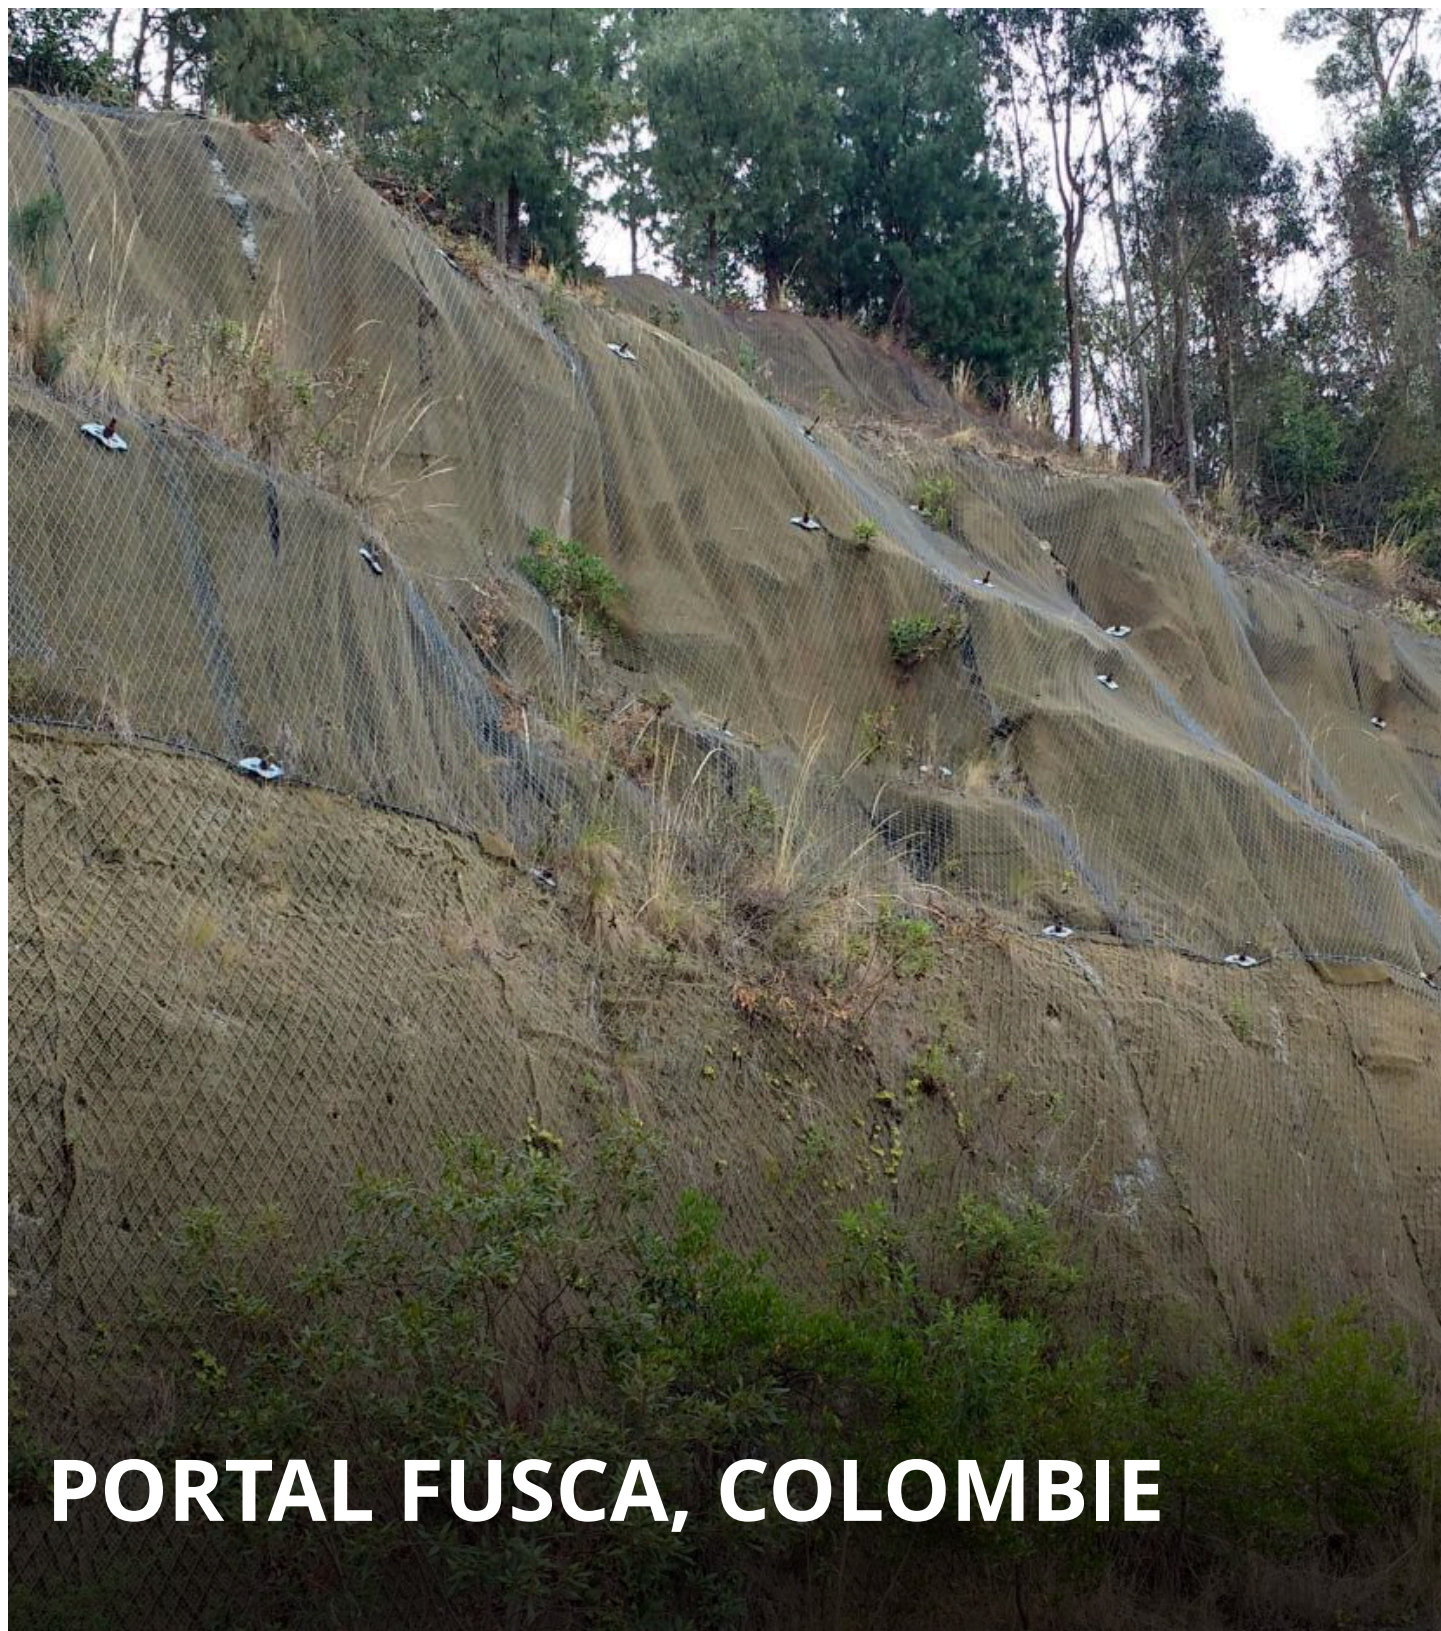
| Description | In the Portal del Fusca condominium, over 3'000 m <sup>2</sup> are protected by two kinds of meshes: TECCO® G65/3 in the very critical areas with falling blocks and GREENAX® drape in the sectors with superficial erosion. |
