PRIVATE CLIENT ROCK SCALING, AMERIKA BIRLEŐİK DEVLETLERİ

Kaya dűşmesine karşı koruma

| Proje | Private Client Rock Scaling |

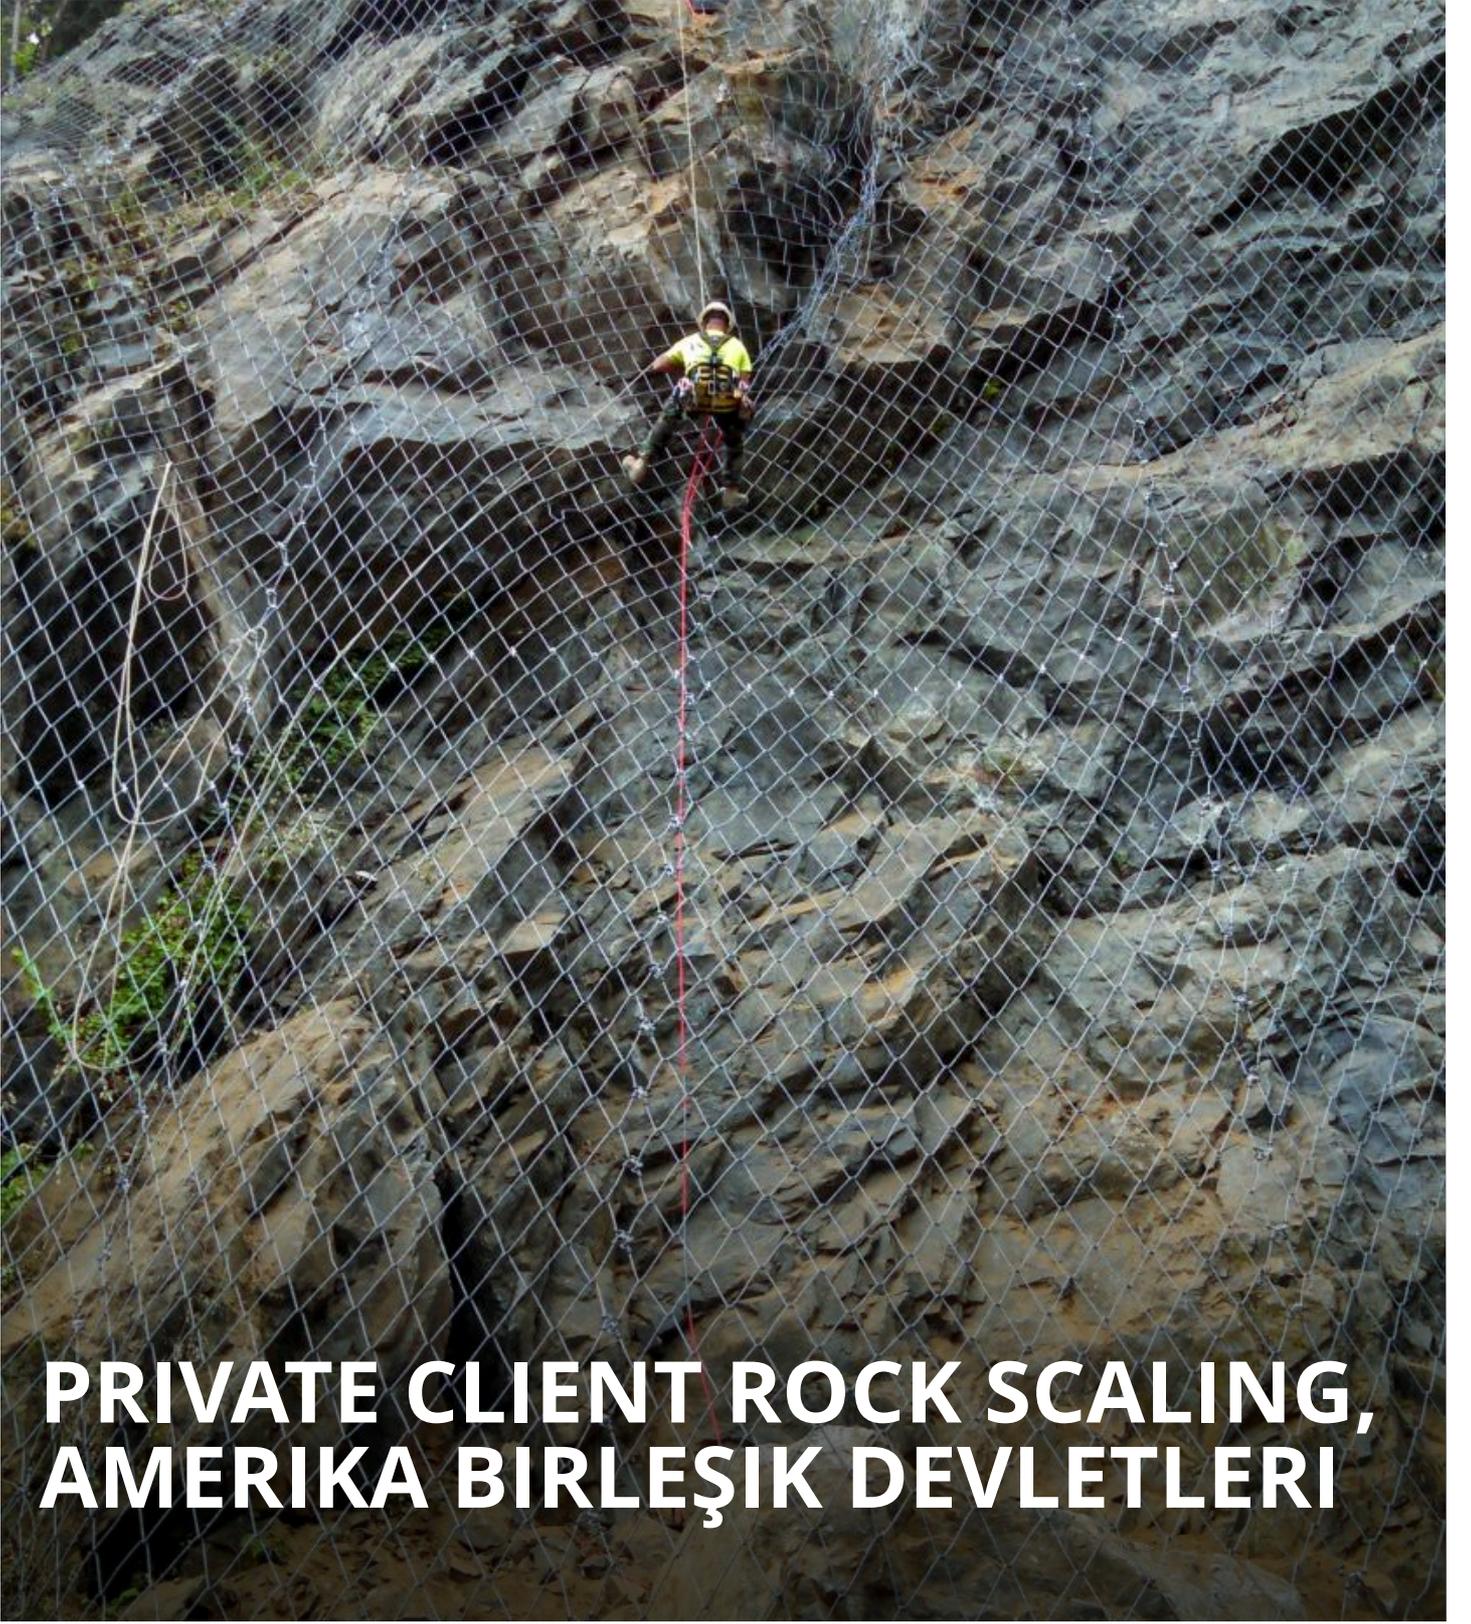
| Açıklama | <p>Geobrugg installed a SPIDER® S4/230 temporary rockfall drape to protect the site from falling boulders. The ~9,000 ft2 drape was anchored using wire rope anchors. A <i>throat</i> was designed at the top to prevent debris from rolling over the top of the netting. Bottom anchorage elements were designed to be removed to facilitate access of labor, equipment, and materials around the base of the slope. Unexpectedly, an approximately 20 ton boulder that was intended to be anchored broke off the slope. Geobrugg's SPIDER® S4/230 controlled the fall of the roughly 10x8x5 ft3 block so that it came to rest at the toe of the slope without damaging the workers, the mesh, the storage tank, or the facility.</p> |

| Durum | <p>A client who prefers not to be named operates a 2-story manufacturing facility in the floor of a former rock quarry. In close proximity to the facility is a rock slope topped with trees and boulders. In between the facility and rock slope sits a 3,700 liter liquid nitrogen storage tank. The client required slope remediation in the form of rock-scaling, a manual process of using hand tools to dislodge loose rocks to allow them to safely fall to the base of a slope in a controlled manner.</p> |
