# FRANSCHHOEK PASS, GÜNEY AFRIKA

Şev ve Yamaç koruma

Proje	Franschhoek Pass
Yer	R45 road between Franschhoek and Villiersdorp
Ülke	Güney Afrika
Kurulum Yılı	2014
Müşteri	Western Cape Department of Transport and Public Works
Mühendislik	SMEC South Africa
Yüklenici	Penny Farthing
Durum	<p>During the latter half of 2013, the region had unseasonably high rainfall which led to several slope instability cases along the route. The majority of instabilities occurred as rock falls and superficial slides. The project was seen as an emergency work to develop a timely solution to the problem to ensure the pass could remain open to traffic while not compromising safety. Furthermore, in keeping with the heritage of the route and the surrounding environment, aesthetically pleasing and environmentally friendly solutions were required.</p>
Açıklama	<p>A key feature of the solution was to significantly improve surface and underground drainage. Geobrugg's RUVOLUM® software was used to ensure the correct system materials/products were chosen and that these effectively integrated with the overall geotechnical solution. A combination of TECCO® System and TECMAT® erosion control material was used to co

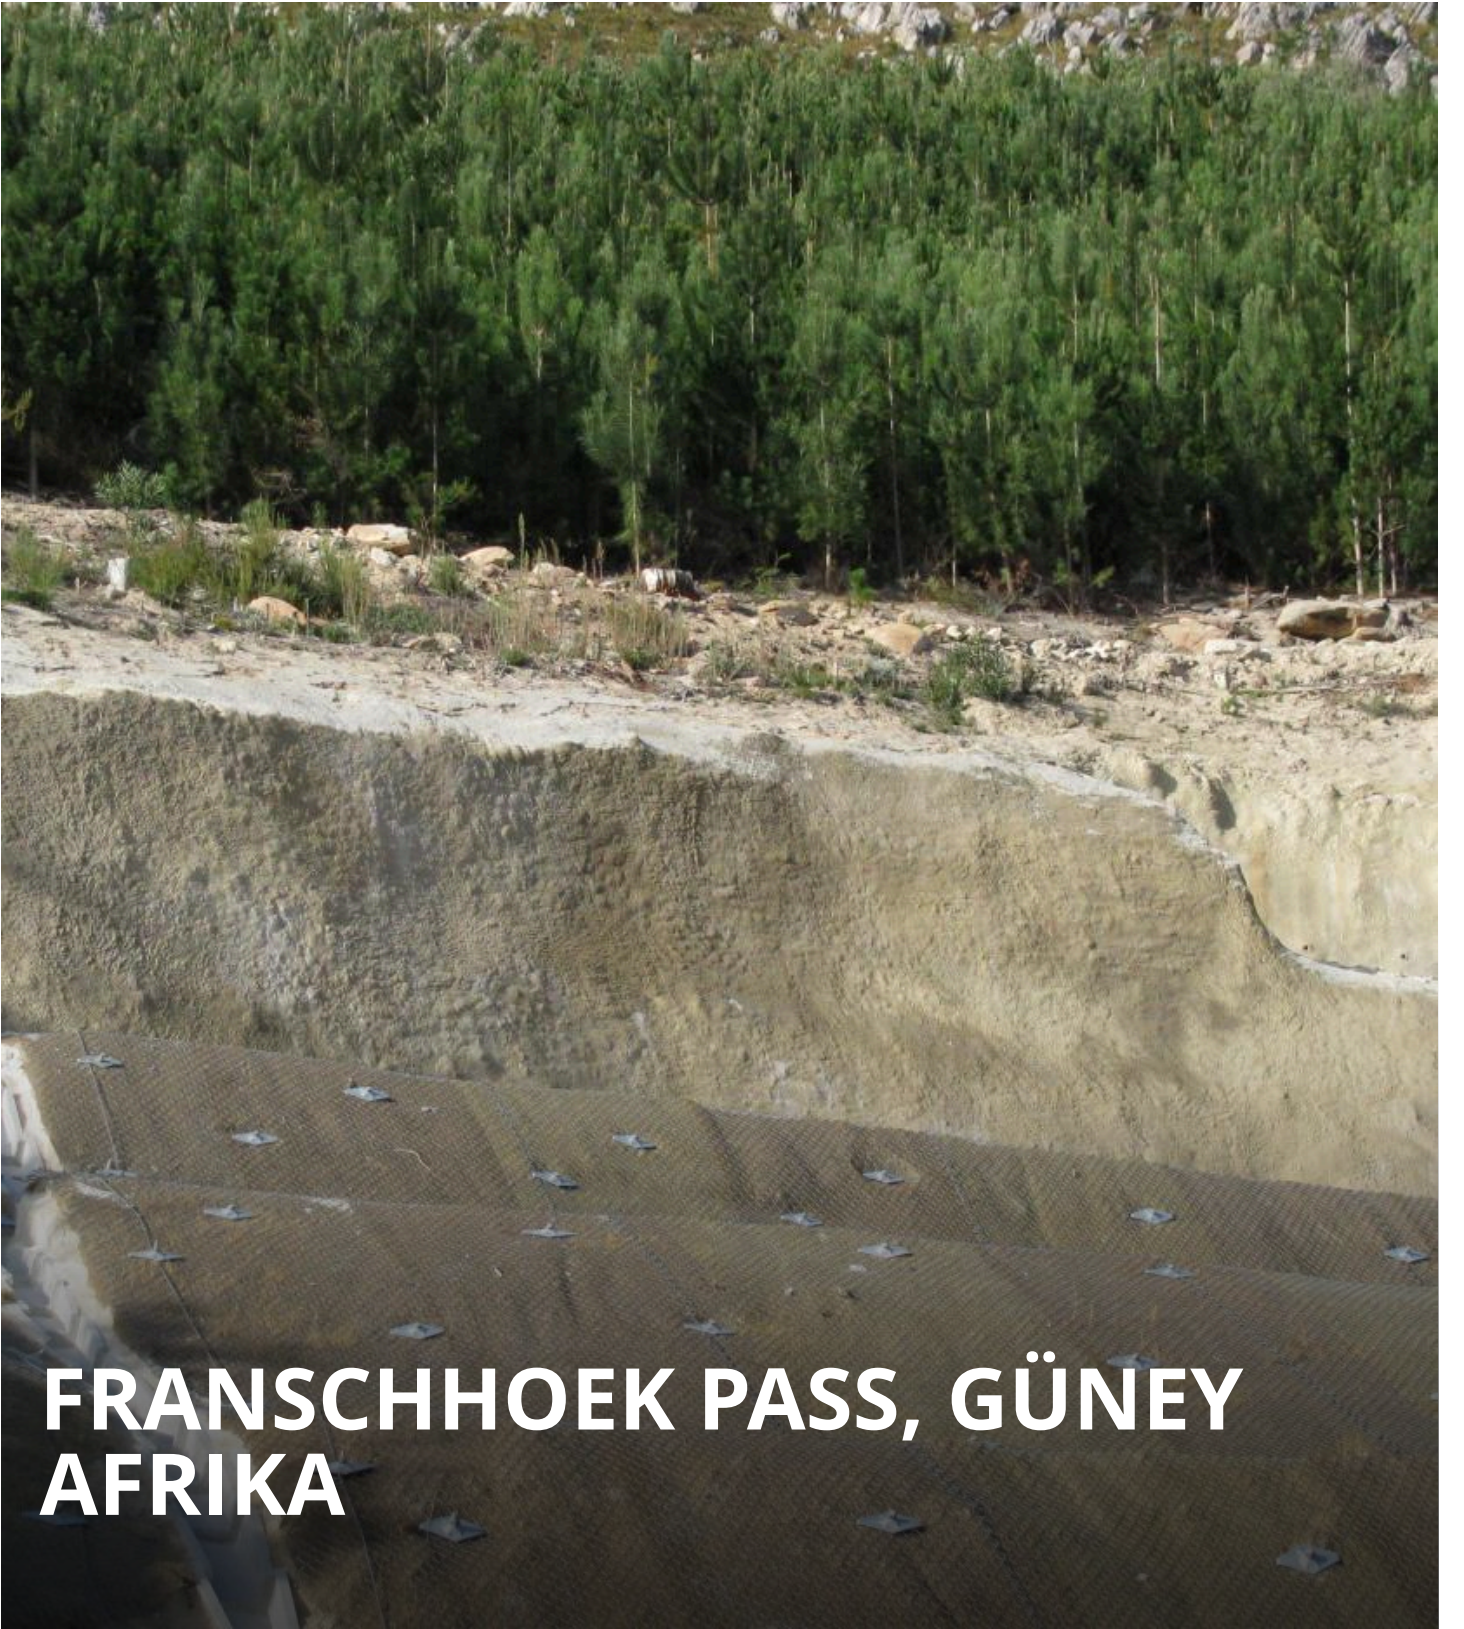
Gösterilen obje	Road
Korozyon koruma	GEOBRUGG SUPERCOATING
Jeoloji	<p>Sedimentary rocks, highly folded. It falls under the Malmesbury Group of rocks and consists of pale-weathering massive quartzites, subgreywacke, conglomerate, dark slate and phyllite. The soil consists of 18-24% clay. The site consists predominantly ML (acc. USCS) materials.</p>
Dengelenen alan	12 m²
Maksimum eğim yüksekliği	50 m
Eğim meyili	30 ° - 65 °
Erozyon kontrol matı	Evet
Konumlandırma	North
