EASTSIDE CATCHMENTS GIBRALTAR, GIBRALTAR

Ochrona przed obrywami skalnymi

Projekt	Eastside Catchments Gibraltar
Lokalizacja	Gibraltar
Kraj	Zjednoczone Królestwo
Rok Instalacji / montażu	2017
Inwestor	Government Of Gibraltar
Projektant	Golder Associates
Wykonawca	CAN Geotechnical Ltd.
Opis sytuacyjny projektu	Following rockfall in 2015 Golder Associates undertook a design for rockfall mitigation measures to protect the road and residential properties below. The detailed rockfall analysis showed a requirement for protection from a 5000 kJ impact with a system height of 7 m.
Opis zastosowanego rozwiązania	<p>In December 2016 CAN Geotechnical were awarded the project to complete phase 1 of the works, a 40 m long and 7 m high 5000 kJ rockfall barrier. We supplied a RXE-5000 barrier. To enable future works to be completed more easily and without deconstructing the existing fence, we provided a solution for the end post to allow for this.</p> <p>Over several years and many projects Geobrugg has worked with both Golder Associates and CAN Geotechnical and a good relationship has developed. This enabled all of the involved parties to work together to find a cost effective and buildable solu

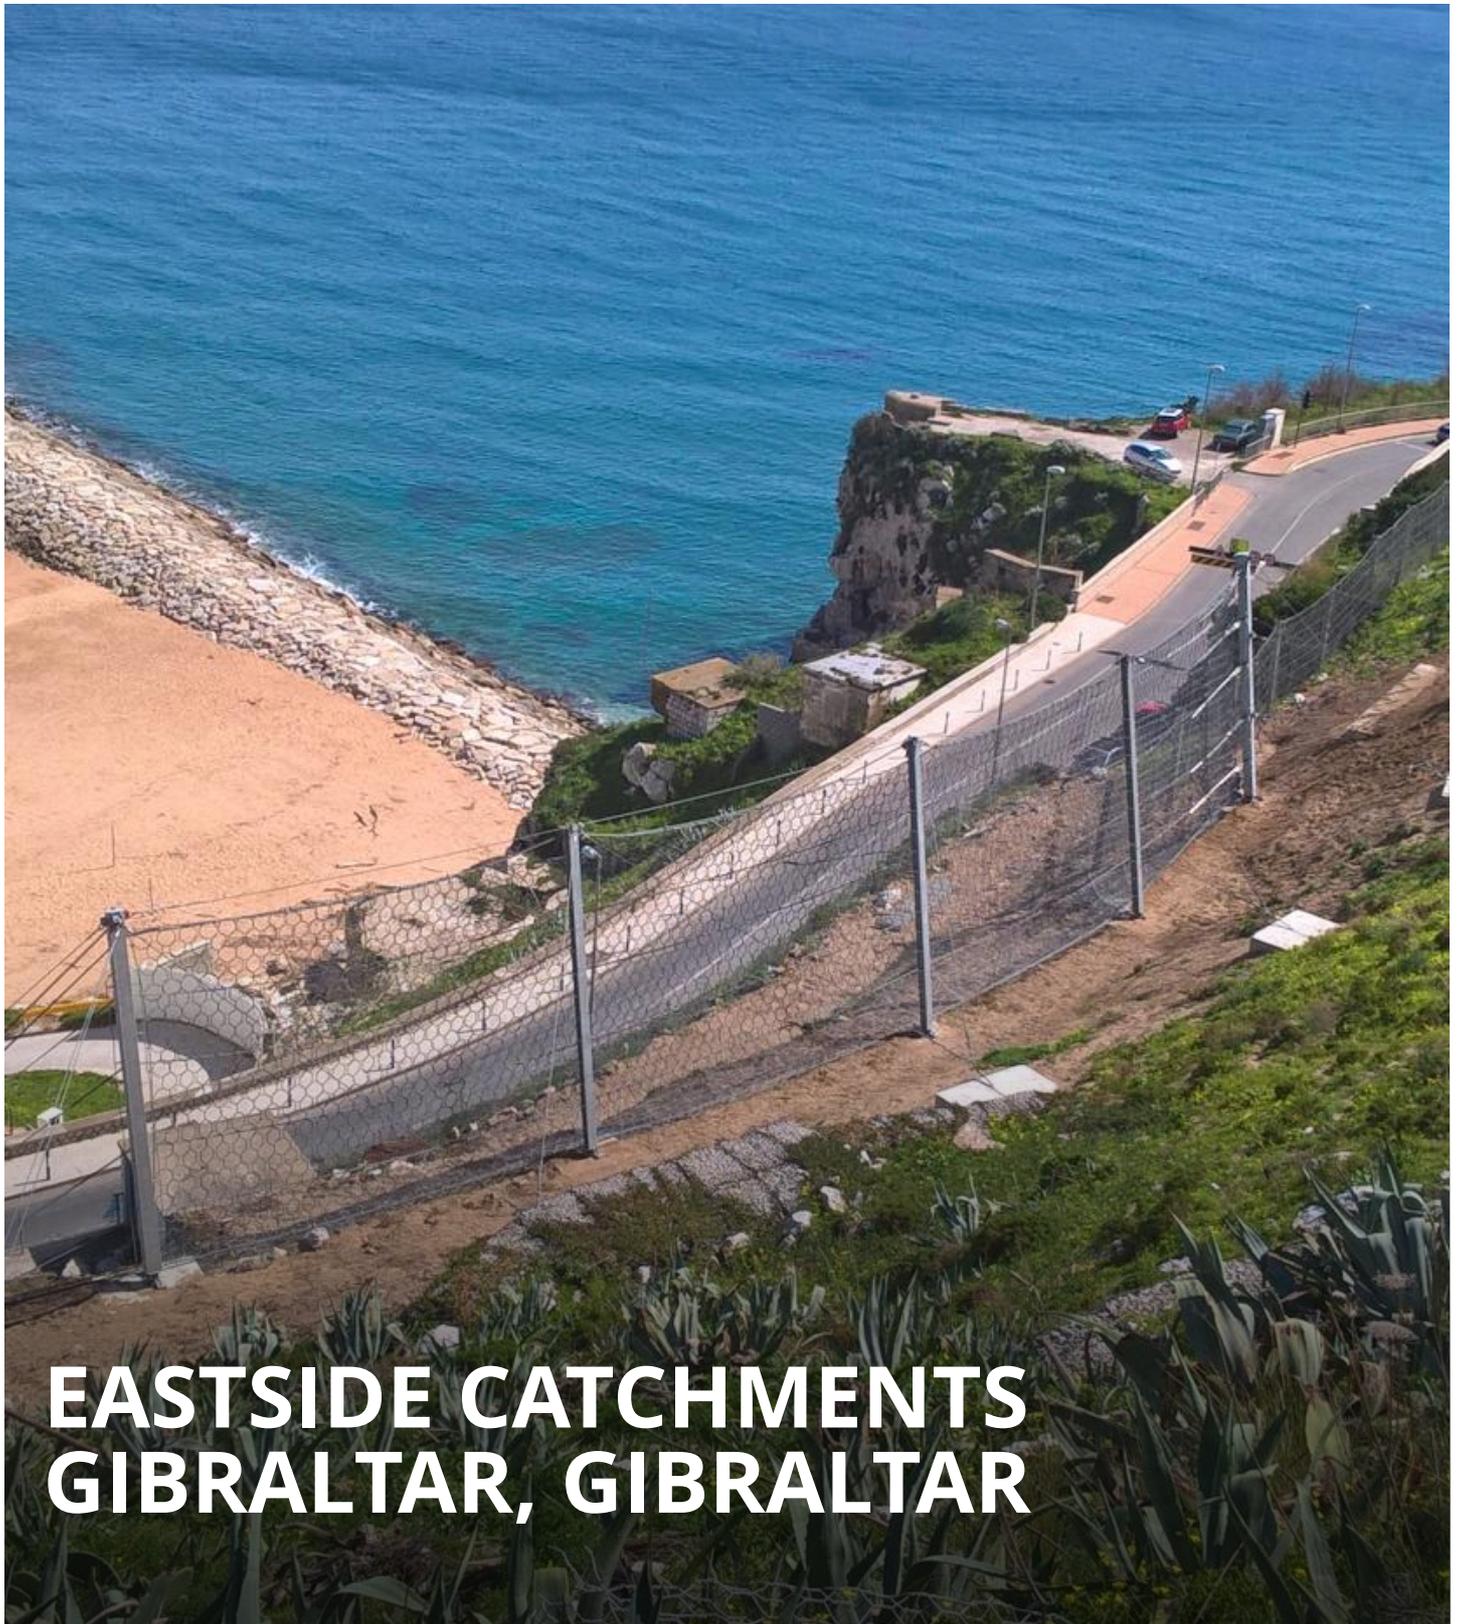
Chroniony obiekt	Road, Touristic infrastructure, Residential area, Infrastructure
Zabezpieczenie przeciwkorozyjne	Galvanized, GEOBRUGG SUPERCOATING
Wytrzymałość systemu	5000 kJ
Wysokość ochrony systemu	7.0 m
Długość systemu	88 m
