# TRBOVLJE ROCKSLIDE PROTECTION, SŁOWENIA

# Trbovlje rockslide protection

| <b>Projekt</b> | Trbovlje rockslide protection |

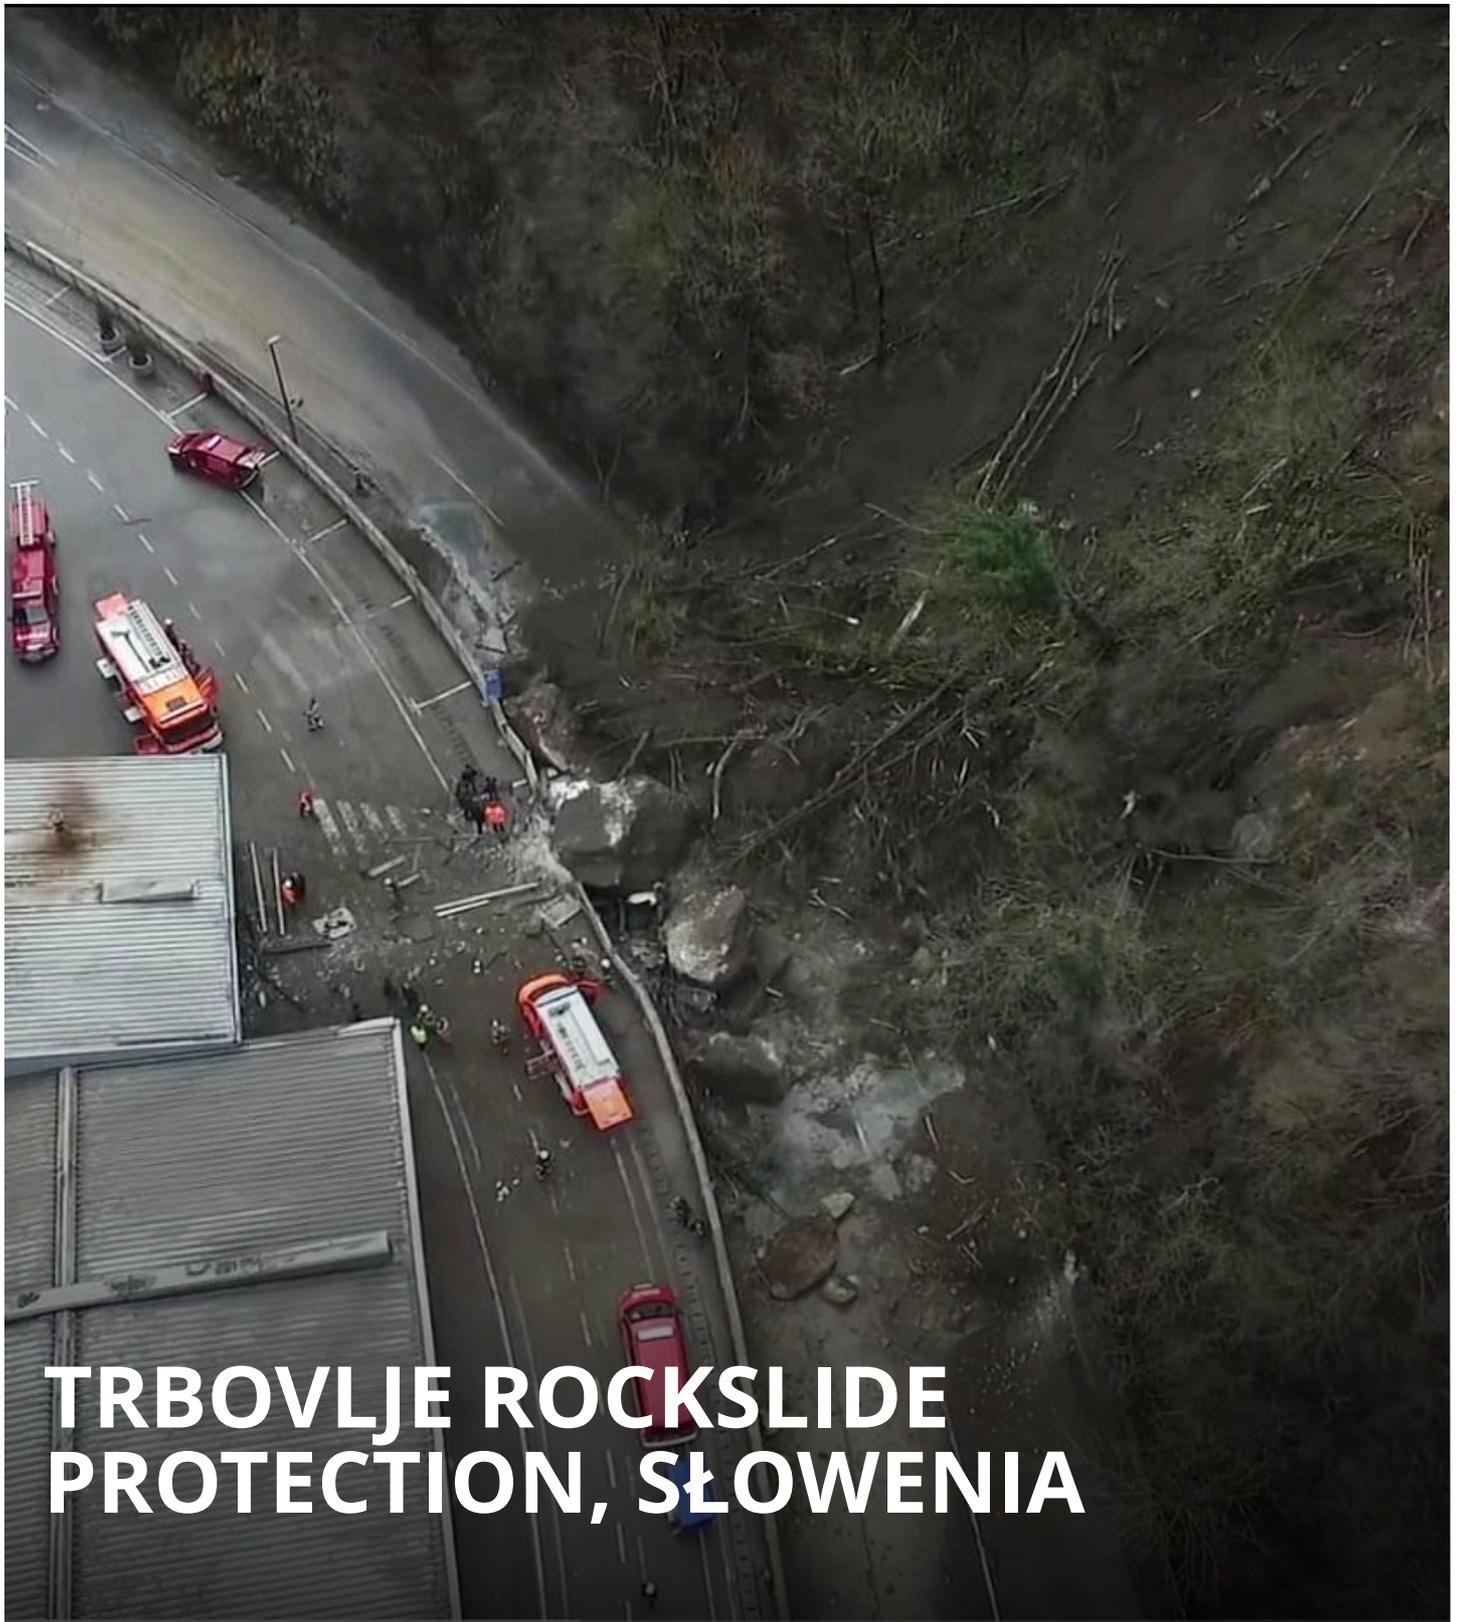
| <b>Opis zastosowanego rozwiązania</b> | <p>Construction commenced on March 8th with rock drilling to install anchors and base plates for the barrier's post foundations. Based on the study results national authorities decided to apply a Geobrugg rockfall protection system from the RXE-Series. With its ring nets made of high-tensile steel wire the barrier design has been tested and approved to absorb impact energies of up to 8,000 [kJ]. Additionally, two GBE-500A systems were selected to protect the lower part of the slope.</p> <p>The posts, ringnet's ropes and accessories produced and pre-assembled in Romanshorn, Switzerland, were already delivered to Trbovlje by mid-March. The biggest helicopter of the Slovenian Armed Forces delivered the four preassembled ring net bundles along with the five posts, weighing almost 2 metric tons, to the heavily inaccessible terrain. Despite high winds the helicopter crew made the decision: "We're flying!" The experience of the entire ground and helicopter crew was needed to connect the posts to the base plates within a millimeter of accuracy. The mega-barrier technical acceptance inspection took place on April 4th, the same day officials, stakeholders and the public are welcomed to the inaugural reopening of the newly repaired and secured road.</p> |
