# MILIBACH TORRENT, HASLIBERG, CANTON OF BERN, SUÍÇA

Proteção contra correntes de detritos

<b>Projeto</b>	Milibach Torrent, Hasliberg, Canton of Bern
<b>Lugar</b>	Hasliberg Reuti
<b>País</b>	Suíça
<b>Ano de instalação</b>	2011
<b>Promotor</b>	.
<b>Situação inicial</b>	<p>In August 2005, a storm in the Weiler Reuti and in Meiringen had caused serious debris coverage and severe damage. To protect the two settlements, a cascade comprised of 13 flexible debris flow barriers was installed to retain a cumulative volume of up to 10,000 m<sup>3</sup> was installed.</p> <p>On October 10, 2011, heavy rainfall triggered a shallow landslide containing a total of 2,000 m<sup>3</sup> of schist in the drainage area of the Milibach river. Approximately 80 mm of rain had fallen onto a 70 cm layer of existing snow in 12 hours. The Swiss Federal Office for Environment (FOEN) categorized these heavy rainfalls as the 100-year event.</p>
<b>Descrição</b>	<p>This multilevel debris flow barrier system successfully retained an estimate 2,000 m<sup>3</sup> of debris from the October 2011 100-year event before the slide had any opportunity to gain momentum and cause significant damage, as had happened in 2

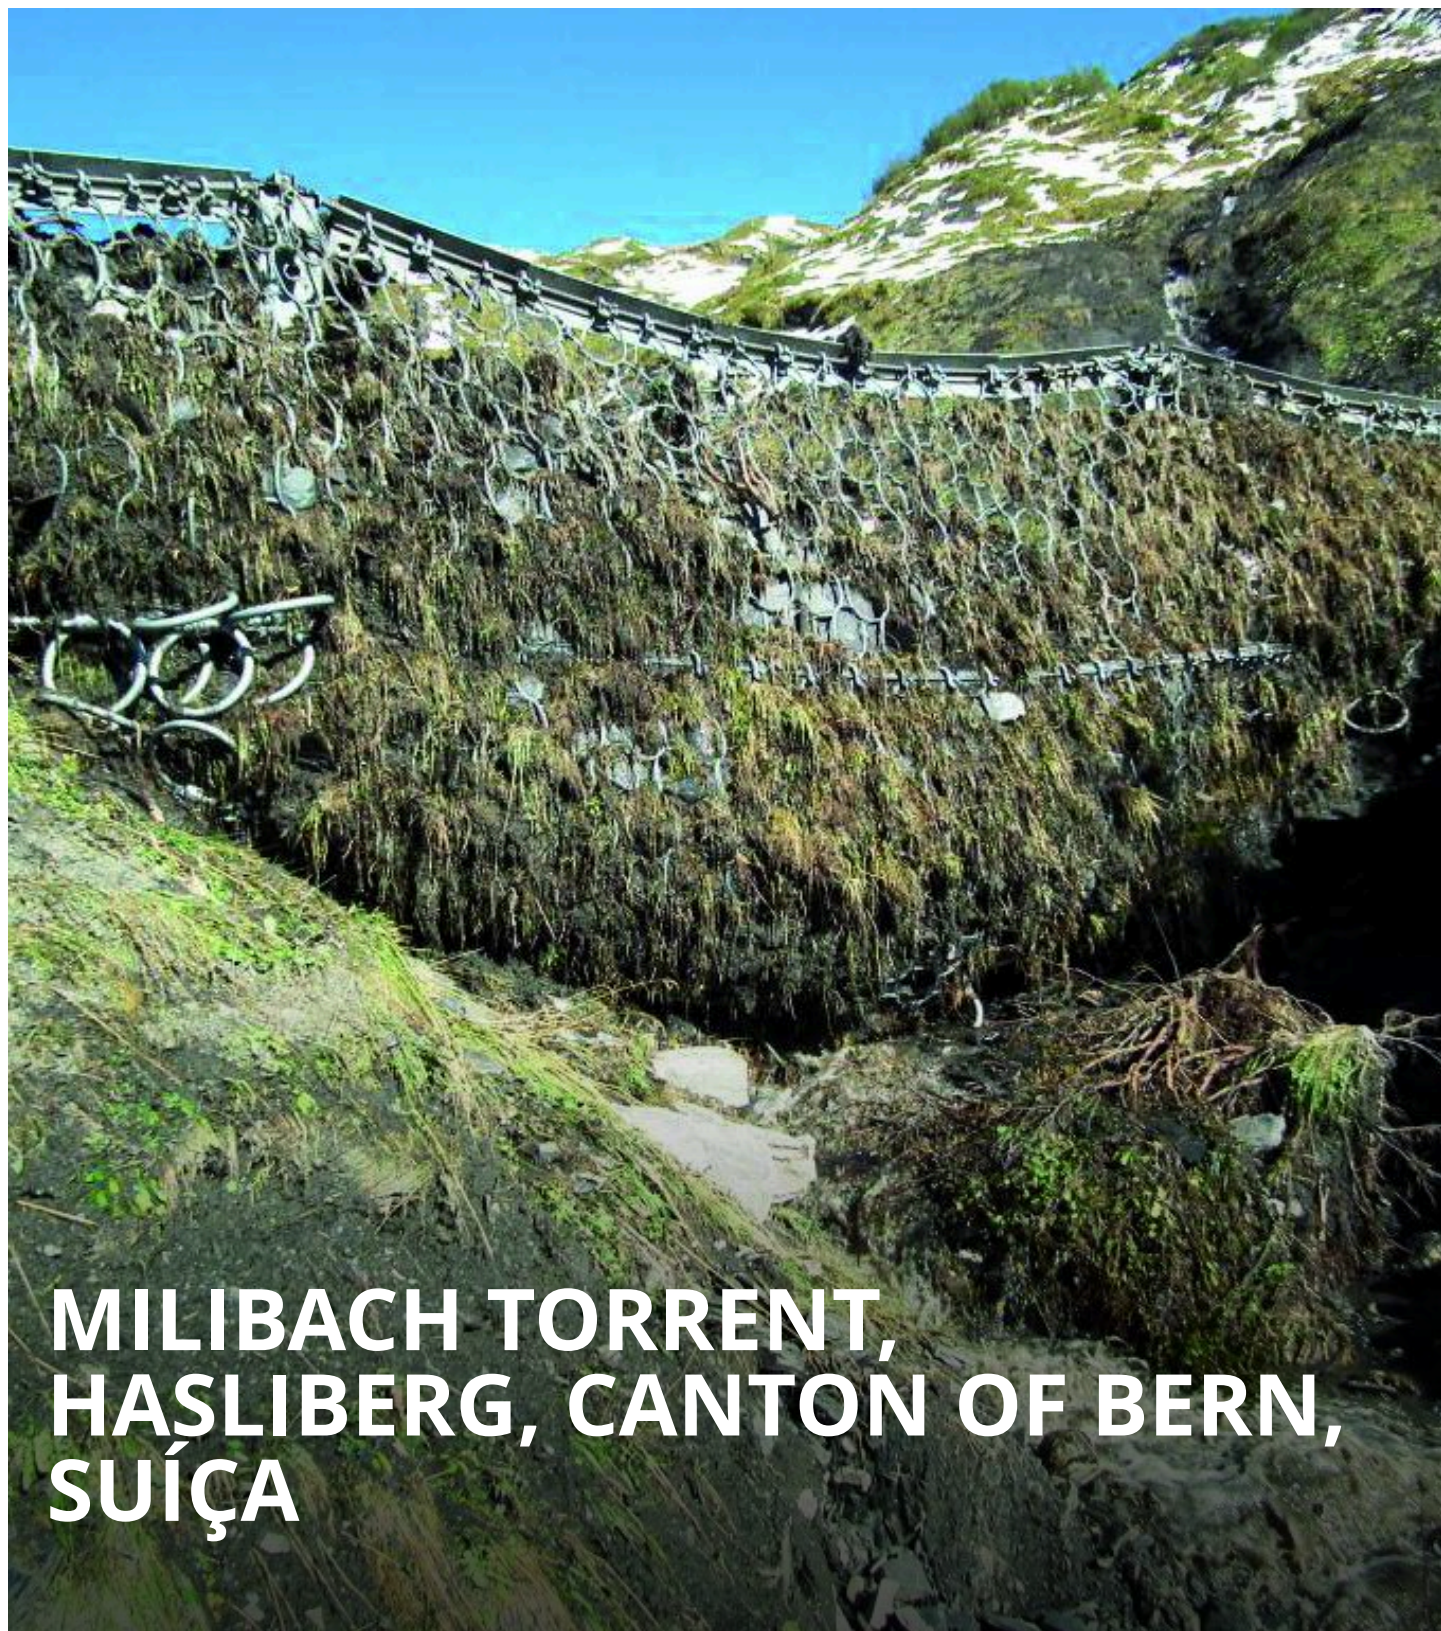
<b>Outras aplicações instaladas</b>	Proteção contra correntes de detritos
<b>Proteção contra a corrosão</b>	GEOBRUGG SUPERCOATING
<b>Altura do sistema</b>	7.0 m
<b>Comprimento do sistema</b>	500 m - 7 m
<b>Número de barreiras</b>	13
<b>Capacidade de retenção</b>	10000 m <sup>3</sup>
