RINGELAIER LEITE ST 2127, ALEMANHA

Estabilização de taludes

Projeto Ringelaier Leite St 2127
Lugar Ringelai
País Alemanha

Ano de instalação 2015

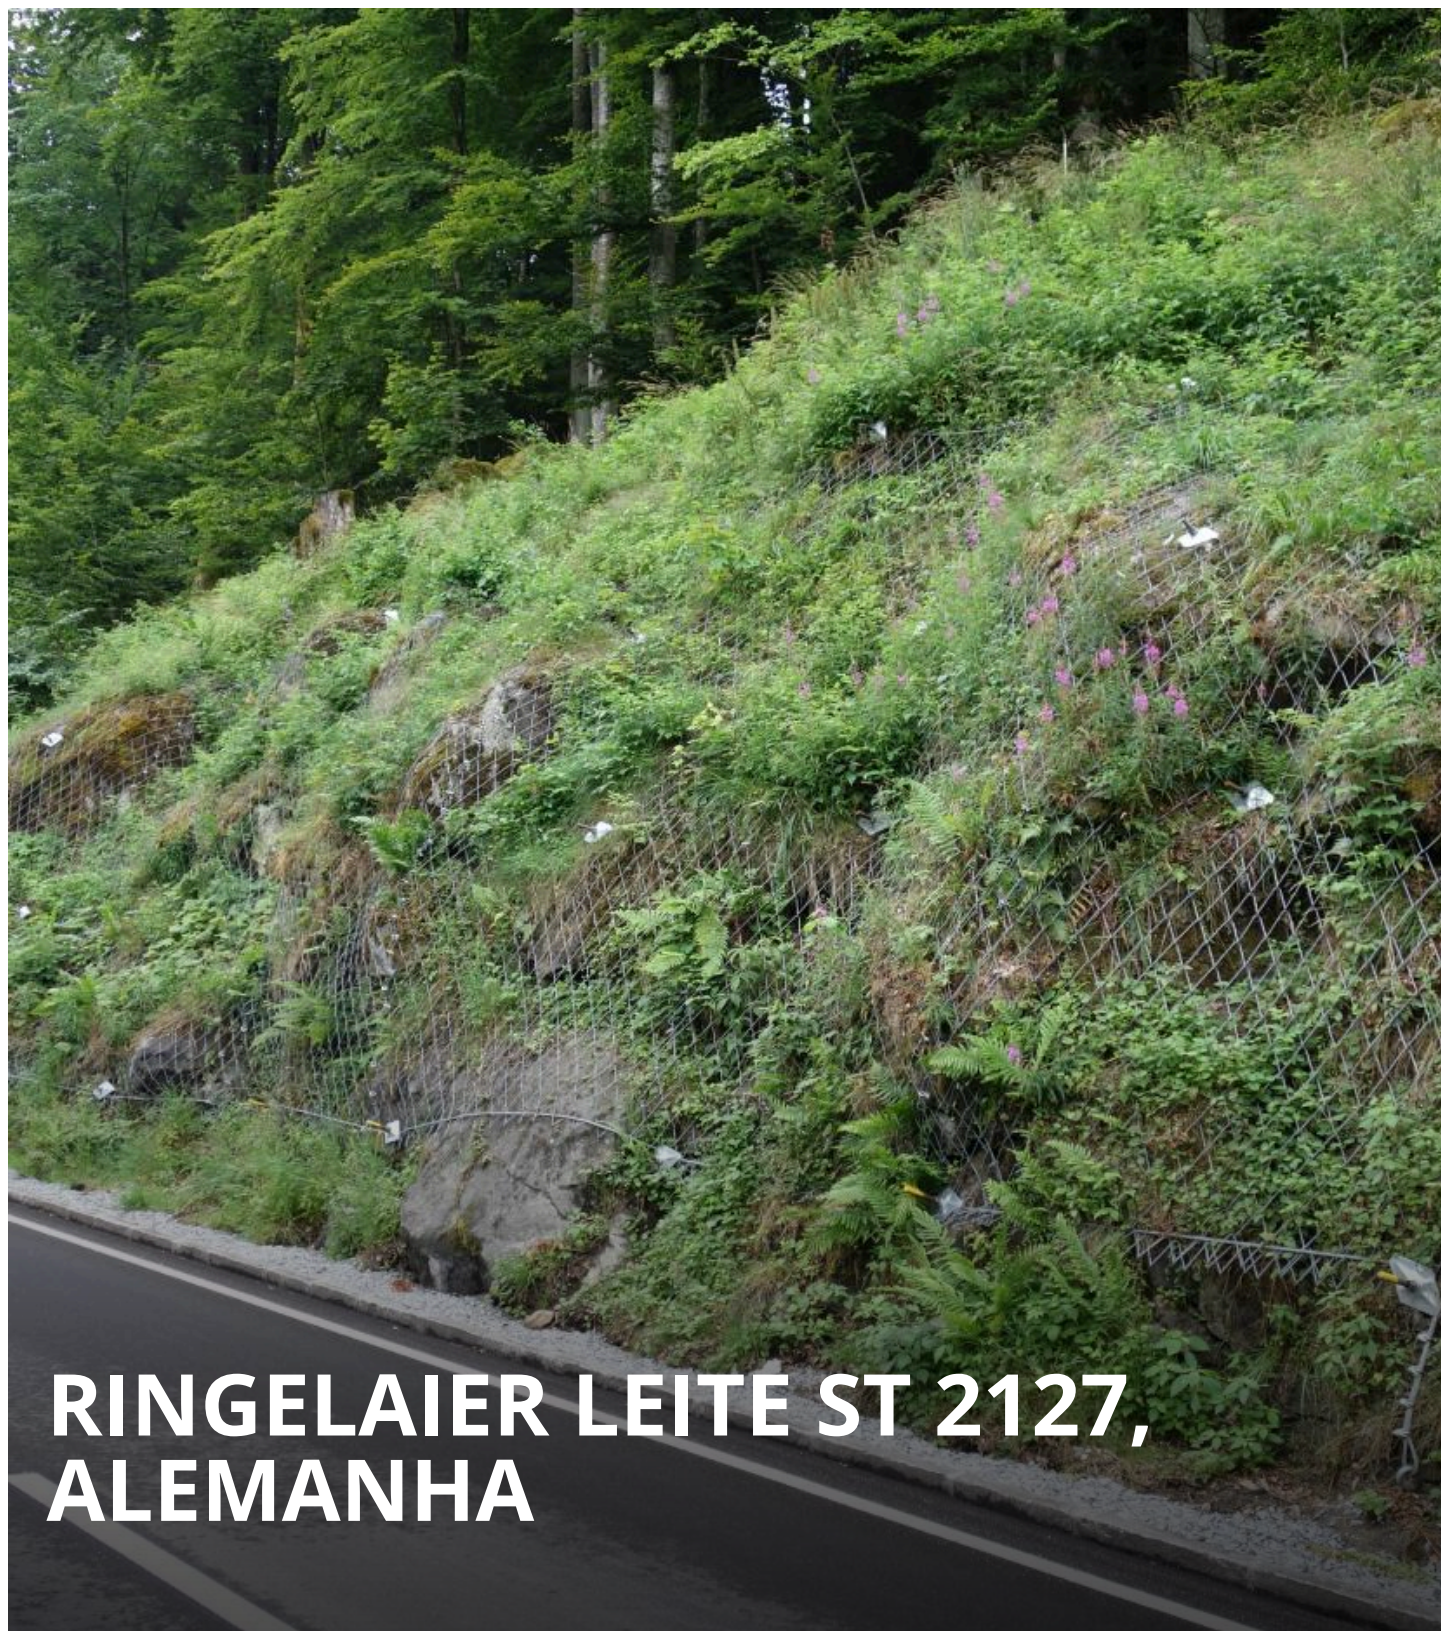
During rock scaling, those rocks with a volume of up to 6 m³ were removed. Critical sections with reduced stability are now being stabilized with the SPIDER[®] and TECCO[®] protection systems.
