PH Belen
PH Belén, Power House Station

2015
CNFL
CNFL
Consorcio Durman - Rodio

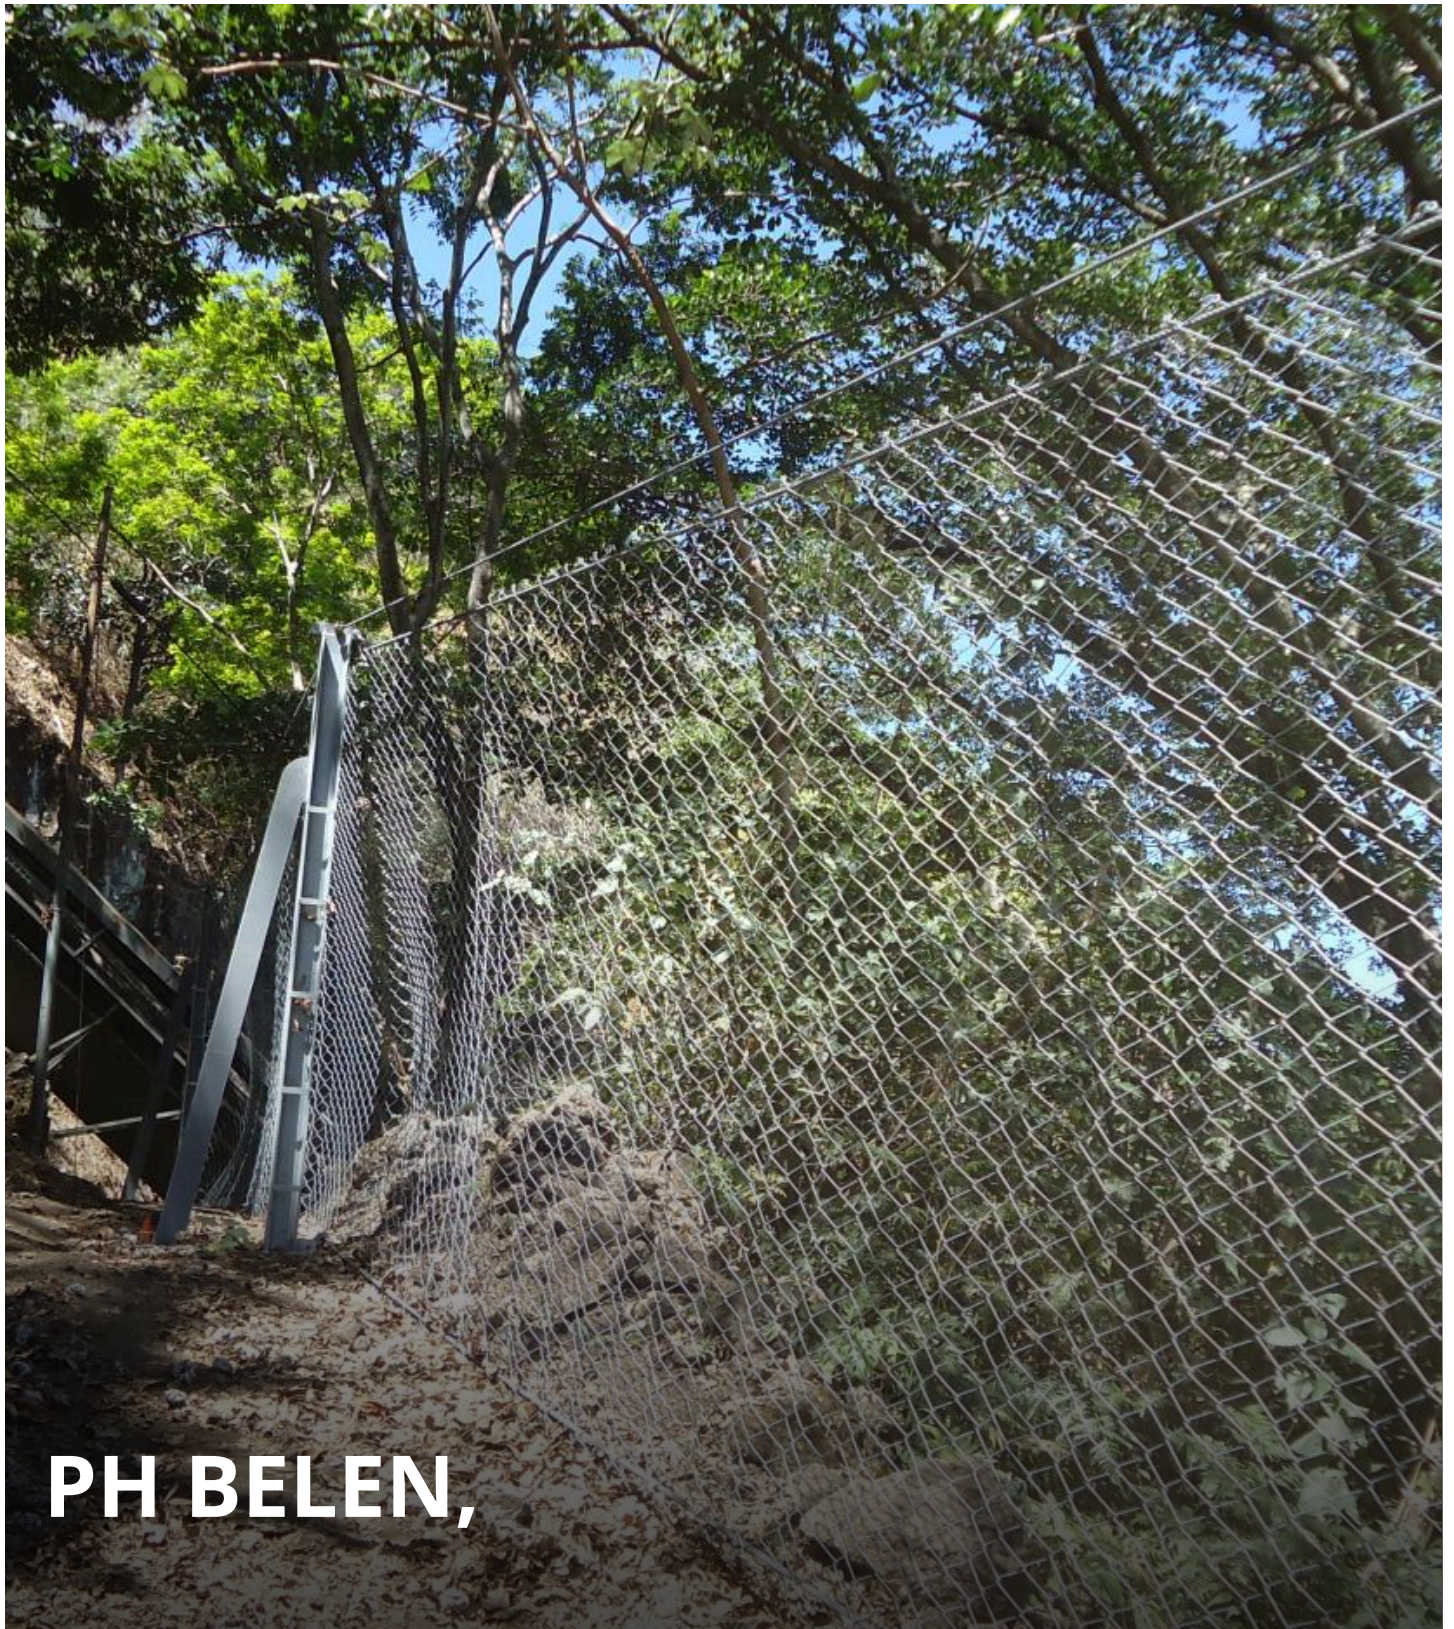
Two pipes and the hydro power house station of PH Belén were threatened by rockfalls.

Combined solution was implemented, including GBE rockfall barriers, shallow landslide barrier and active slope stabilization with TECCO® SYSTEM³ and DELTAX® mesh.
