HYDROELECTRIC POWER PLANT TUNNEL, 20.06

During construction of the headrace tunnel in July 2012 for a hydro power plant some severe rockburst occurred. The high internal stress in the rock and overburden over 1000 m on top of the tunnel as well as the brittle metamorphic character with a rock mass rating RMR > 65 caused some severe problems during the project.

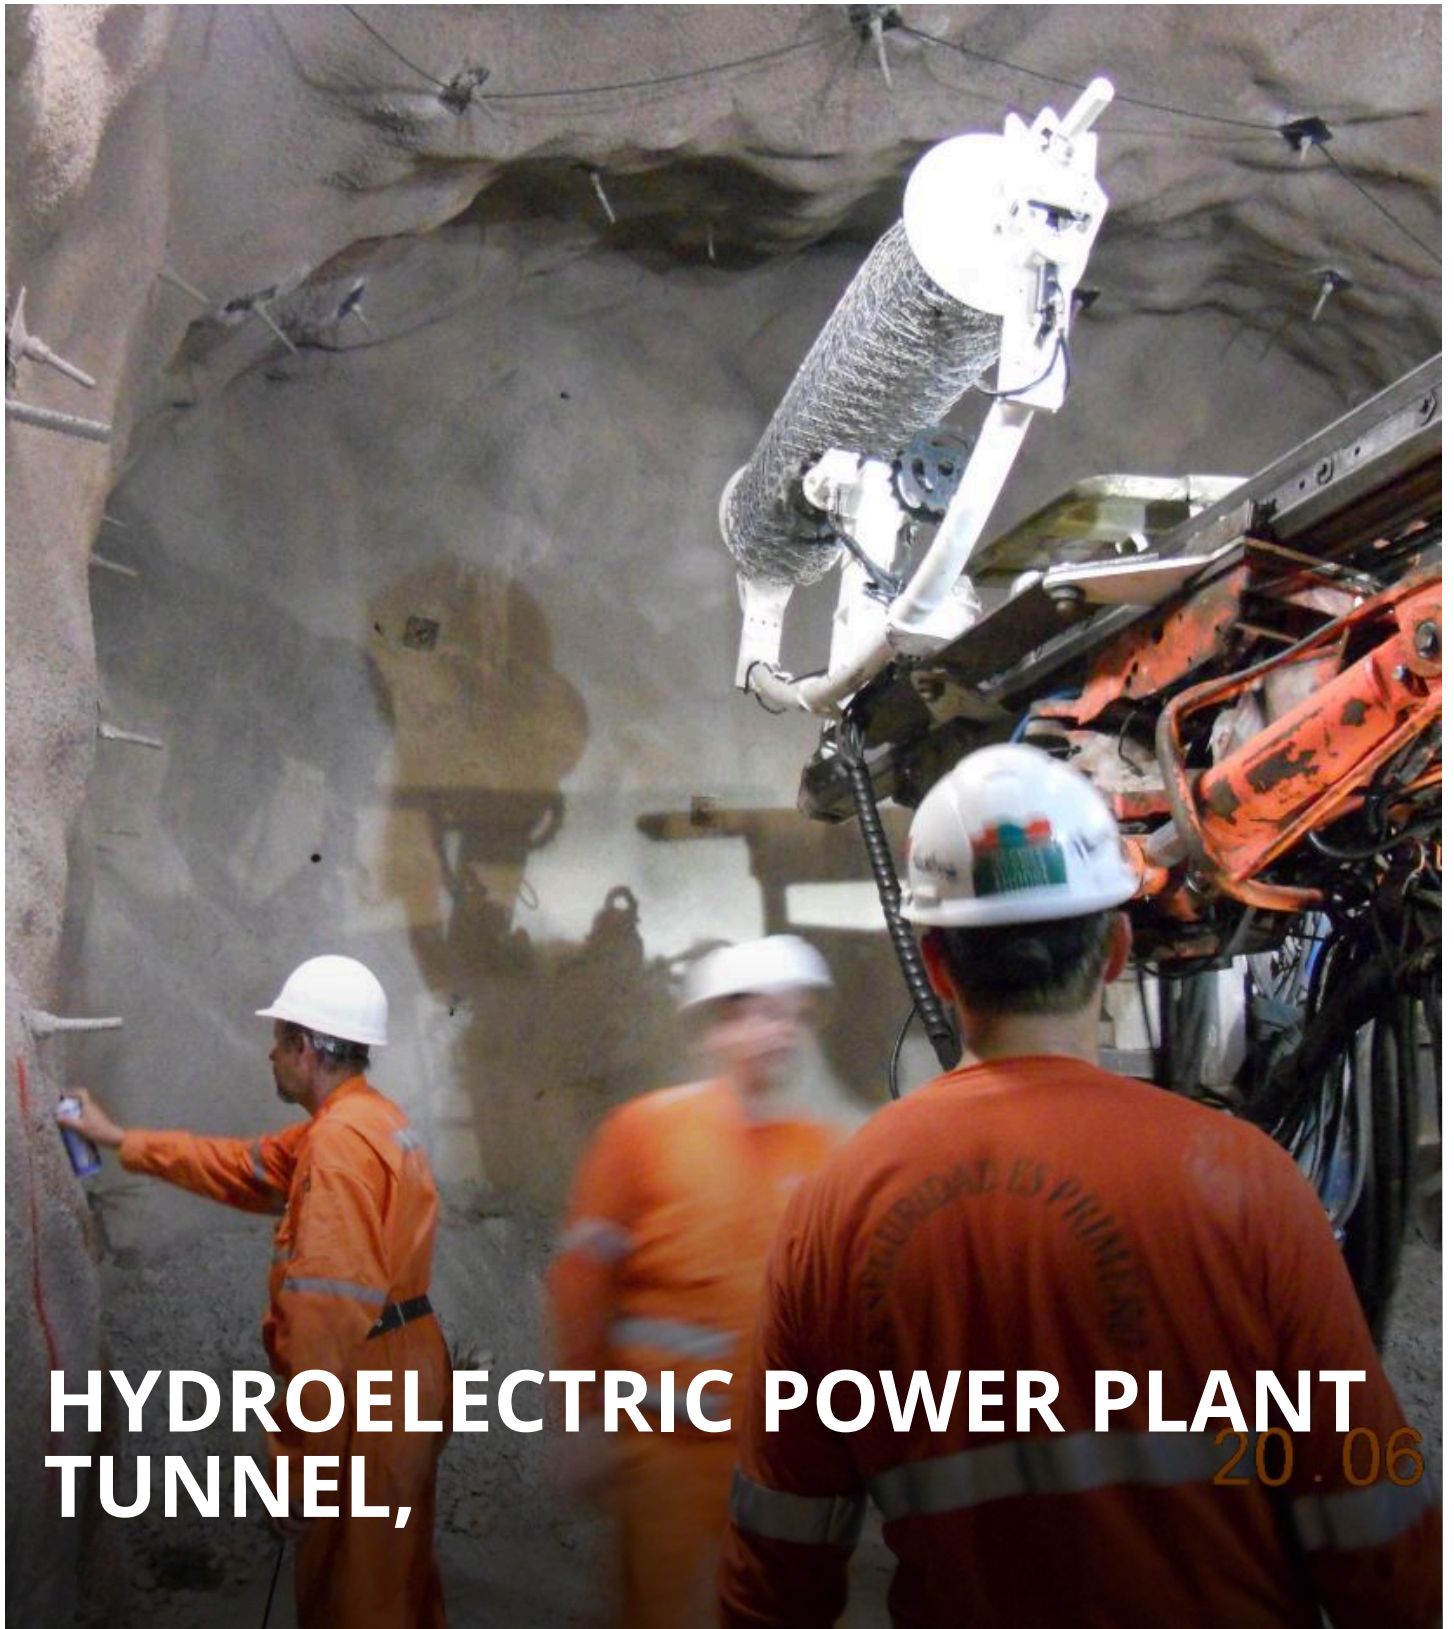
The tunnel was divided in sectors to analyse the stress level in regard to the *high stress classification* whereas it shows that some rockbursts of level 2 and 3 occurred. In the most critical zone a support system with MINAX® 80/4 was applied in combination with mechanized installation thanks to Geobrugg's MESHA® handler. The installation time had been decreased between 20 to 25% and safety for workes was significantly improved.
