STEIGERWEG, HEIDELBERG,

2014

Civil Engineering Department, Heidelberg
Dr. Spang, Ing.-gesellschaft mbH
Bremer Schutz Verbauungen GmbH

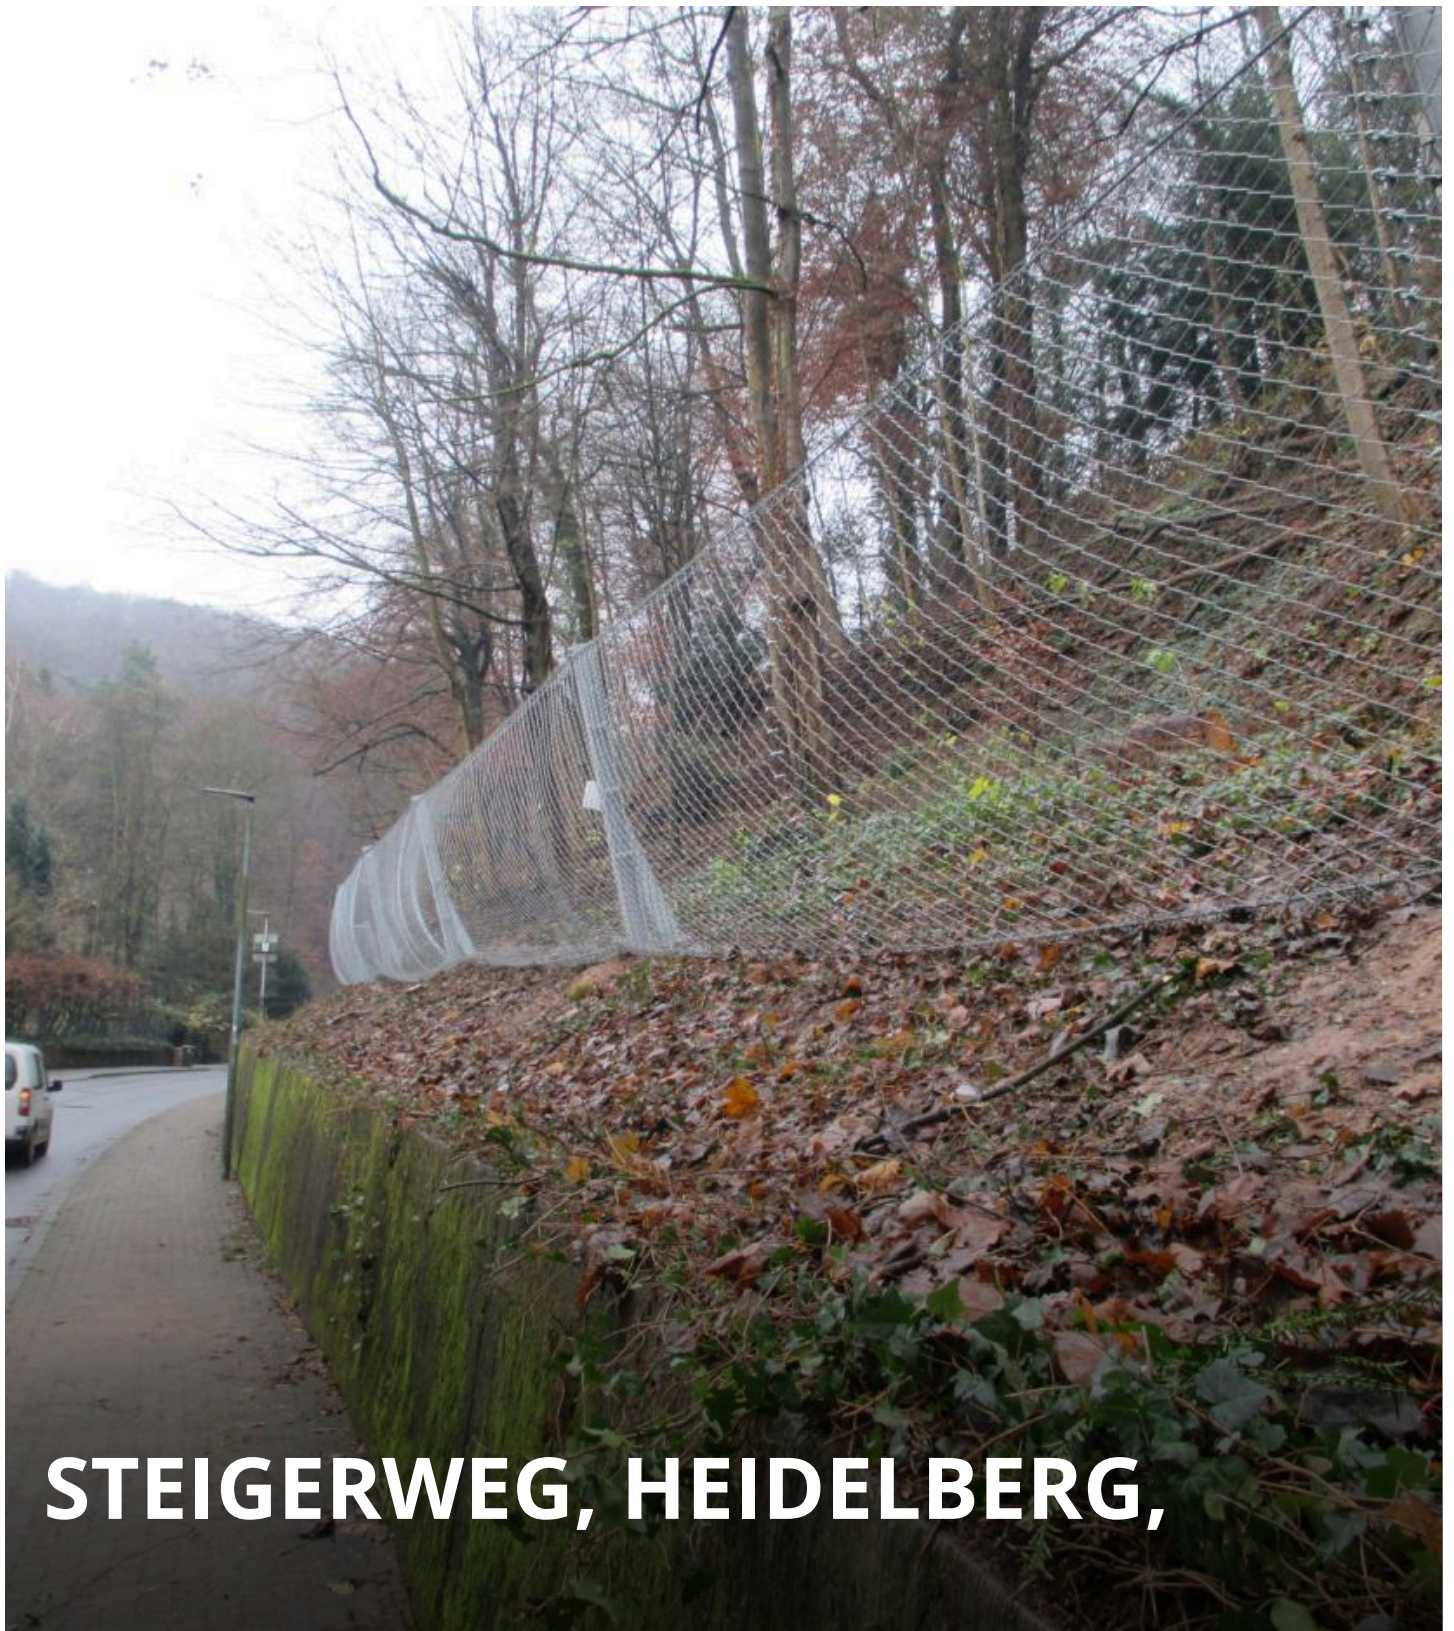
Installation of two rockfall protection fences at a length of 195 meter just behind an existing supporting wall right beside the road Steigerweg.

Pedestrians and traffic on Steigerweg road, at the Western end of the town Heidelberg, was in danger because of falling rocks and stones as well as weathered hillside rock. In the past, the hillside was worn away after heavy rainfall. It was planned to permanently secure Steigerweg road and the parking space in the Eastern part of the area by installing a rockfall protection barrier and fixing the exposed rocks with anchors.
