# NESSELWÄNGLE BEI REUTTE,

# Nesselwängle bei Reutte

Wildbach- und Lawinenverbauung WLV Ausserfern  
Wildbach- und Lawinenverbauung WLV Ausserfern  
Wildbach- und Lawinenverbauung WLV Ausserfern

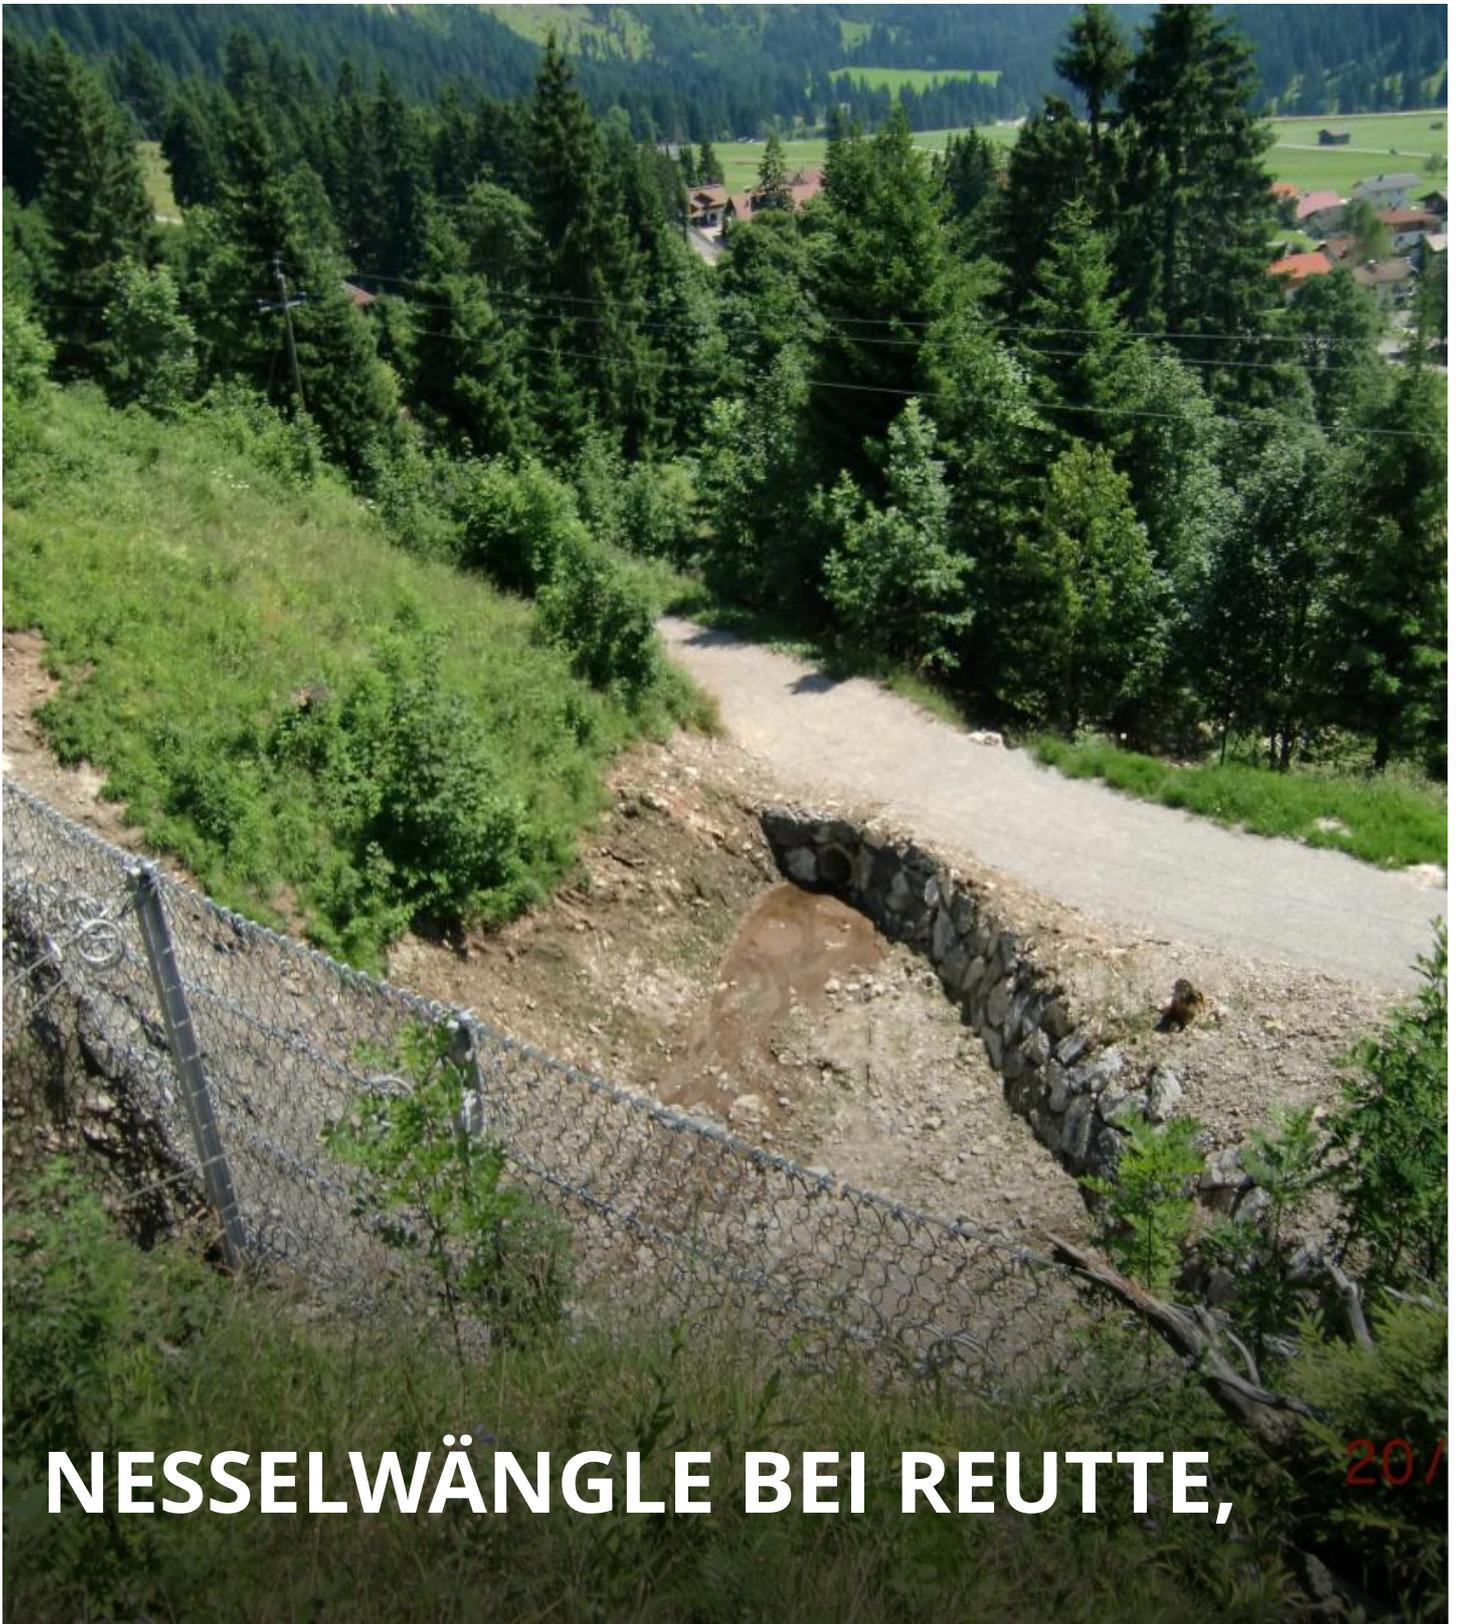
The geometry and the slopes of the Schmalecklesbach stream, positioned some 10 meters above the woodland trail, provide an ideal location for the installation of a debris flow barrier. The slopes of weathered, loosened, or solid dolomite rock ensure that the earth cannot work itself free at the sides. The UX120-H6 barrier is designed with two supports to provide optimum protection for the overall height of 6 meters and with an upper span of 23 meters, should an incident occur.

By opening the nets, the barrier can be cleared out from the existing woodland trail following debris flow from the valley.

In the fall of 2009, heavy local rainfall above Nesselwängle was responsible for the accumulation of debris caused by flooding. The inconspicuous Schmalecklesbach stream brought debris, humus, and deadwood down into the valley. A high proportion of deadwood led to logs becoming jammed. The woodland and hiking trail leading to the mountain cabin was washed away. The rock settled at the lower levels of meadowland and in the gardens neighboring the settlement.
